SELECTED CONSERVATION WORK IN MARINA EL-ALAMEIN IN THE 2012 AND 2013 SEASONS

Marlena Koczorowska,¹ Wojciech Osiak²

Abstract: In the 2012 and 2013 seasons, the conservation program of the Polish–Egyptian Conservation Mission to Marina el-Alamein included conservation activities in selected rooms of the complex of Roman (southern) baths in the central part of the town and, in 2013, elements of the monumental tomb T21, as part of the general program for the preservation of its remains. In 2013, conservation of selected items, wall paintings in particular, from the stores was undertaken.

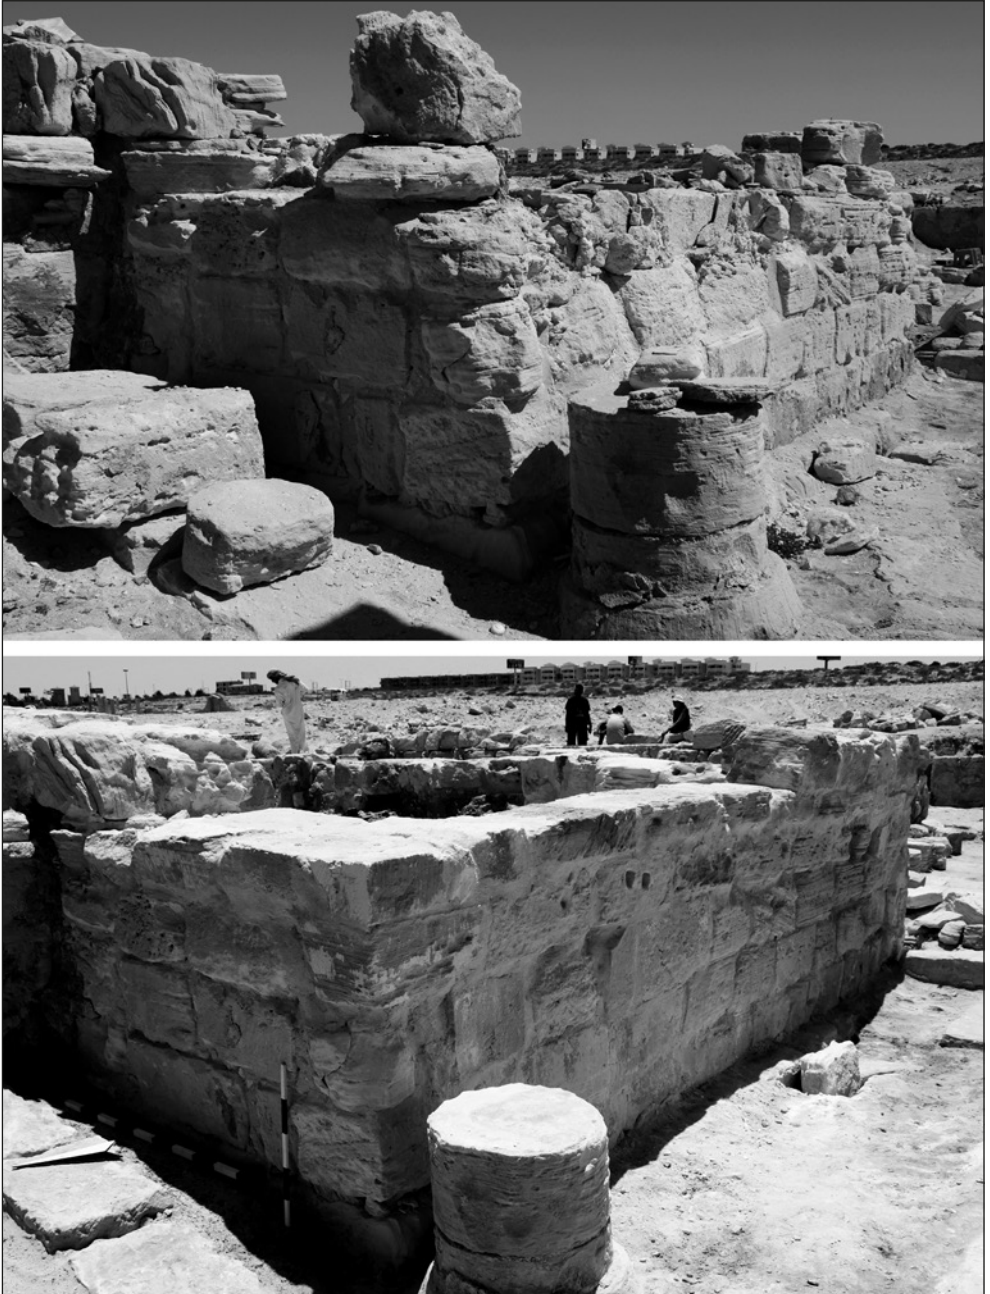
a plan of the baths and their location within the urban layout of the ancient town of Marina, see below, Fig. 1 on page 115). The bands protecting the edges were found to be slightly damaged, hence the need to reinforce them in places and to fill in the gaps. Detached tesserae were reinserted and the protective band repainted. In both cases a lime–cement mortar with

Fig. 1. Bath courtyard (room 4): external walls of room 7 before (top) and after (bottom) conservation in 2012 (Photos R. Czerner)

Protective bands were introduced around numerous relics of plaster and wall painting on the east, south and west walls. Patches of stone were prepared for the east wall (surrounding the *alveus* = room 7a). Slabs 15–20 cm thick were used, matching their size to the original blocks. They were mounted then in prepared sockets using mineral lime–cement mortar with sand filler. Several eroded remnants of limestone blocks and lime mortar were removed from the top layers of the wall. Slabs matching the original ones were found to replace them, and they were set with the use of mineral mortar [Fig. 1].

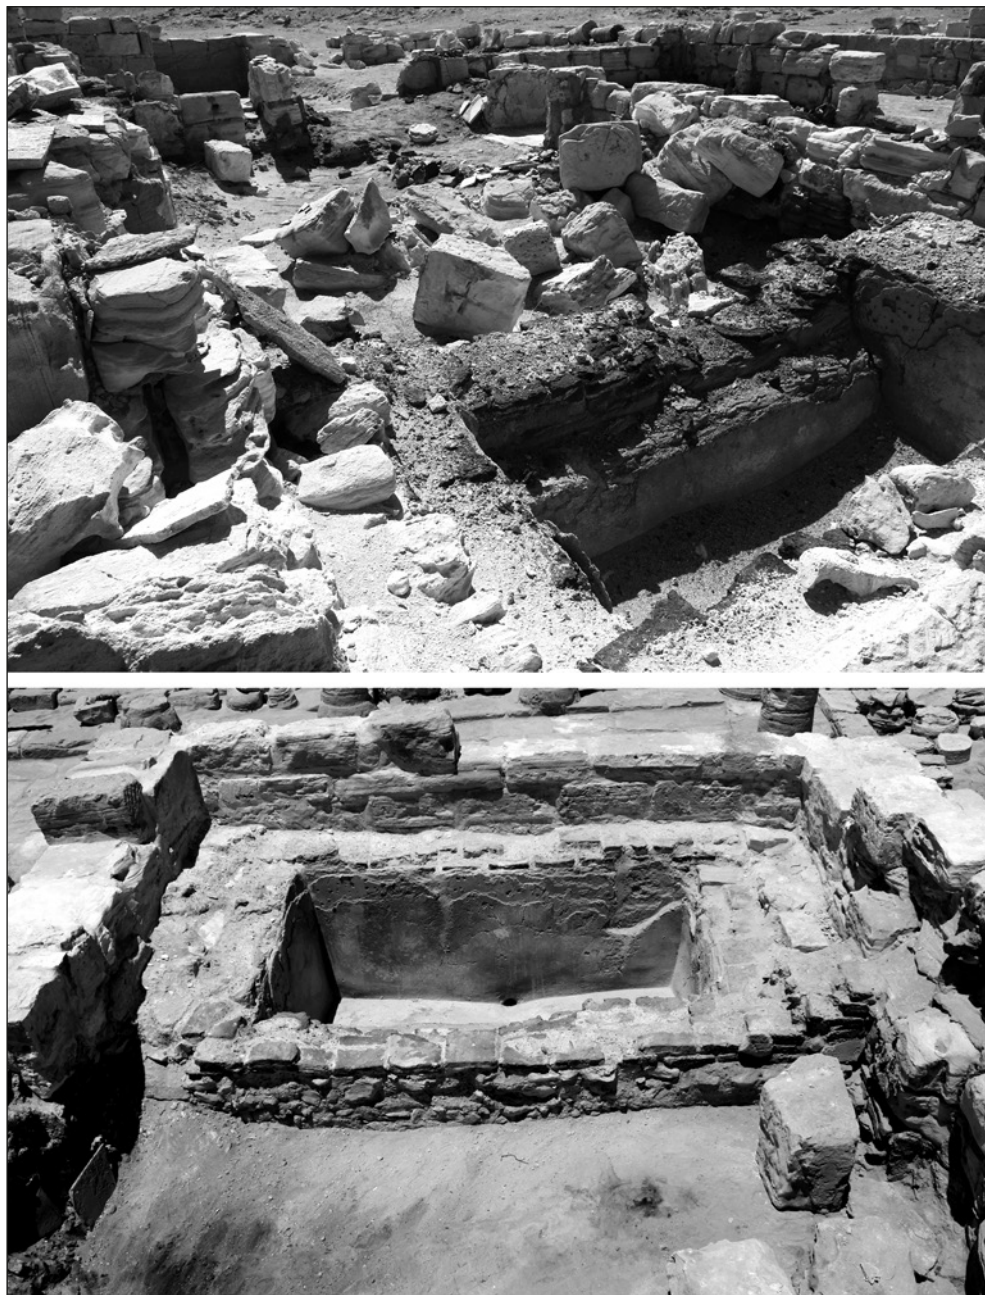
*Fig. 2. Baths, alveus 7a before (top) and after (bottom) conservation in 2012
(Photos R. Czerner)*

In the *alvei*, 7a and 7b, protective bands were put around the edges of plaster that had become detached from the wall. Damaged joints were filled in with lime–cement mortar with sand filler (six parts sand to one part lime to one part white cement). Putties from mineral mortar as above were used to protect the edges of preserved plaster on the walls of the bath. The top surface of the wall surrounding the *alveus* (7a) was reconstructed in places [Fig. 2].

The biggest breach in the east wall built of broken stone was filled with blocks of local limestone set in lime mortar. Apart from sand, finely crushed pottery was used as filler to make the mortar similar to the preserved original one. A layer of ancient bricks salvaged

from rubble heaps lying nearby was placed on the tops of the wall. Whole bricks or pieces of them were chosen and fitted not to exceed 4 cm in height and 24 cm in length. Four whole bricks and 10 fragmentary ones (surviving 30–50% of the original brick) were used. Lime–cement mortar as above was used with ceramic filler similar to the original one preserved in the ancient mortar.

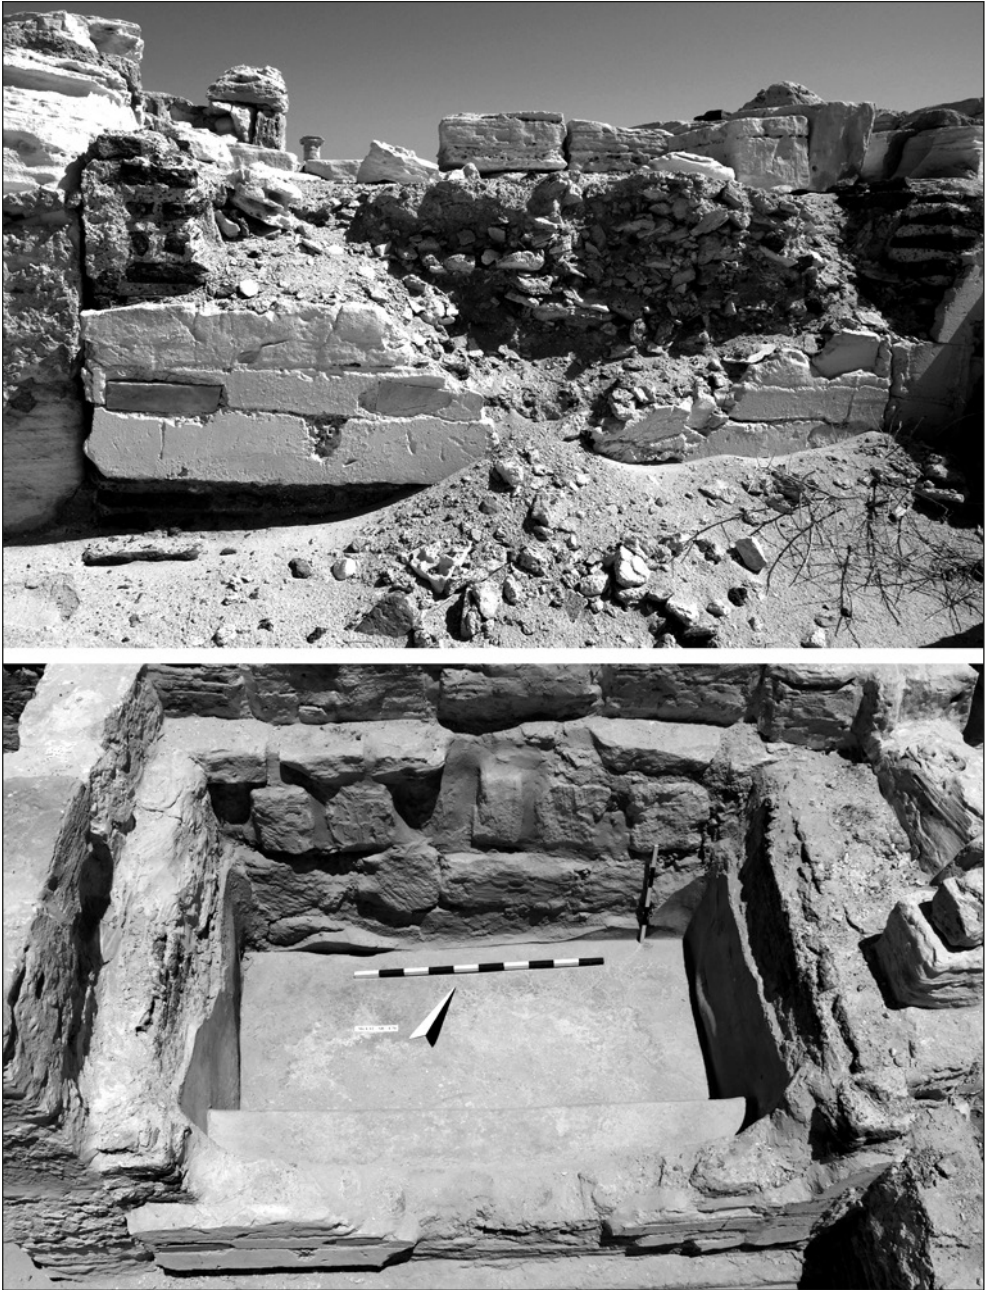
*Fig. 3. Baths, alveus 7b before (top) and after (bottom) conservation in 2012
(Photos R. Czerner)*

In the other *alveus* (7b), it was necessary to protect numerous extensive relics of plasters. On the front (southern) wall, big losses in the corners were filled in and bands were put around the mortar which used to be the base for setting a facing of marble slabs. Deep losses of the joints were filled in, as well as gaps in the upper parts of the wall resulting from intensive weathering of the limestone [Fig. 3].

A patch of stone was fitted into a highly weathered block in the face of the east wall. The entire face of this block was cut back 25 cm in order to fit in the replacement, which was set using mineral mortar as described above.

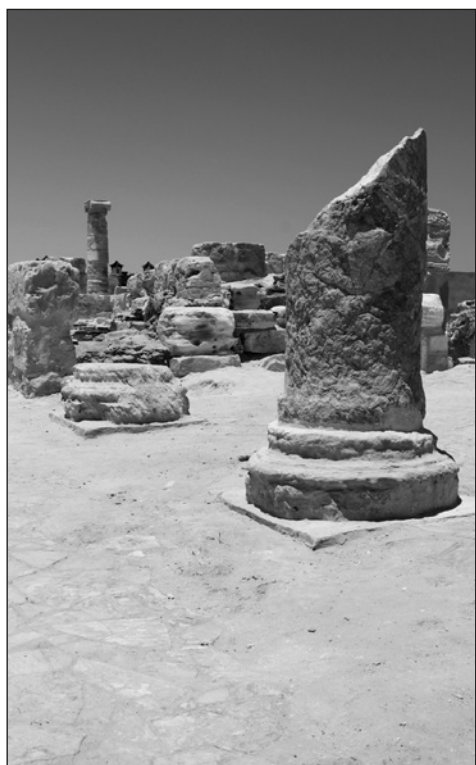
Fig. 4. Baths, room 8a–8b: marble columns after partial anastylosis and conservation in 2012 (Photo R. Czerner)

Square plinths were levelled above the marble floor in room 8, preparing the place for the anastylosis of two ancient marble bases [Fig. 4]. Horizontal insulation against humidity in the form of bitumen paper of high resistance was introduced between the plinths and the bases. The biggest losses in the bases were filled in with lime–cement mortar in proportions as above. Joints were filled between the plinths and marble. A relic of a column shaft made of similar veined marble was placed on the eastern one of the two bases. The shaft had been found in this room in the previous season. It was smoothed on the surface and mounted with the use of mortar as above. A joint was introduced. The two plinths were partly reconstructed to a square plan in order to make their geometric form more evident.

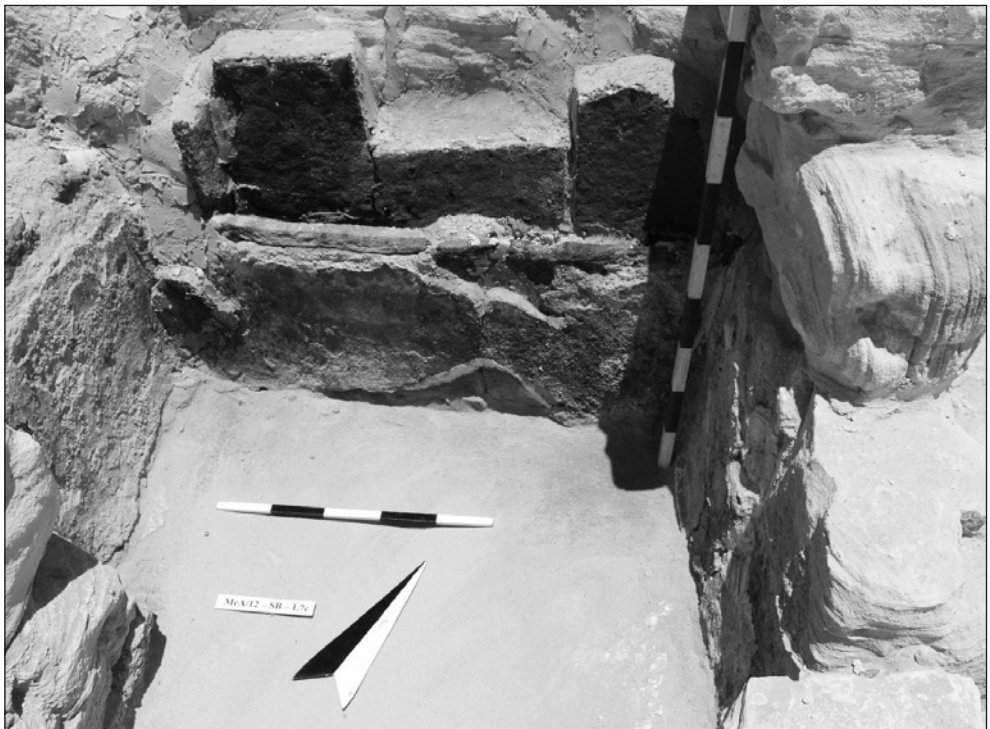
Fig. 5. Baths, room 7c: element of the heating system after conservation in 2012 (Photo R. Czerner)

Relics of plasters and vertical ceramic elements of the heating system were protected [Fig. 5]. Mineral mortar as above was used. The loss of ceramic elements amounted to about 60%. The best two matching elements from among the pieces that were recovered during excavation of the chamber were mounted in place, next to the only surviving one. Mineral mortar as above was used for the purpose. The ceramic elements were restored with glue. The highly weathered wall around the ceramic elements was made smooth and reinforced with lime–cement mortar.

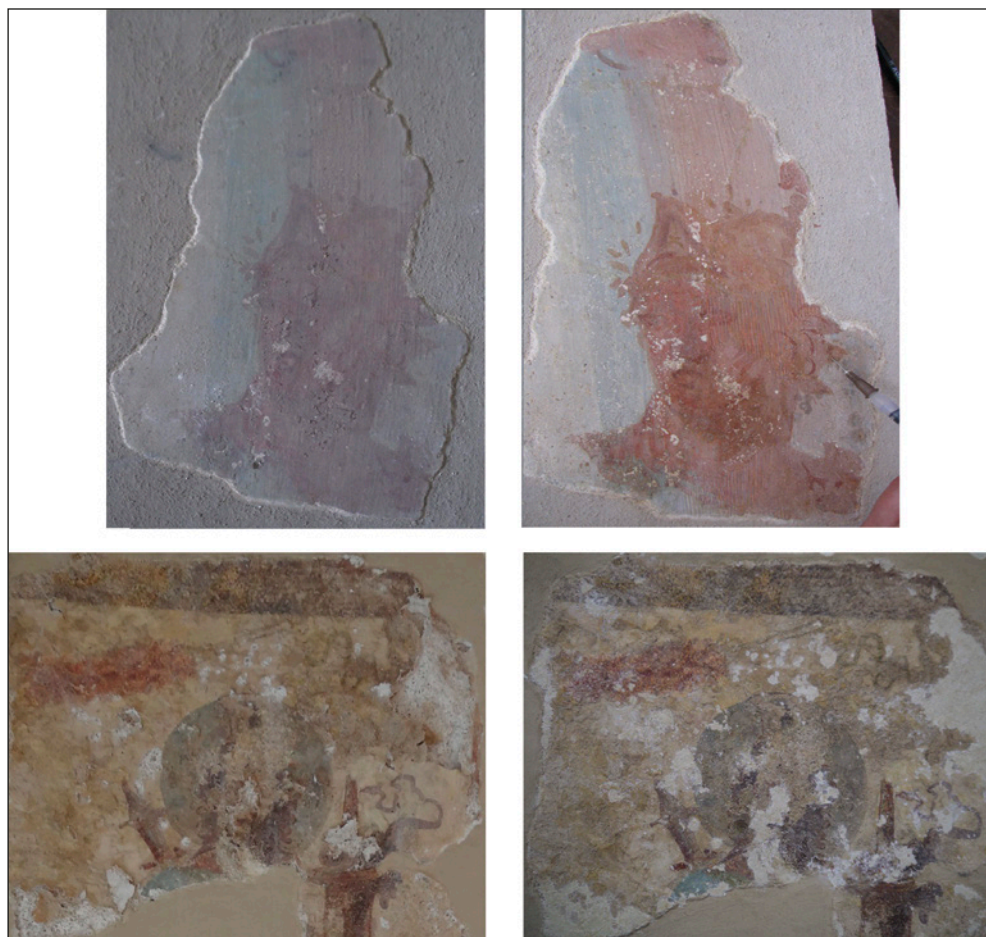
Fig. 6A. Wall painting fragments, before (left) and during (right) salvage conservation in 2013: top, portrait of a queen in nautical crown; bottom, depiction of Heron (Photos M. Koczorowska)

cleaned from the surface. The painting had undergone thorough conservation in 1999, after being transferred to substitute ground. Damp in the storeroom caused the thin paint layer to become detached from the mortar layer and to start to crumble. In numerous places the paint and mortar layers have also become detached from the substitute ground.

This transfer proved to be in the worst condition, 80 percent of the surviving original having become detached. A considerable part of the painting was missing from the top right corner. The whole surface of the paint layer was covered with a salt deposit about 0.5 mm thick, which became hard and strongly integrated with the polychromy. The painting had become much less clear, and was rising and swelling due to the constant migration of salt to the surface.

Standard documentation was made. The paint layer was cleaned of loose deposits. In 1999, the painting had been cut from the wall with a fragment of the limestone block that was the original ground. A thorough conservation of the paint layer together with the mortar layer was carried out at the time. The damp in the storeroom affected this piece in a similar way as the previous two transfers.

The weakened spots were reinforced by injection of PRIMAL AC 33 with water (1:3), after an earlier reduction of the surface tension by ethanol with water (1:1). Wet layers were pressed against the ground with flat marble pieces, and simultaneously small fragments of non-adhering paint layer were put in place. The process was completed with the making of the final documentation.

Injections of PRIMAL AC 33 with water (1:3) were made after an earlier reduction of the surface tension by ethanol with water (1:1). Wet layers were pressed against the ground with flat marble pieces and with spatulas, and simultaneously small fragments of the paint layer non-adhering to the ground were put back in place. Empty spaces where the mortar layer had degraded and started to crumble were filled with a suspension of LEDAN TC1 in water (1:1). Losses in the mortar layer were filled in next, using lime-sand mortar with filler consisting of fine-grained sand and marble powder (1:1) in a proportion of 1:3, adding water with about 2 percent of PRIMAL AC 33 as plasticizer. The layer of mortar applied was minimally thinner than the original, and its surface was smoothed. Next, a kind of levelling white-wash made of LEDAN TC1 colored with pigments was applied to the newly filled spots. Retouch is planned using pigments with 5 percent solution of PRIMAL AC 33 in water. Final documentation was made.

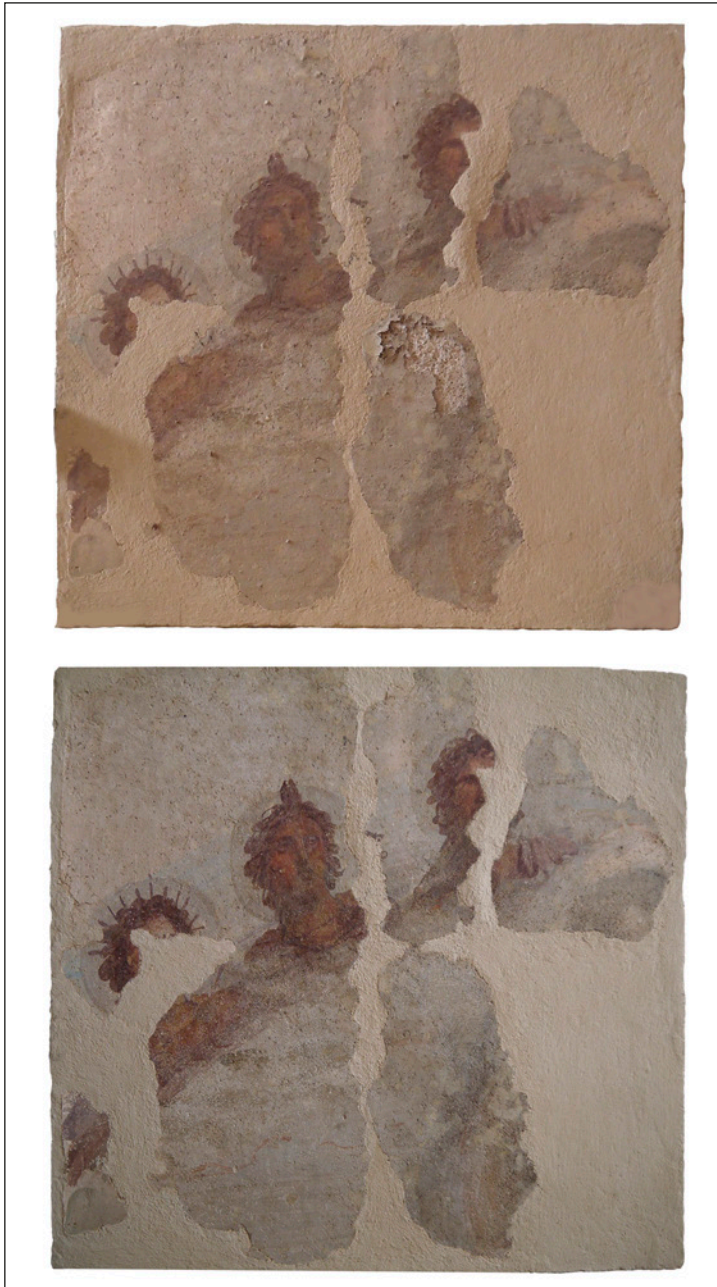
Fig. 6B. Wall painting fragments with representations of Helios, Harpokrates and Serapis before (top) and after (bottom) salvage conservation in 2013 (Photos M. Koczorowska)

The same preliminary procedure was followed in the case of the second transfer which had also been conserved in 1999 and which also suffered from the damp in the storeroom. About 60 percent of the mural had become completely detached from the substitute ground and a considerable part of the painting was missing from the central section.

As in the case of the first transfer, injections of PRIMAL AC 33 with water (1:3) were made after an earlier reduction of the surface tension by ethanol with water (1:1). Wet layers were pressed against the ground with flat marble pieces, and simultaneously small non-adhering fragments of the paint layer were replaced. Furthermore, wherever the mortar layer had degraded and crumbled, empty spaces had formed, depriving the original paint

layer of a support substrate. These spaces were filled with a suspension of LEDAN TC1 with water (1:1). Next, losses of mortar were filled with lime-sand mortar with filler consisting of fine-grained sand and marble powder (1:1) in a proportion of 1:3, adding water with about 2 percent of PRIMAL AC 33 as a plasticizer. The layer of mortar applied was minimally thinner than the original, and its surface was smoothed. Next, on the filled in spots a kind of levelling whitewash made of LEDAN TC1 colored with pigments was applied. On the ground prepared like this, a retouch is planned using pigments with 5 percent solution of PRIMAL AC 33 in water. Standard final documentation was prepared.
