RESEARCH AND CONSERVATION IN MARINA EL-ALAMEIN IN THE 2012 AND 2013 SEASONS. THE POLISH–EGYPTIAN CONSERVATION MISSION

Abstract: In 2012 and 2013, the Polish–Egyptian Conservation Mission to Marina el-Alamein focused on research and conservation in the public part of the ancient town, the dwelling houses and the necropolis. A site presentation program was continued in the area south of a public square, where remains of Roman public baths, in use from the 2nd to the 4th century, have survived. Current maintenance and conservation was carried out on the site of dwelling houses and, in 2013, on the aboveground mausoleum of tomb T21 in the necropolis. Conservation of mural paintings was undertaken also during the seasons.

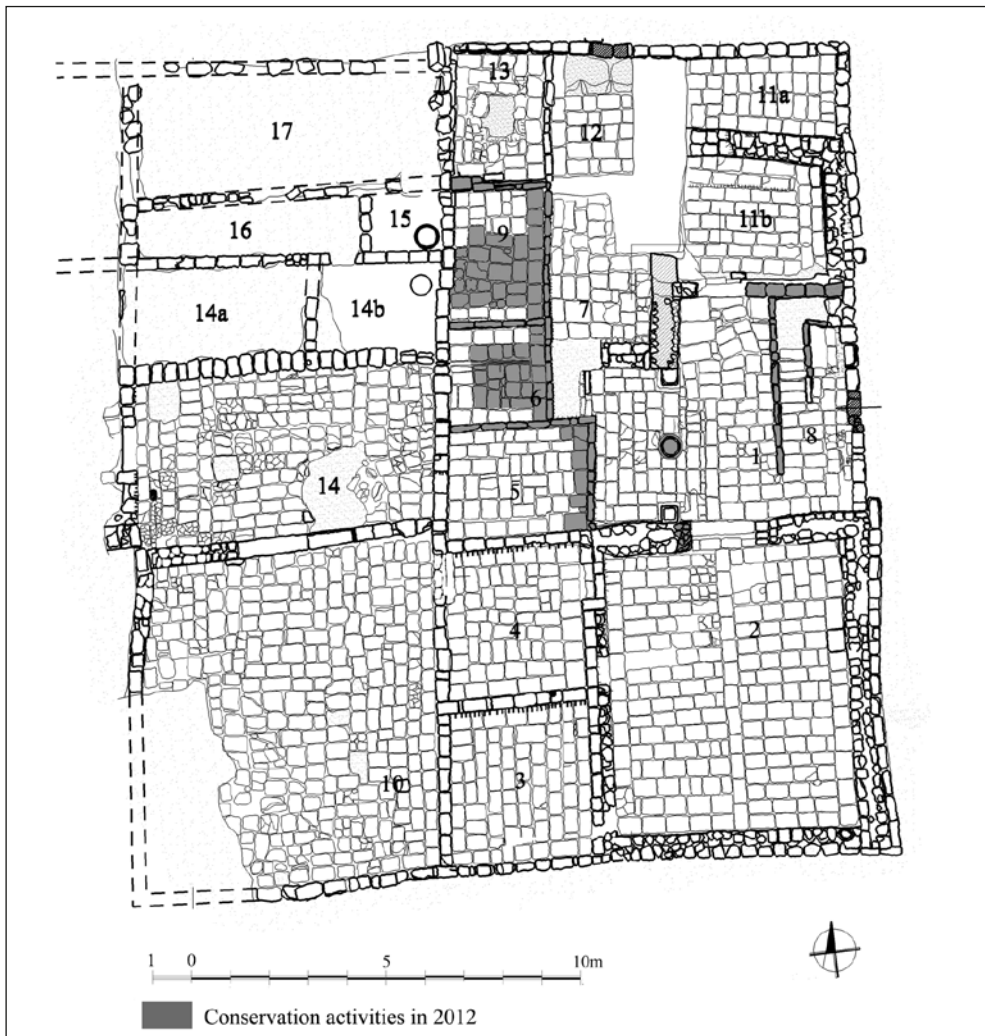
Fig. 2. Houses H2 and H2a. Plan showing areas of conservation activities in 2012
(Drawing R. Czerner, M. Krawczyk-Szczerbińska, S. Medeksza)

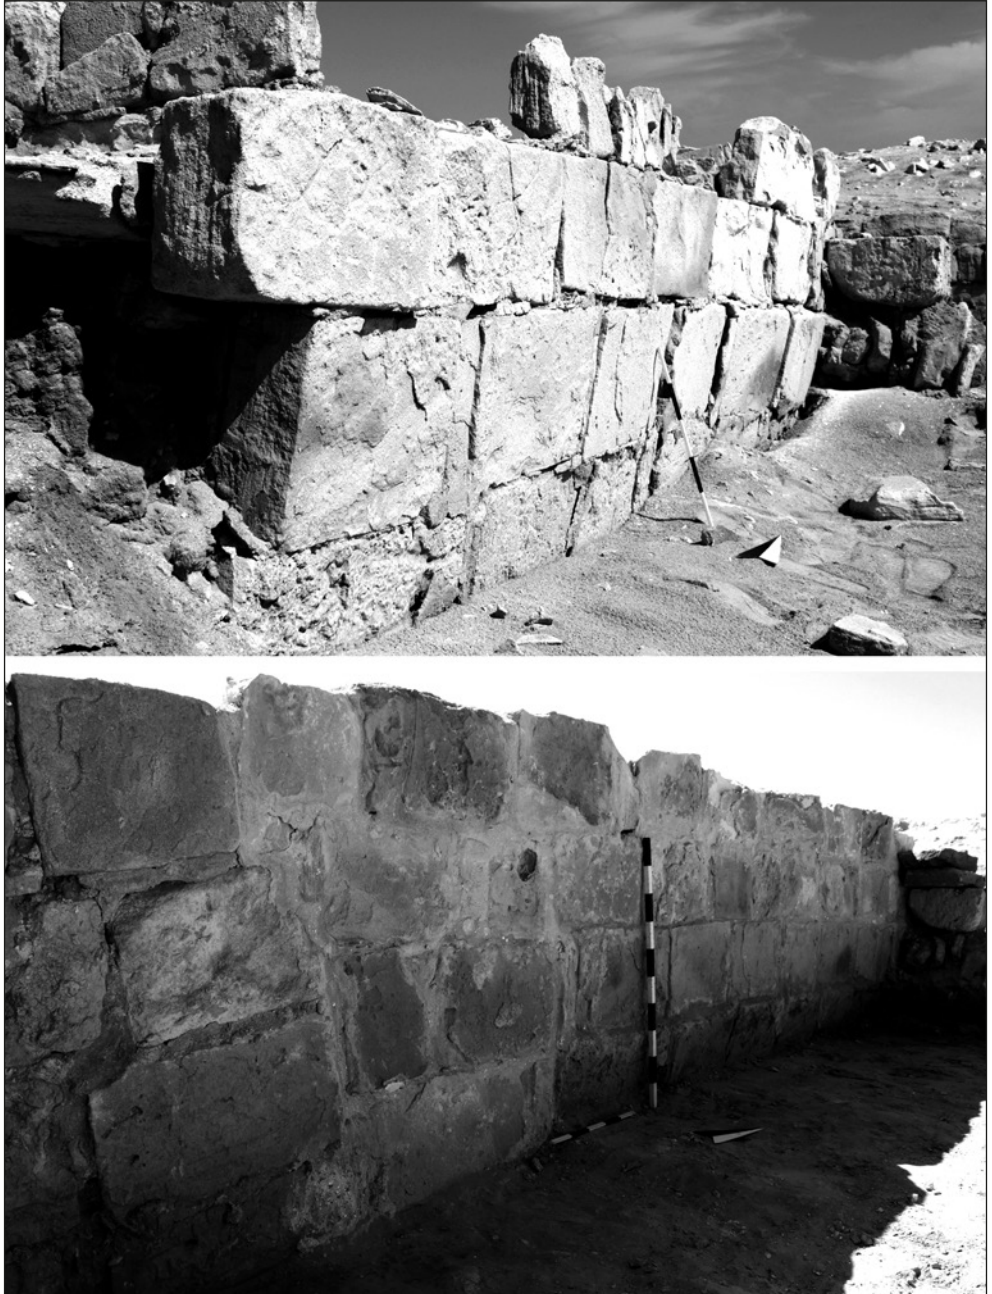
The wall separating house H2 from house H2a was heavily tilted eastward in its northern part and threatened to collapse.

occupational levels, the lower parts of this wall acted also as a retaining structure. However, being built of very narrow (about 0.20 m thick) upright slabs, it had started to lean dangerously toward the east and was in danger of collapse [Fig. 3 top]; indeed, it had already collapsed in one

Fig. 3. Houses H2 and H2a: retaining wall before (top) and after (bottom) conservation in 2012 (Photos R. Czerner)

place, next to room 6, along with the vault of a cistern in room 9. The aim of the protection and reconstruction project was to dismantle the top two courses of the endangered east wall in rooms 5, 6 and 9, as well as the parts of floor on the higher level adjacent on the west, and to rebuild

them restoring the correct geometry [Fig. 3 bottom]. The damaged part of the cistern vault in the room 9 was also rebuilt and the floor above it was reconstructed.

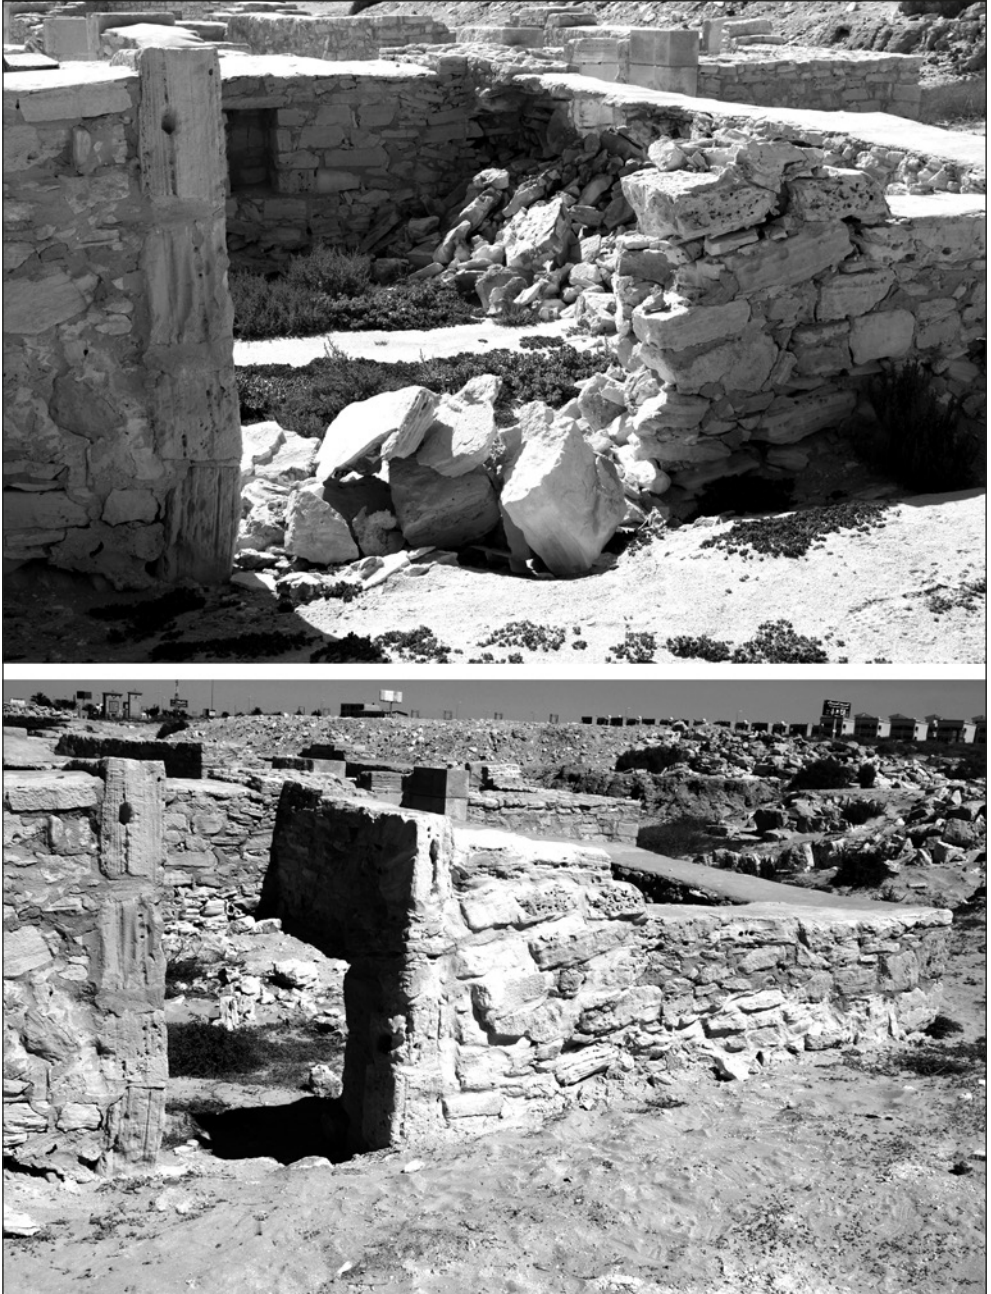
In houses **H9** and **H9a**, where the upper parts and tops of walls of broken stone had been added as part of the conservation effort in 1996–1999, water flowing along the walls of the building caused erosion of limestone and mortar in the joints of the walls in the lower (ground) zone up to a height of 0.20–0.40 m, resulting in the collapse of some parts of the walls, collapse of the right jamb of the entrance to the “tavern” [Fig. 4 top], collapse of a 2-m-long fragment of south wall in the “tavern” under the wall top [Fig. 4 top], considerable washing out of the mortar and stones in the northwestern corner of house H9a. Repairs were carried out in 2013.

Fig. 4. House H9. Walls and door jamb of the “tavern” before conservation (top) and after, view in 2013 (Photos R. Czerner)

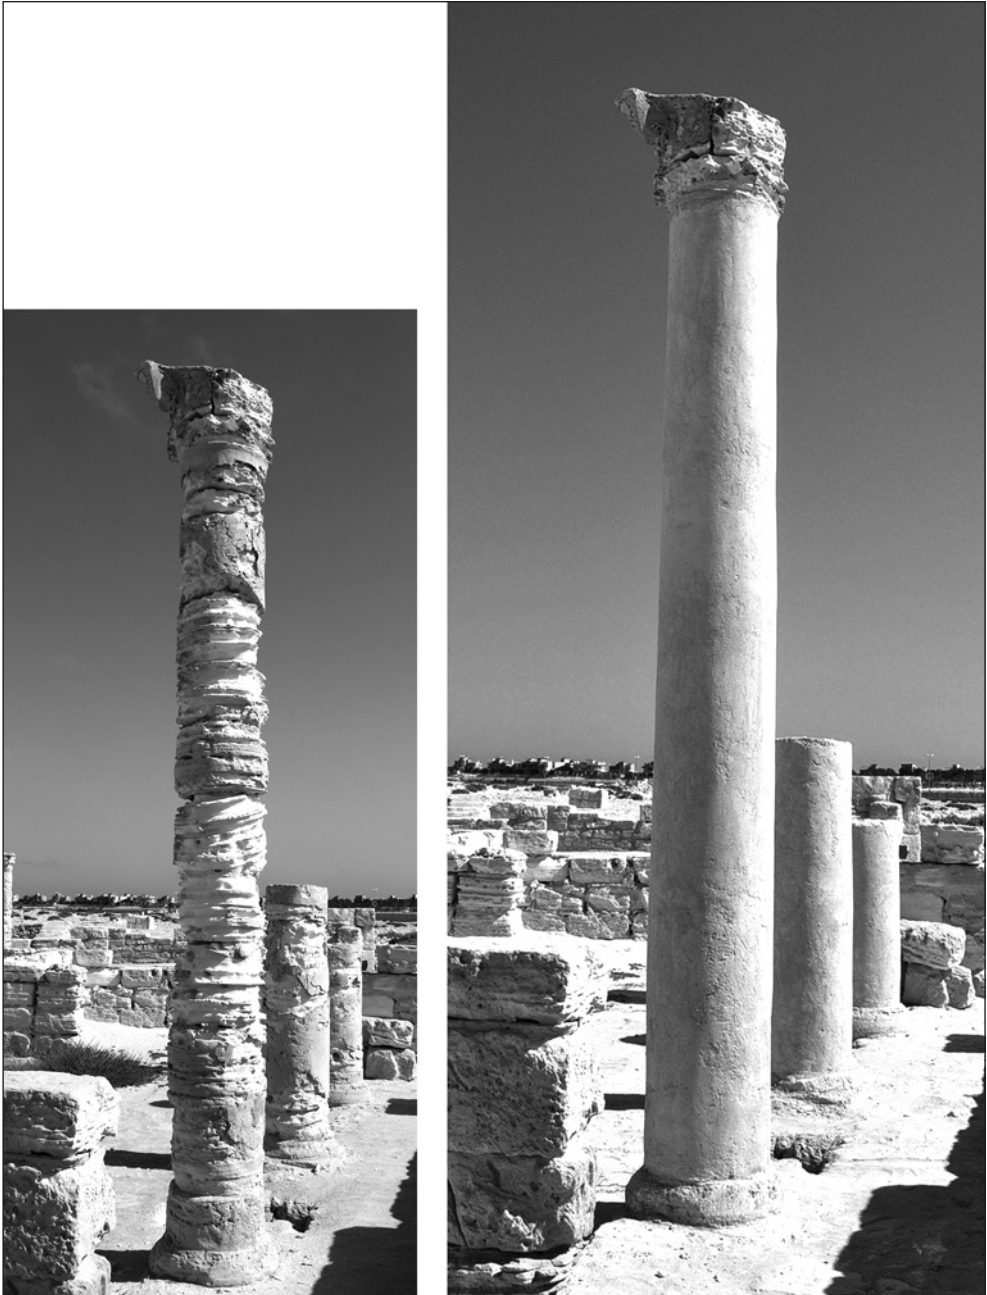
Heavy winter rains, blowing winds and high salinity also caused losses of mortar in joints of columns and powdering of limestone used to built houses **H21c**, **H10**, **H10a**, **H19**, **H2**. A progressing weathering was observed of stones in the wall and the drums of the columns, which

had undergone anastylosis in 1998–2005 [Fig. 5 left]. Original drums had been used then, following a study of the scattering of the elements and replacing missing elements with new drums carved from limestone.

Fig. 5. House H10a. Damaged columns before conservation in 2012 (left) and after (Photos R. Czerner)

Conservation now aimed to clean the side surfaces of stones and the inner spaces of joints, to soak them thoroughly with water and to fill in the losses in joints with lime–cement mortar in standard proportion, and to apply one or several (bigger losses) layers of plaster using lime–cement mortar in a proportion of nine parts sand to three parts lime to one part cement [Fig. 5 right]. White Portland cement and hydrated lime were used.

House H10a: joints and plasters on six columns;

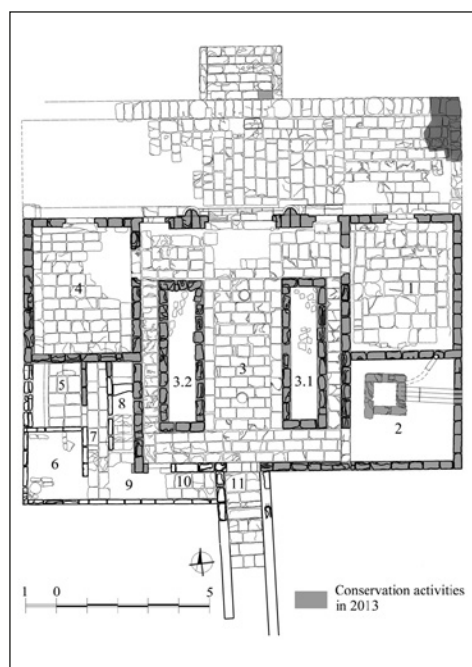
Fig. 6. Tomb T21. Plan showing areas of conservation activity in 2013 (Drawing W.A. Daszewski, A. Błaszczuk; PCMA Mission Archives)

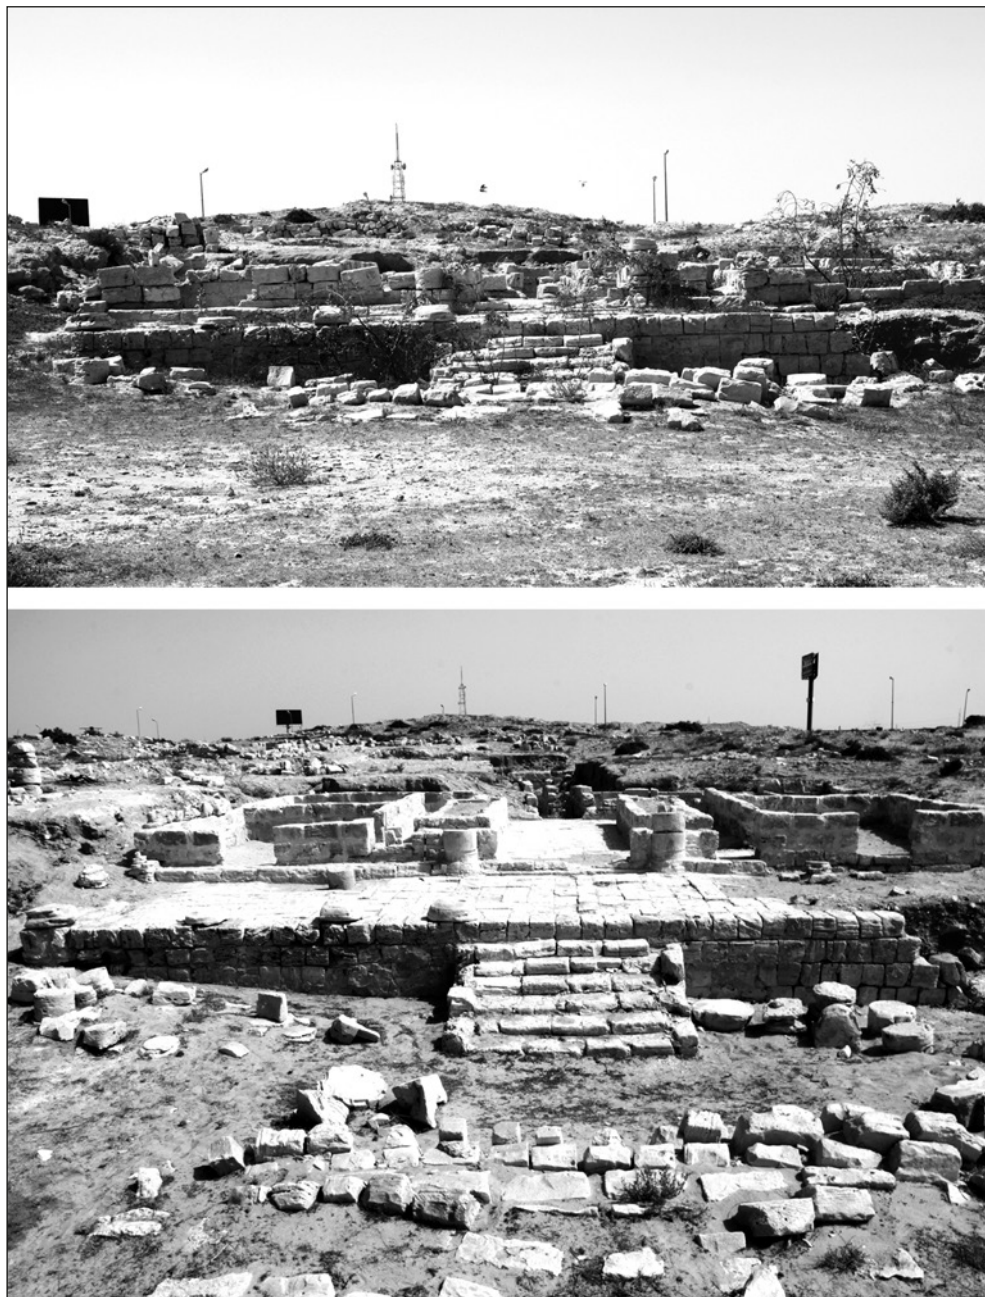
*Fig. 7. Tomb T21. Mausoleum before (top) and after (bottom) conservation in 2013
(Photos R. Czerner)*

Conservation work added a course of stone blocks to the walls of room 1. Blocks from the excavation, which had been stored next to the tomb, were used for the purpose [Fig. 7]. Blocks were cut to size to be placed in the jambs of the entrances. In room 2, some stones from the second course were replaced with blocks that had

a patinated, resilient surface. To the south and to the east, a third course was laid from blocks stored next to the tomb. An original block cut to hold a downspout carrying rainwater into the cistern was left in place (another drain ran into the cistern from the outside of the tomb on the east). The third course in the east wall was laid using blocks sized 0.20–0.24 m by 0.28 m by 0.48–0.54 m.

For masonry work lime–cement mortar with sand, hydrated lime and white Portland cement (6:3:1) was used.
