Assessment of the building's geometry and technical condition on the basis of the data acquired by means of 3D terrestrial laser scanning

The measurement was conducted in Klewki, a location in the Warmia-Mazury Province (Poland). The historic St. Valentine and Roch's parish church has been selected as the object of the study. The first temple building was erected in this place approximately in 1352. Unfortunately, it was burnt at the beginning of the 15th century. The church was rebuilt, but it experienced another fire in 1718. During its reconstruction some parts, e.g. windows, were redeveloped. In 1829, the subsequent redevelopment took place, during which a timber tower was erected. The church is buttressed, which means that vertical counterforts have been used in it as structural members, transferring the load to the foundation and strengthening the walls. It is a Gothic church built of bricks and field stones. The timber tower adheres to its western side and the sacristy is located at the northern side (Fig. 1). The main body of the building is covered by the ridge roof, made as double collar-beam timber structure.

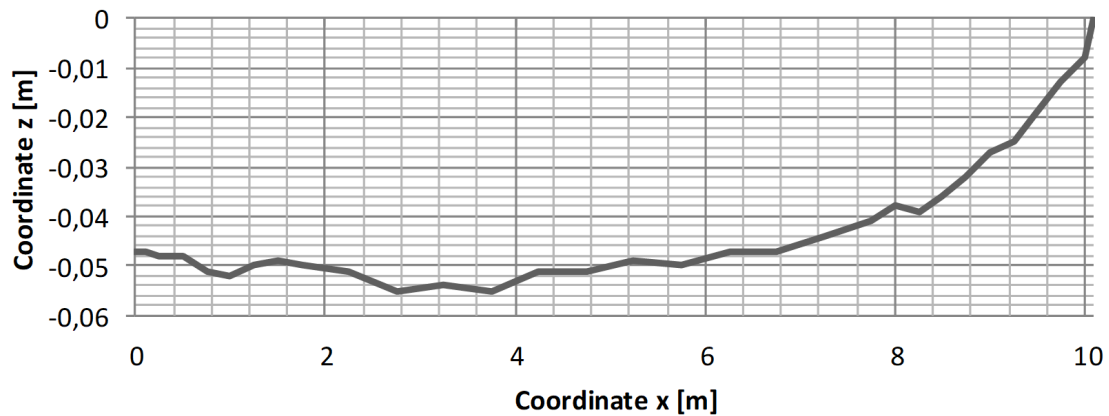
The results of the detailed analysis of the beam deformation are presented in the form of a chart (Fig. 7). It shows that up to the seventh meter the deformation is within the limit of 1 cm, however, after passing this distance the beam is deflected upwards by 4.7 cm in relation to the second support. Such deformations could occur as a result of slipping of the southern wall of the building.

Fig. 7. Results of measurements of the deformation of the beam
Source: Own work.

Standard PN-EN 1995-1-1:2010 [6] specifies the limit bending value for timber members (w_{fin}) which for beam members of the rafter framing is $l/200$. The length of the beam was read from the scan: $l = 10.1 \text{ m}$. The calculations showed that the limit bending value had been exceeded and it totalled (1):

$$w_{fin} = \frac{10100}{200} = 50,5\text{mm} < w = 55\text{mm} \quad (1)$$

The standard [6] provides for increasing the limit value by 50% for calculations for members of old and renovated objects. When the above assumption is adopted, the condition is not met, while the limit bending value is not exceeded (2):

$$w_{fin} = 1,5 * \left(\frac{10100}{200} \right) = 75,75\text{mm} > w = 55 \text{ mm} \quad (2)$$

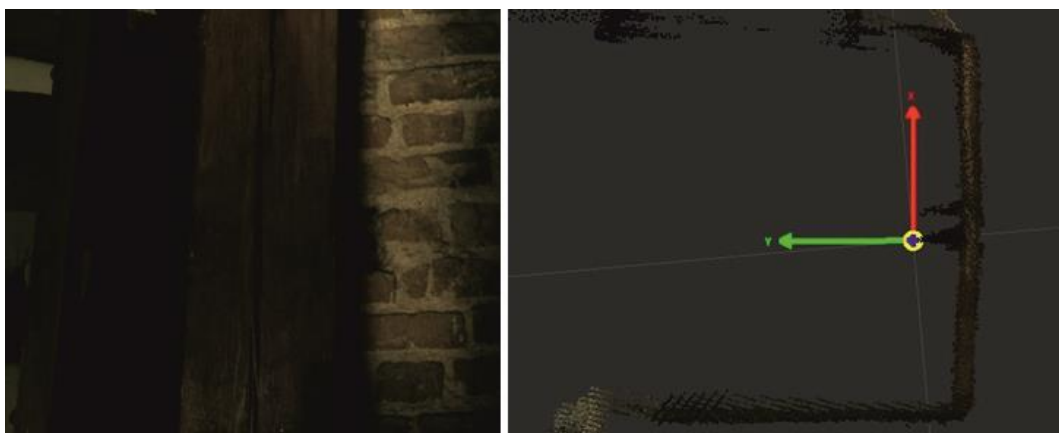
To illustrate the above, the analysis focused on the column of the timber tower, located in the vestibule of the church, as during its macroscopic examination a crack, probably caused by drying, was detected. Shrinkage cracks, resulting from varying timber properties (strength, degree of swelling, etc.), occur in the tangential and radial direction (the phenomenon of anisotropy). Below the fibre saturation point (timber moisture of about 30%) non-uniform shrinkage produces stresses which lead to the occurrence of cracks.

In order to read properly the depth of the crack in the column, the coordinate system was oriented on its scan, at the deepest point of the cross-section, so that one of the axes could be positioned in parallel to the face of the column and the other one along the examined crack (Fig. 8). The measurement of the crack depth was taken by setting up a plane in the face of the cross-section and orientating it with reference to the established coordinate system. On the basis of the results thus obtained it was stated that the dimensions of the column's cross-section were 275×235 mm, and the maximum depth and width of the crack running along the whole column were 43 mm and 18 mm, respectively.

Fig. 8. On the left: crack of the column on the digital photo, on the right: point cloud – cross-section of the column with the established coordinate system

The weakening of the cross-section caused by cracking was calculated according to the procedure described by Nowak [7] and compared with Table 2, from which the α coefficient, decreasing the surface area of the member, equal to 0.98, and the β coefficient, decreasing the cross-section's bending strength ratio, equal to 0.96, were taken. From the coefficient values it can be inferred that the crack does not have a significant impact on the load-bearing capacity of the structural member. It should be emphasised, however, that its significance in another member, e.g. a bent one, would be different, so the presented method is useful for a relatively quick inspection and identification of damage in the structure composed of numerous elements.

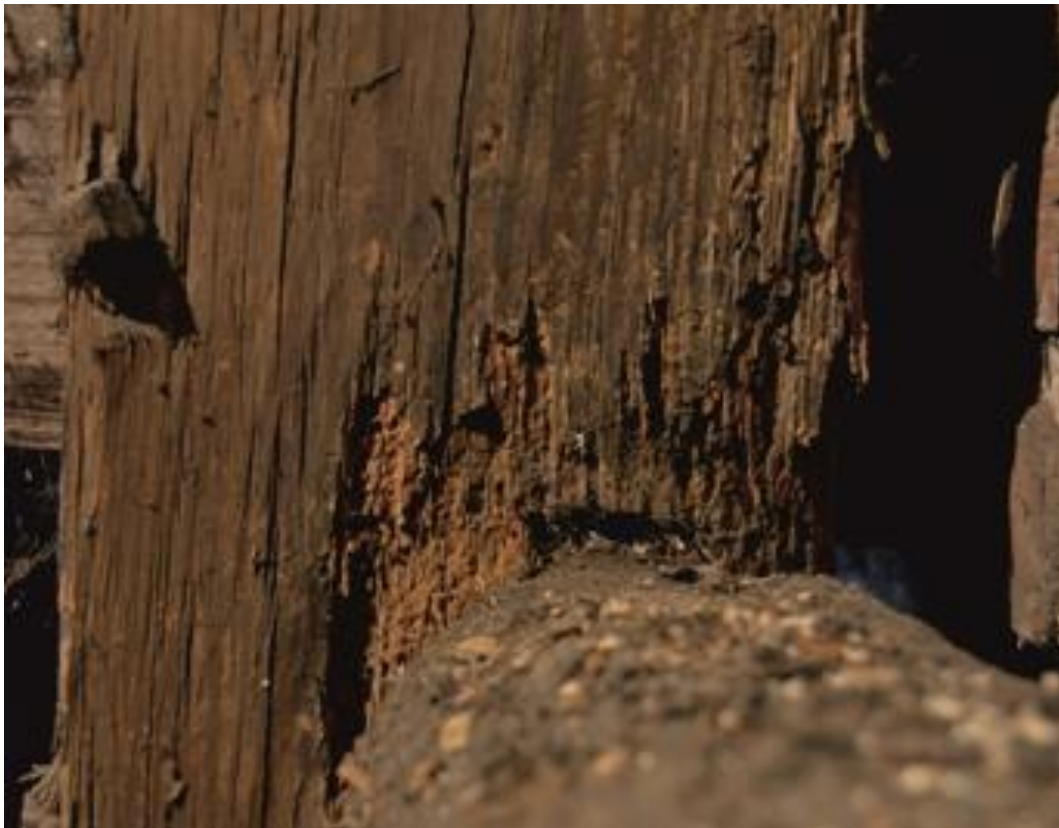
During the in-situ examination of the structural members of the church tower damage caused by insects from the family Anobiidae was detected, in the area where the beam is connected to the transom (Fig. 9). Therefore, an additional high-resolution scan was made for the timber column located on the second storey of the timber tower, in the staircase used as the entrance to the attic and to the church bell.

Fig. 9. Damage caused by insects
Source: Own work.

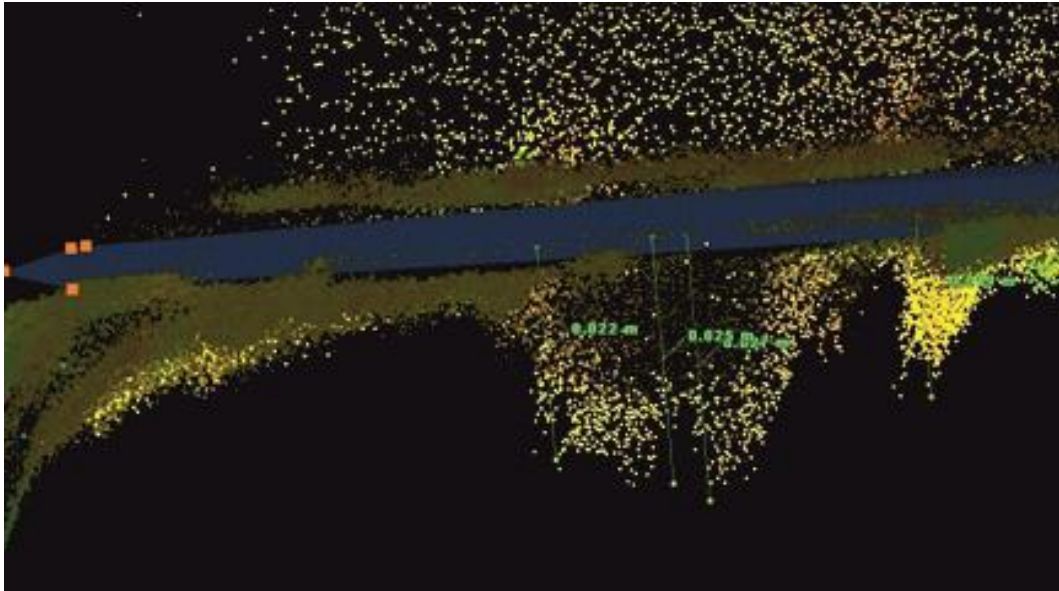
To read the depth of the cross-section's damage, a reference plane was established in the point cloud, overlapping the face of the column from its damaged side. Such location of the reference plane made it possible to examine the depth of defects and to evaluate the scale of damage to the structural member. The measurement of the size of the defect was carried out by the determination of the distance from any point (on the defect) in the direction perpendicular to the reference plane (Fig. 10).

Fig. 10. Taking measurements in the cross-section of the column in relation to the reference plane marked in blue
