SELECTED CONSERVATION PROJECTS IN MARINA EL-ALAMEIN IN THE 2014 AND 2015 SEASONS

Marlena Koczorowska,¹ Wojciech Osiak² and Piotr Zambrzycki³

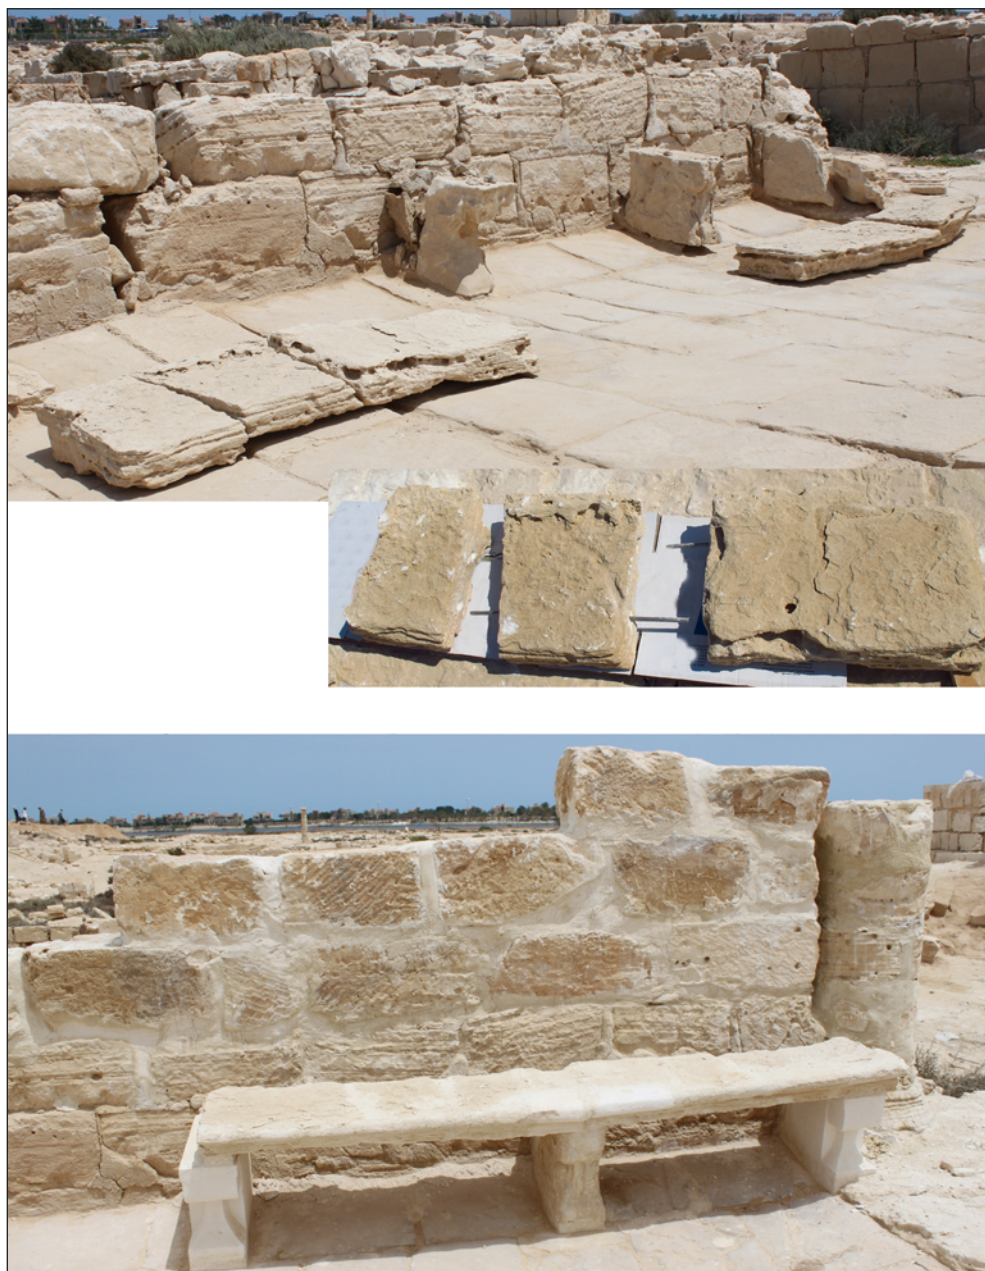
Fig. 1. Conservation of bench seats against the north wall of the central square: top, before conservation; center, conservation in progress; bottom, after conservation in 2014 (Photos R. Czerner, P. Zambrzycki)

The heavily damaged seats of benches in the northern part of the central square were treated according to procedures developed in previous years. The broken fragments were washed and peeled, then bonded. KEMAPOXY 150 epoxy resin with lime filler was used as an adhesive. The bonded areas were reinforced with stainless steel bolts (12 x 200 mm) [Fig. 1]. Patches, 8 x 25 x 15 cm in size, had to be fitted in the fronts of both benches, just above the center supporting leg. The heavily weathered rounded edges of the seats were filled using lime–cement mortar (Doehne and Price 2010: 36). Substantial losses in cracked places and on the upper surface of seats were also filled in. Two of the legs underwent a comprehensive reconstruction replacing the heavily worn original ones. The middle

legs, being the best preserved, were left untreated. Assembly in the square used cement–lime mortar. The original slight tilt of the benches resulting from earthquake-related damage in antiquity was maintained.

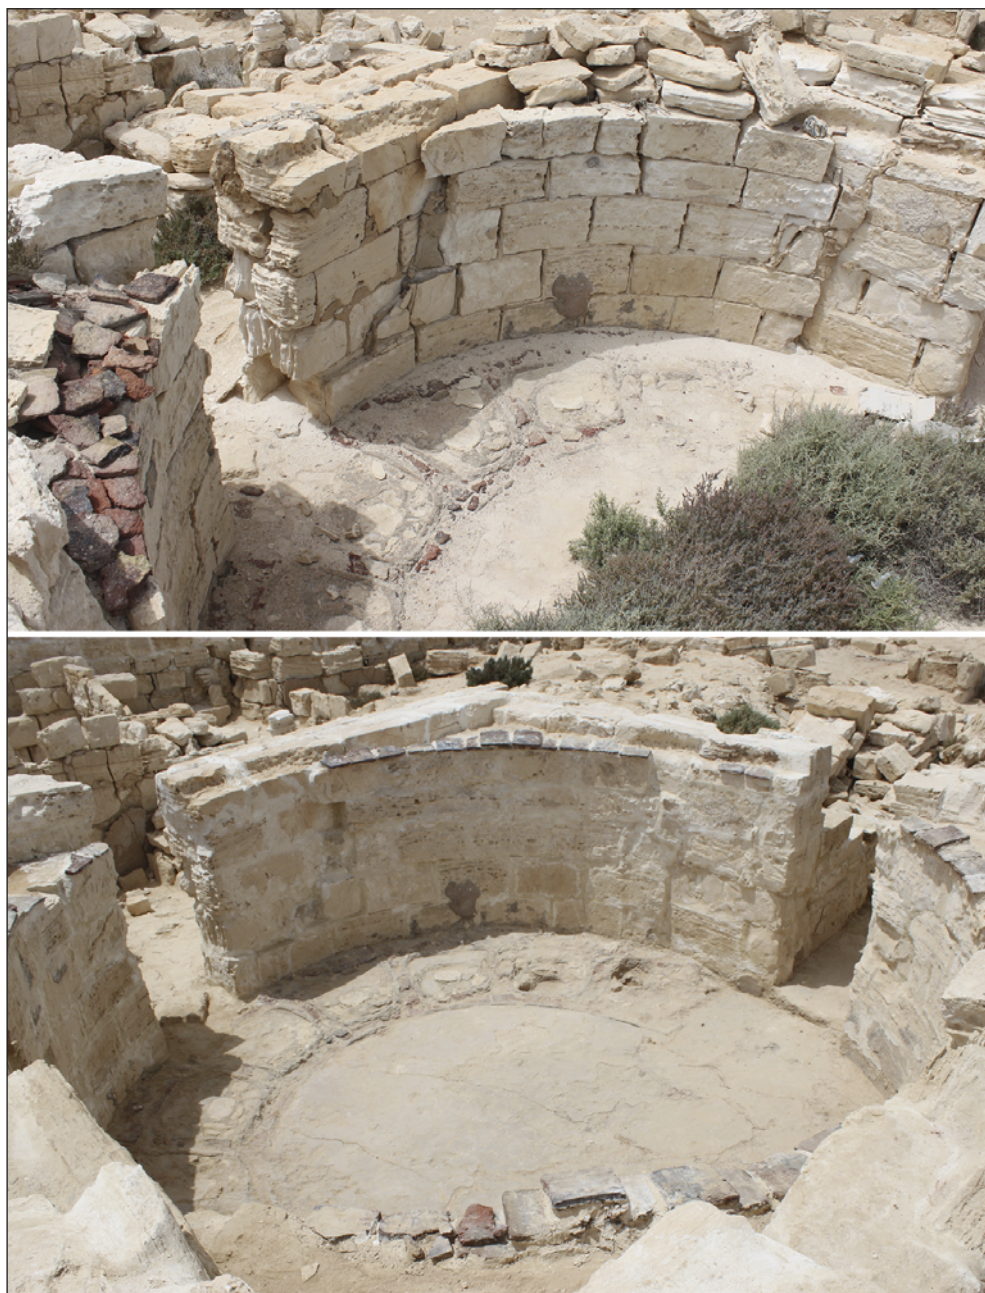
Fig. 2. The tholos of the Northern Bath before and after conservation in 2014; note the bricks of the base of the dome over the chamber [see also above, Fig. 11 on page 181] (Photos R. Czerner)

Soil and pieces of brick scattered around inside the chamber (which was excavated in the late 1980s by an Egyptian team right after the site was discovered) were removed from the tholos room of the bath. A course of original bricks or even two courses were set on top of the wall running around the chamber and inclined inward, the goal being to reconstruct the base of the now missing brick dome [Fig. 2]. The plasterwork of a small immersion bathtub on the west (room 2) had reinforcing bands put in place. The edges of the preserved mortar inside a water reservoir (No. 3) were cleaned of loose accumulations, the cracks were filled and protective bands placed on the wall top. A lime–cement mortar with ceramic filler and ashes added, similar to the original, was used.

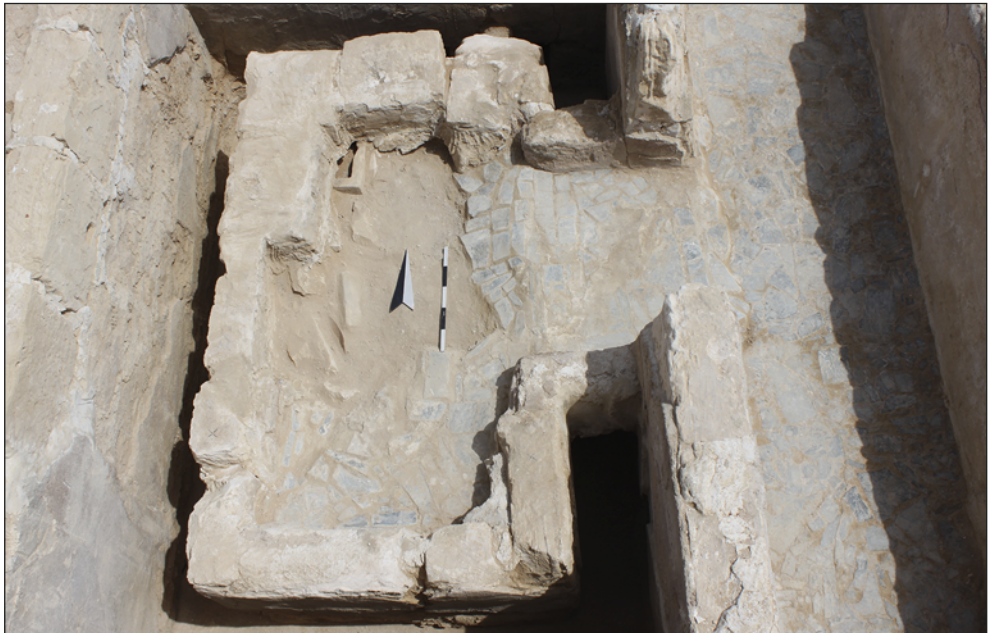
Fig. 3. Southern bath. Latrine 14 and corridor 15 after conservation in 2014
(Photo R. Czerner)

The marble flooring in the latrine (No. 14) was reconstructed in part [Fig. 3] by matching fragments grouped by their thickness with the preserved elements. Floor tiles, detached from the foundation in the southwestern corner and by the entrance to the latrine, were fitted using lime–cement mortar. Mortar bands were placed on all endangered plaster on the inner wall. The same was done for the plaster on the walls of the other latrine (No. 12).

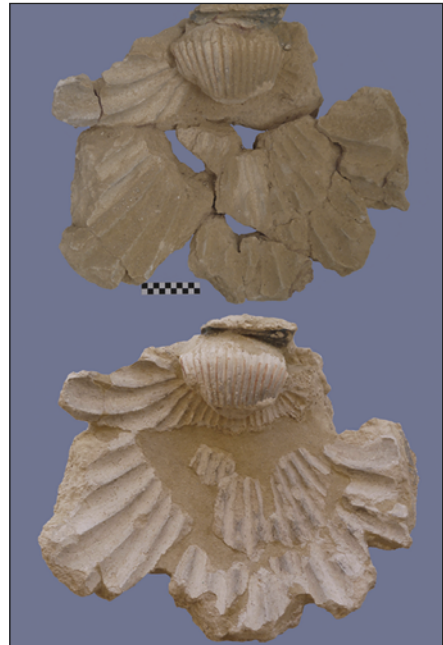
Fig. 4. Decorative polychrome shell from house H10, before and after conservation (Photos M. Koczorowska, W. Osiak)

technique was in bad condition [Fig. 4], detachments caused by salt migration to the surface (Doehne and Price 2010: 15, 28) covering over 80% of the surface. The fragmented decoration was found in 1999 and was reintegrated during intervention work with putty made on the basis of a polyester resin. Full preventive conservation in 2015 was carried out. The mortar layer was reinforced first by saturation with ethanol with water in equal parts to reduce surface tension; next PRIMAL AC33, one part to three parts water, was applied and the voids filled with lime-sand mortar with PRIMAL AC33

as plasticizer. Loose deposits were first removed mechanically from the paint layer and then cleaned thoroughly. Injections of PRIMAL AC33 with water (1:3) followed reduction of the surface tension using ethanol with water equal parts. The wet layers were pressed. Also the back of the paint layer was pasted to the plaster ground using PRIMAL AC33 with water in a 1:6 proportion with some ethanol added, taking care not to allow glossing to appear on the surface. Filling of losses in the mortar layer and plaster and retouching are planned.
