Restoration of the Lion of Allat statue from Palmyra after the 2015 devastation

Abstract: The Lion of Allat statue from the Temple of Allat in Palmyra suffered extensive damages during the 2015 devastation of monuments in the ancient oasis city. Discovered in the mid 1970s, it was reconstructed in 1977 and then preserved again in a new arrangement that recalled the original context of the statue in 2005. In 2017 and 2018, the statue was recreated once again in the gardens of the National Museum in Damascus. The article traces the restoration process, providing detailed data on the current condition of this monumental statue.

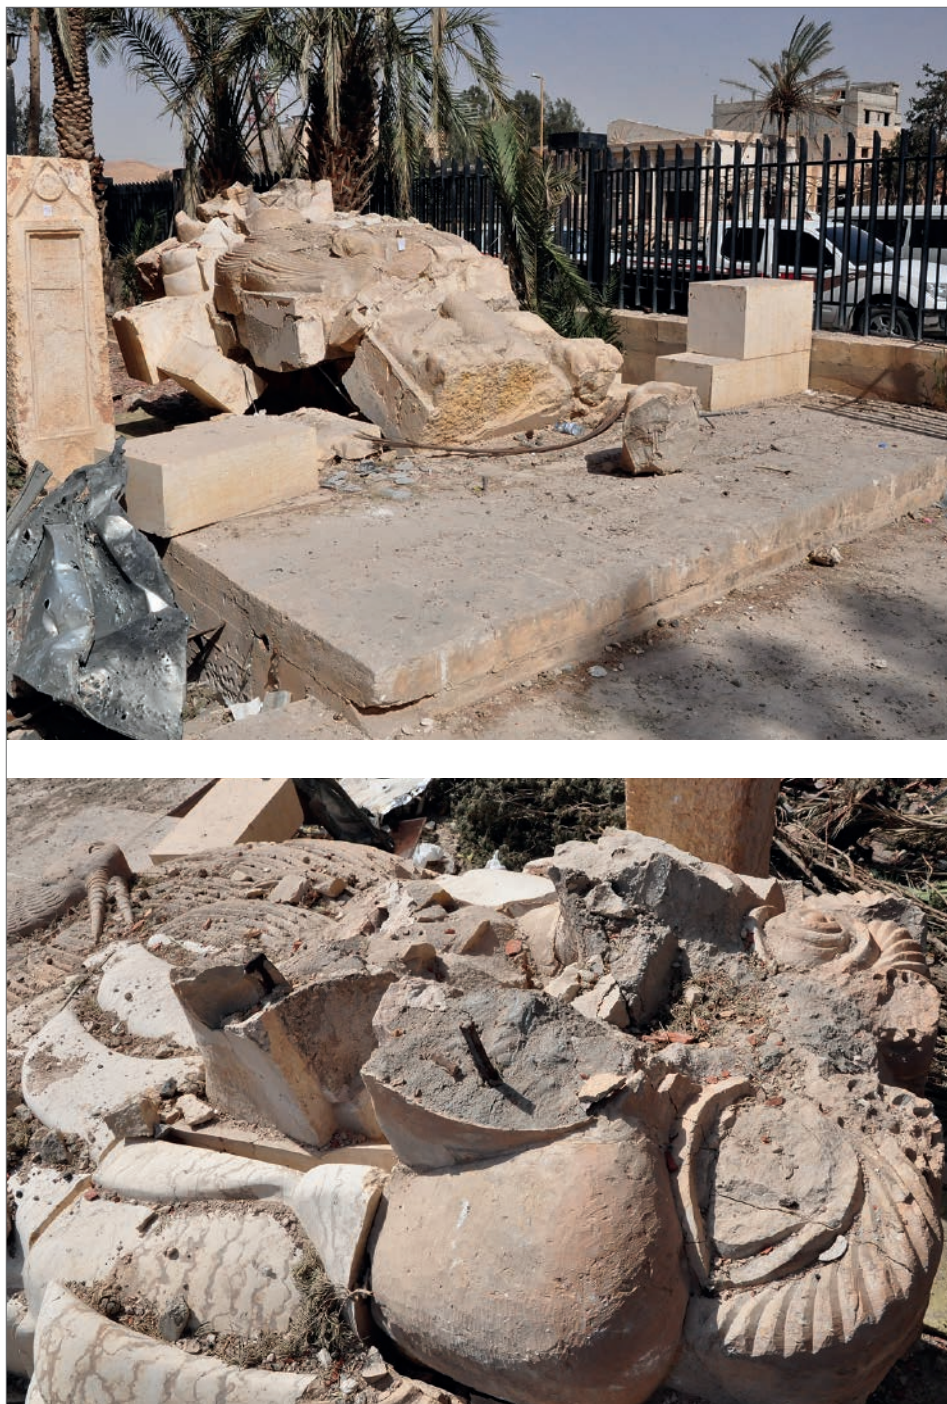
Fig. 1. The destroyed Lion of Allat: top, state in April 2016; bottom, close-up of the defaced lion's head (PCMA UW Documentation Center | photos B. Markowski and R. Żukowski)

After 10 years, in spring 2015, when the crisis was close to Palmyra, the statue was protected with metal shields installed on steel rods drilled into the reconstructed stone elements. However, the shields were removed and the statue, like many of the priceless monuments of Palmyra, was destroyed in the wake of an unprecedented act of vandalism, probably on 23 May 2015 (<http://www.dailymail.co.uk/news/article-3101031/ISIS-destroys-famous-lion-god-statue-captured-Syrian-city-just-days-promising-locals-not-obliterate-Palmyra-s-ancient-monuments.html> [accessed: 10.08.2019]). The destruction of the statue was done by using a bulldozer to knock the sculpture down on its back. The concrete structure at the back of the statue cracked in two places: at the base and at a height of 0.70 m, just under the

antelope's head. The large stone elements did not fracture or break as they were anchored in concrete. The lion's muzzle was shattered. Smaller sculptured details were hammered out [Fig. 1].

All the biggest fragments of the statue were found with the exception of a part of the lion's lower jaw. The destruction was mostly mechanical. Stone elements were cracked and separated when the statue was pushed over and hammered with heavy tools. The most destroyed part was the lion's head [see *Fig 1* bottom]. The muzzle, partly reconstructed in 1977, was shattered and details like the nose and lower jaw were broken into small fragments. The curls over the left paw, the nose of the antelope and the toes also demonstrated severe damage. There was also plenty of lesser damage and scratching of the original stone surface. The stone blocks reconstructed in 2005 were also damaged, but not very heavily; some corners and edges were broken. There were also some bullet marks.

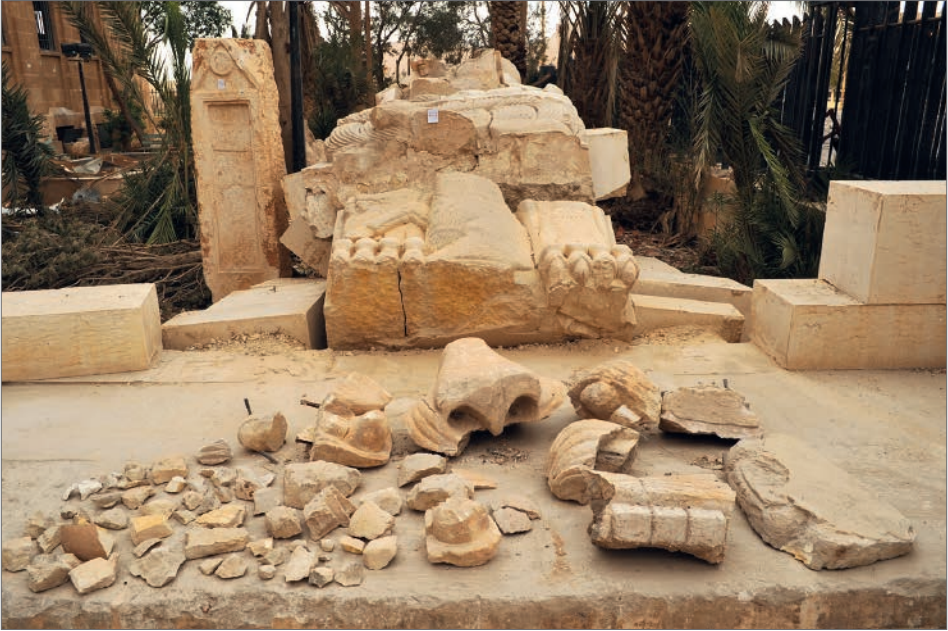
Directly after the liberation of Palmyra on 27 March 2016, between 8–14 April 2016, the fragments of the statue were collected by Polish specialists Bartosz Markowski and Robert Żukowski, sent to Palmyra by the Polish Centre of Mediterranean Archaeology University of Warsaw [Fig. 2]. Then, on 1 May 2016, using a Russian military crane, Polish and Syrian specialists and Russian army sappers moved the fragments in preparation for transport to Damascus. This took place in July 2016 under the supervision of Syrian specialists.

Fig. 2. The destroyed Lion of Allat: fragments of the statue collected in April 2016 in its original location in the museum grounds in Palmyra (PCMA UW Documentation Center | photo B. Markowski)

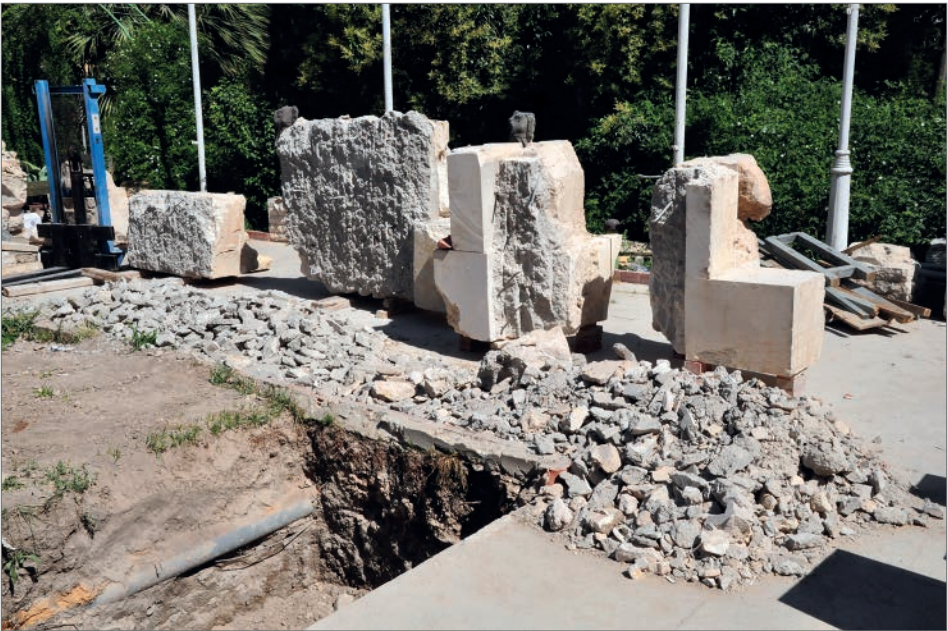
Fig. 3. The lion fragments in their new location in the gardens of the National Museum in Damascus: removing the old concrete backing of the statue, June 2017 (PCMA UW Documentation Center | photo B. Markowski)

The main objective of the restoration in 2017 was to preserve the statue anew and to arrange it in its new place of exposition in the National Museum in Damascus [Fig. 3]. It was decided to recreate the project from 2005, using not only all the original fragments of the sculpture, but also those reconstructed in the previous restorations of 1977 and 2005. There being no viable alternative, it was decided to apply the original conservation methodology as in 2005. The big stone elements were assembled with mineral mortar based on white cement, small fragments with artificial resin and con-

The concrete backing of the statue, which had been broken, needed to be replaced following the same design that was used in 2005 [see *Fig. 3*]. The place chosen for the new presentation of the statue is in the southeastern part of the museum gardens, by one of the fountains. After restoration, the lion is facing west, the large space in front of it providing a good view of the statue.

The first step was to remove the broken concrete backing of the statue [Figs 3, 4 left]. The process had to be carried out by hand, using an electric grinder and cleaving the concrete off piece by piece; the strong vibrations of a pneumatic hammer could have damaged the original limestone blocks. Only about 25 cm of the thickness of the concrete backing had to be removed, just enough to make room for the new stainless steel backing [Fig. 4 right]. The most damaged upper fragment of the statue with the lion's head was divided into four fragments.

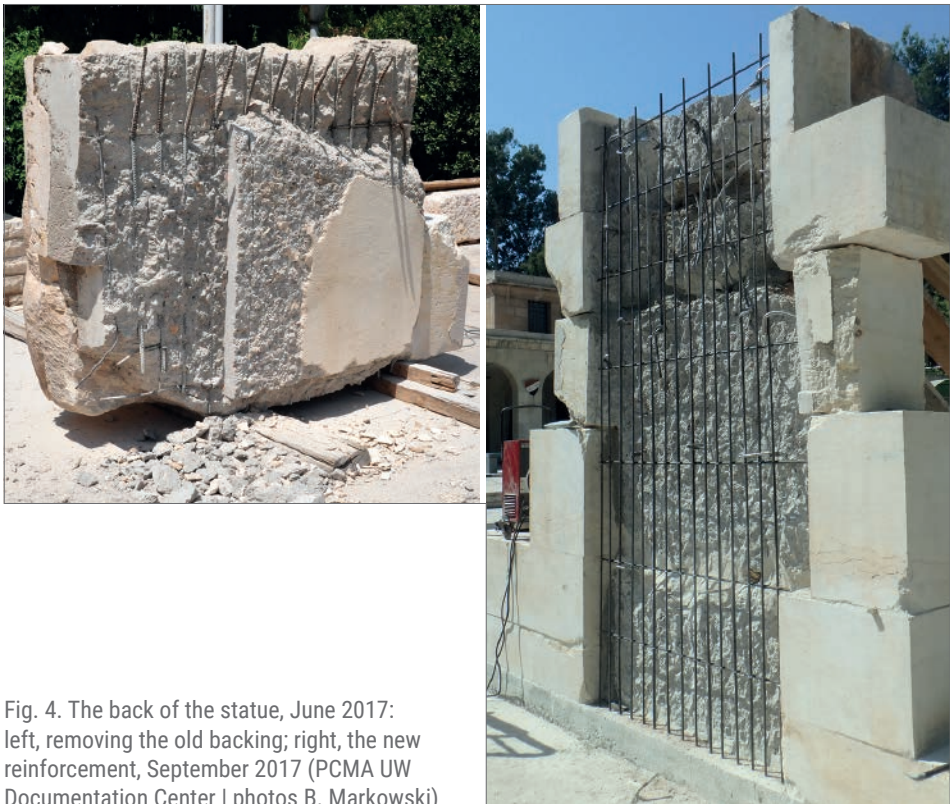
Fig. 4. The back of the statue, June 2017: left, removing the old backing; right, the new reinforcement, September 2017 (PCMA UW Documentation Center | photos B. Markowski)

The backing structure from 1977 was made of concrete reinforced with stainless rebar. It still worked, so there was no need to change it. The steel elements were uncovered and protected with Paraloid B-67 (5% in nitro) to inhibit corrosion process.

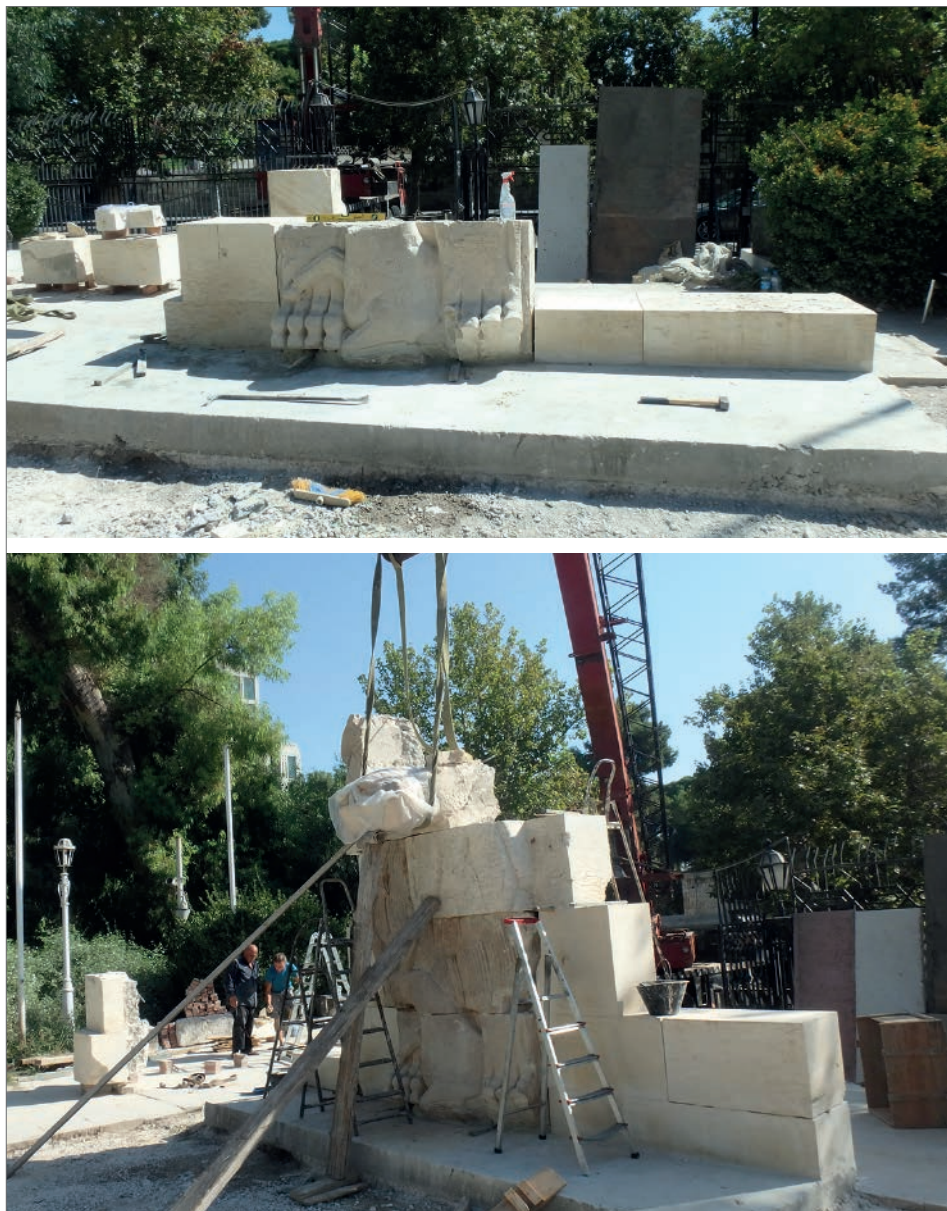
Fig. 5. Assembling fragments of the statue, September 2017 (PCMA UW Documentation Center | photos B. Markowski)

The elements of the statue were assembled on the new foundation slab in the museum gardens using a heavy crane. Stone blocks were picked up on textile belts and one by one put in place [Fig. 5].

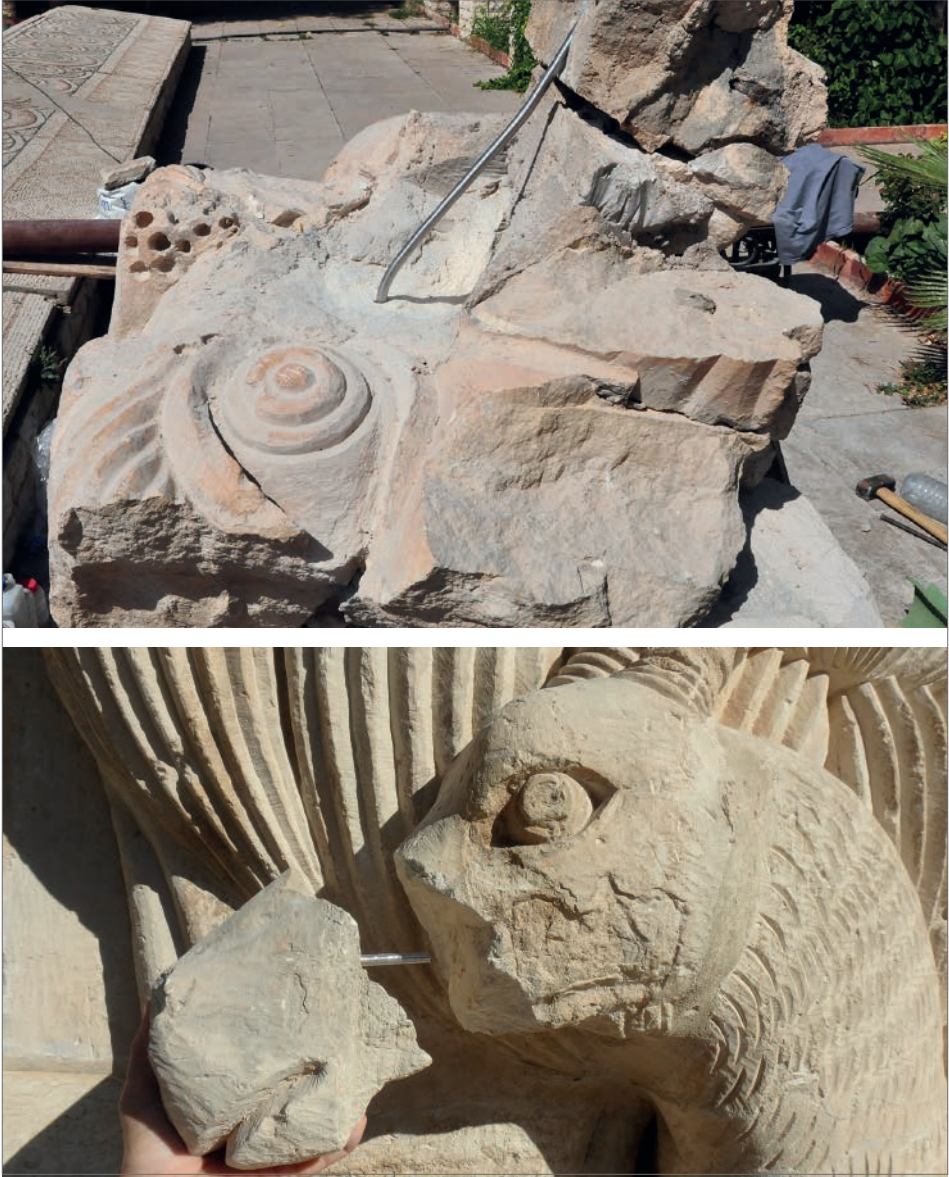
The face of the lion had to be taken down in smaller pieces and reassembled [Fig. 6]. The main problem was that the head had been reconstructed partly after

both original and reconstructed in 1977, were connected with epoxy resin mixed with limestone powder. In all cases, the surface of the original limestone was protected with Paraloid B-72 (3% in acetone) before application of either resin or mineral glue. The latter (white or grey, based on modified cement) was used for connecting bigger fragments that had been reconstructed before. Stainless-steel anchors or rods were used for essential reinforcement; the biggest anchors were mounted under the nose, over the crack on the left side of the upper element of the head, and to support the new reconstruction of the lower jaw fragments that were lost in the recent destruction [see Fig. 6 top]. Cavities were filled with min-

Fig. 6. Assembling fragments: top, the lion's nose, and bottom, the gazelle's original nose, September 2017 (PCMA UW Documentation Center | photos B. Markowski)

monument. That is why some parts were reconstructed in smaller detail, while others just as a general shape. The main reconstructions were made around the toes, on the curls over the lion's left paw and on both sides of the head. The nose of the antelope was reconstructed first, but then replaced with with the original fragment when it was fortunately found in October 2018 [Fig. 6 bottom].

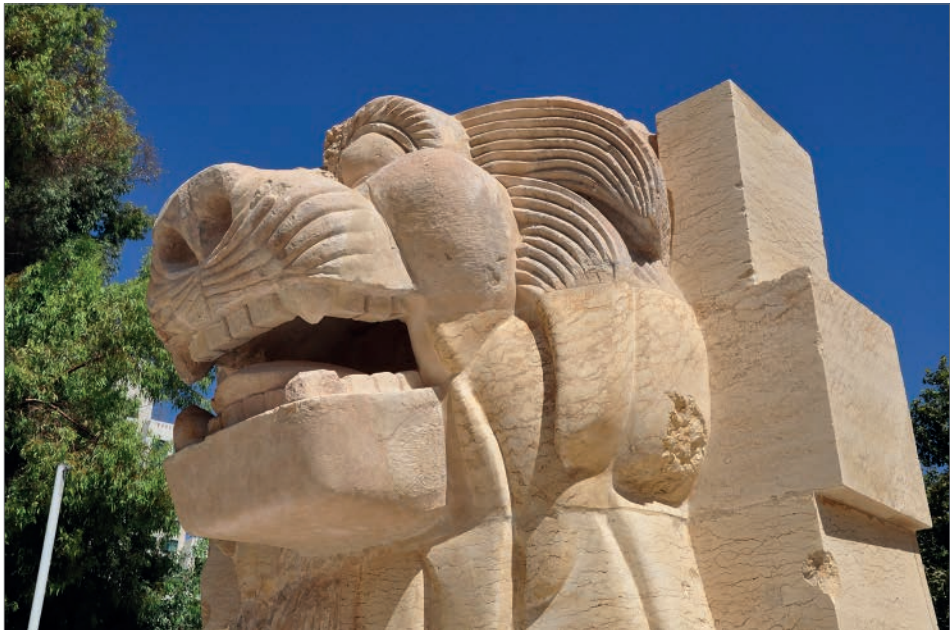
eral mortar made of white cement and quartz sand (1:3), same as in the previous restorations. The biggest reconstruction was made on the lower jaw, teeth and tongue of the lion, smaller on the

nose and right cheek [compare *Fig. 7*]. Many small gaps had to be filled. Some of original fragments were cracked, but still stuck together. They were located on the head (eyebrows, left cheek) and also

Fig. 7. The head of the Lion of Allat after restoration, October 2018 (PCMA UW Documentation Center | photo B. Markowski)

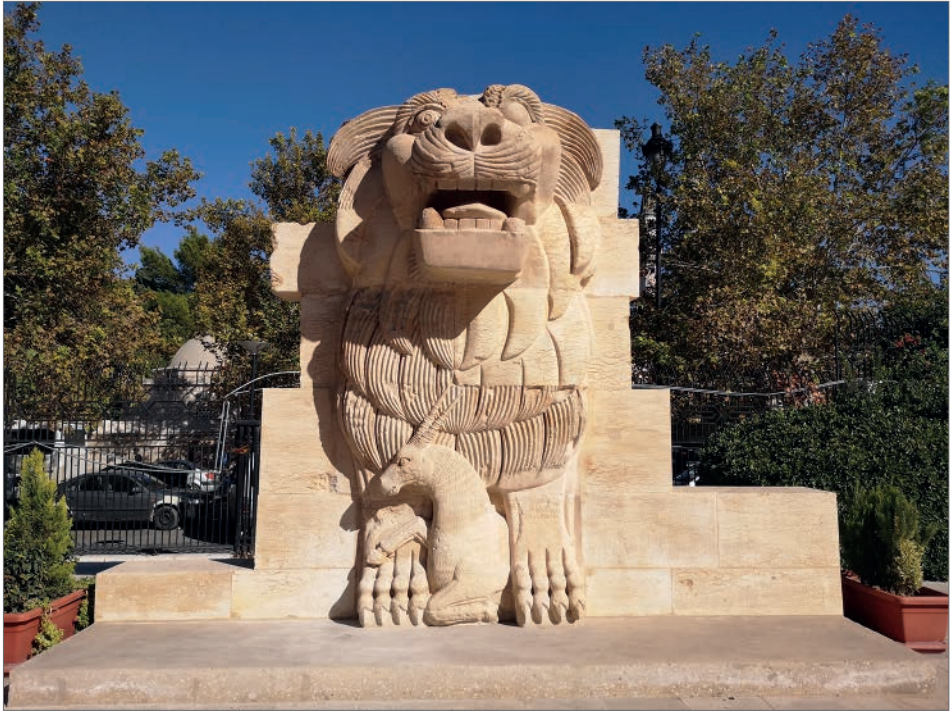
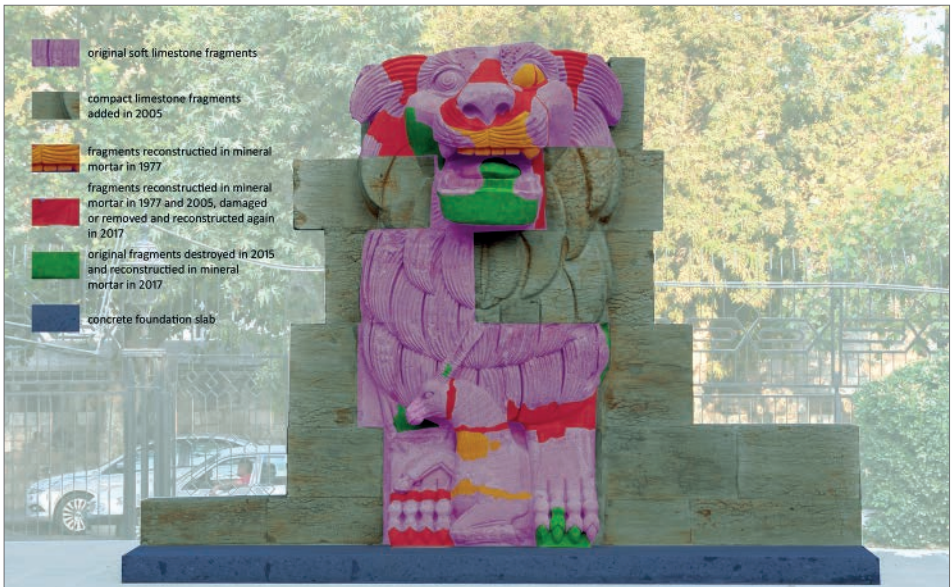
Fig. 8. The Lion of Allat statue after restoration, October 2018 (PCMA UW Documentation Center | photo B. Markowski)

Fig. 9. Stratigraphy of the reconstructions of the Lion of Allat statue after restoration, October 2018 (PCMA UW Documentation Center | photo B. Markowski)

The main issue was to find an aesthetical balance between all the elements of the composition: original fragments, stone reconstructions made in 2005, mortar reconstructions made in 1977 and 2005, missing and lost fragments after the 2015 destruction [Figs 8, 9]. Some recent damages, like bullet marks, were left as witnesses of the latest history of this
