# RESEARCH AND CONSERVATION IN THE ROMAN BATHS OF MARINA EL-ALAMEIN IN THE 2012 AND 2013 SEASONS (POLISH–EGYPTIAN CONSERVATION MISSION)

**Abstract:** A Roman bath in use from the 2nd to the 4th century AD at the harbor of Marina el-Alamein on the Mediterranean coast of Egypt continued to be researched, conserved and prepared for exhibition by the Polish–Egyptian Conservation Mission working under the auspices of the Polish Centre of Mediterranean Archaeology, University of Warsaw and the Faculty of Architecture, Wrocław University of Technology. The bath and adjacent civic basilica were located in the center of the ancient town, to the south of the ruins of the main square. By updating results of research carried out in previous seasons, the present studies on the caldarium and frigidarium of the bath and a part of the civic basilica have brought us significantly closer to identifying the functional layout of the southern baths. Phases of construction were investigated as well and it is now possible to trace the transformation of the building over time.

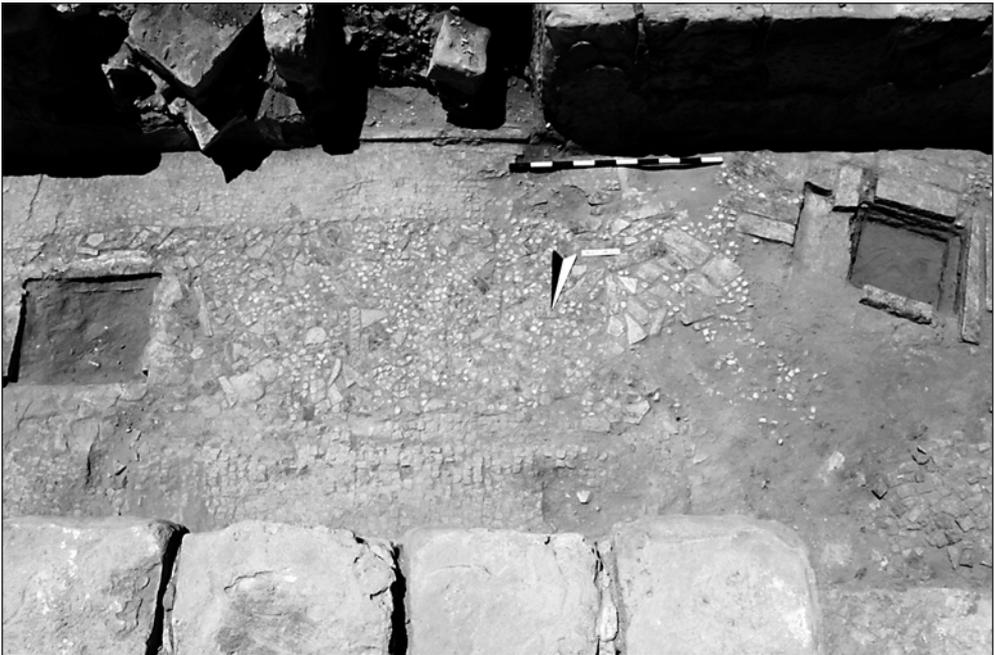
tesserae was discovered in the southern portico. This passage extended to the east into corridor 11, which was 2.03 m wide and which led to hall 8a. It was cleared in 2012. More of the mosaic floor was uncovered there [*Fig. 2*], indicating that

*Fig. 2. Southern baths, mosaic in corridor 11  
(Photo R. Czerner)*

A mosaic floor in this room [see *Fig. 2*] consisted of bands 0.45–0.60 m wide, made of large cubes of grey limestone (3.0 cm to each side) along the north and south walls, surrounding a mosaic of marble tiles of different color and size in the center. A well opening, 0.46 m square in size, was found in the center with remnants of the original frame of four wooden beams and surrounded by larger marble tiles.

An important surviving element of the joined rooms described, the southern portico of courtyard 4 and corridor 11 [see *Fig. 2*], is a mosaic floor of large tesserae. In 2009, the edges of the mosaic fragments preserved in the portico were protected and in some parts of it the mortar was filled in. After finishing the work in the current season, the whole mosaic was covered with geotextile and buried.

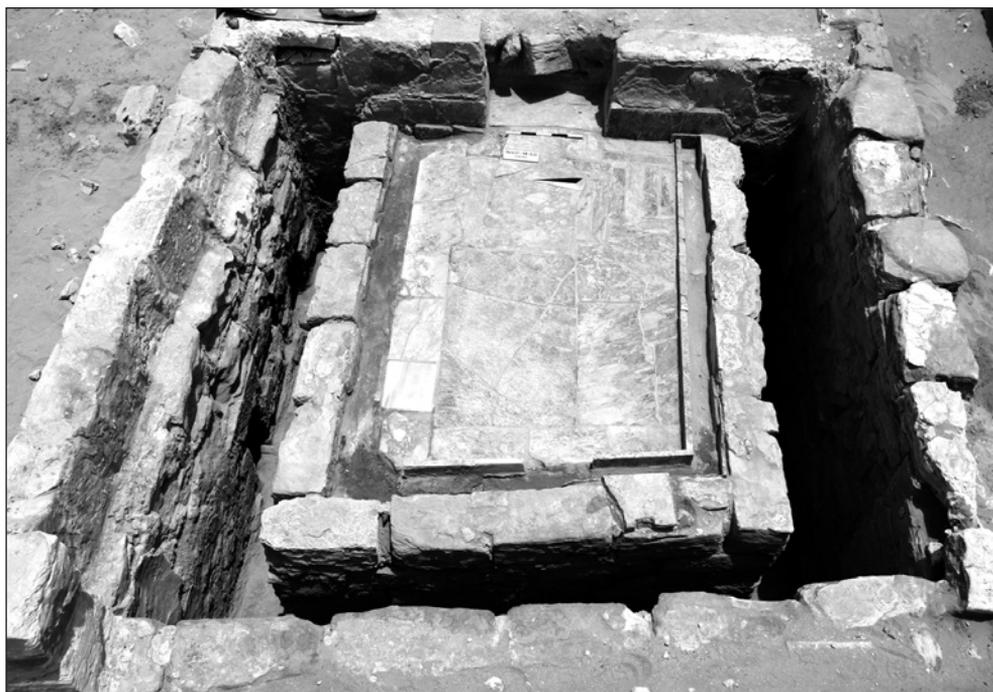
Fig. 3. Southern baths, latrine in room 12 after conservation in 2013  
(Photo R. Czerner)

The shape was irregular: N–S, 3.86–3.31 m, E–W, 3.49–3.51 m; the floor with small drain: N–S, 2.80–2.66 m, E–W, 2.02–1.89 m [Fig. 3]. The walls of the latrine were built of large stone blocks (0.50 m by 0.42 m by 0.25 m). The north wall was 3.77 m long and preserved to a height of about 0.62 m; the west and east walls were 2.60 m high. A door in the east wall, 0.83 m wide (0.77 m measuring with the mortar), led in from the corridor. Traces of white plaster have survived on the walls above the threshold (0.28 m wide). Two column drums, 0.30 m in diameter and 0.17 m high, were found

The most interesting room in the bath complex of those which underwent conservation in 2013 was room 12 housing the latrine [see *Fig. 3*]. Having survived in exceptionally good condition, the rich decor of the interior, comprising marble floor and revetment at plinth level, as well

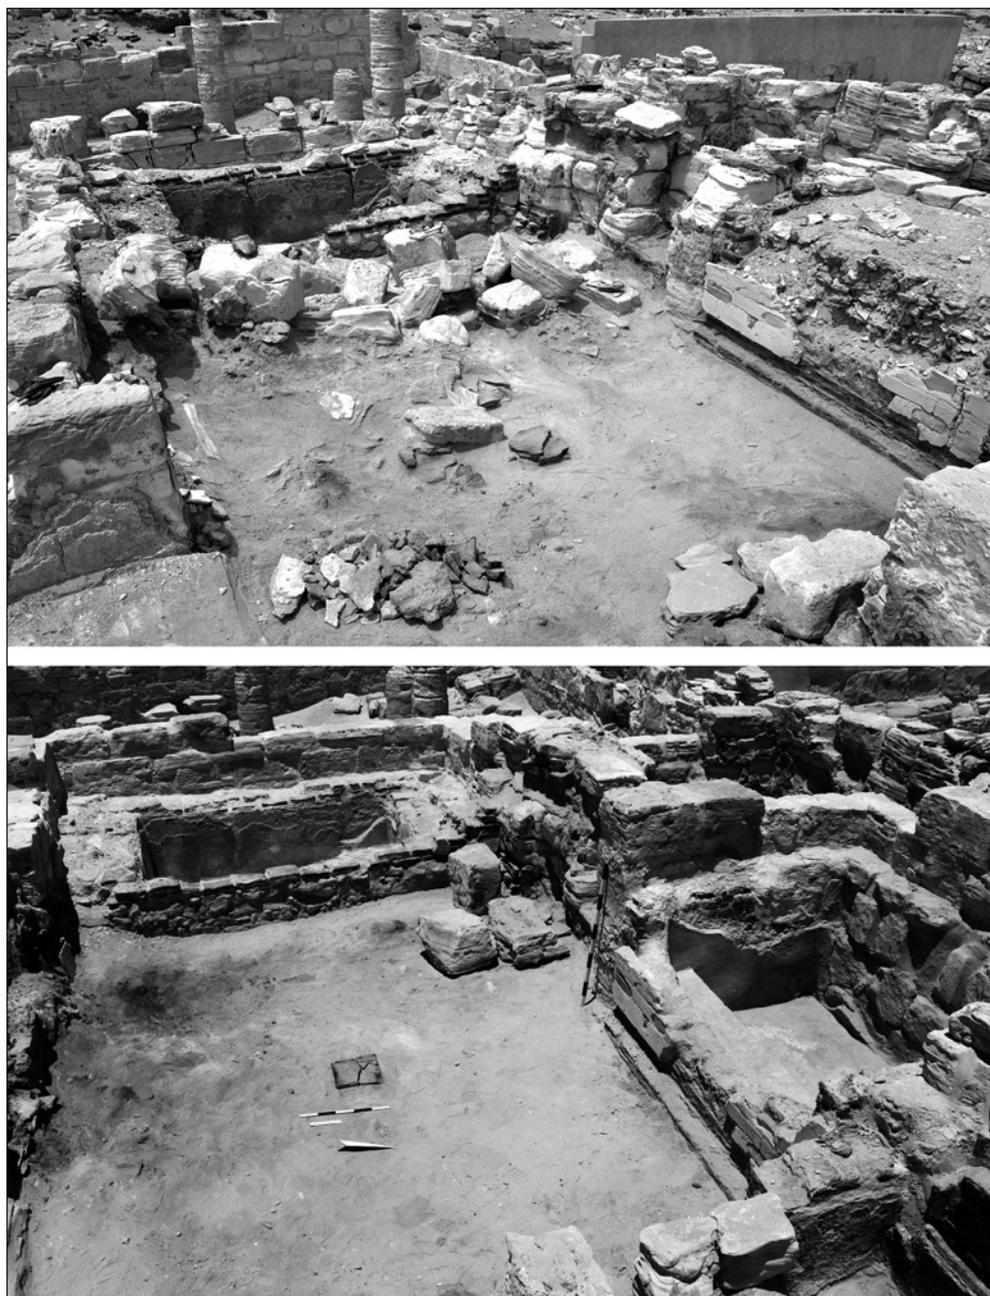
*Fig. 4. Southern baths, caldarium in room 7 before (top) and after (bottom) conservation in 2012 (Photos R. Czerner)*

The most comprehensive work was carried out in 2012 in room 7 (caldarium) [see *Fig. 4*], this owing to the complicated layout and presence of various installations and facilities, such as two heated and one unheated bath plus elements of a heating system: relics of a hypocaust and of *tubuli* flues in the walls. The walls were consequently of different thickness, incorporating recesses, and the edges of the two bathing basins formed extra walls inside the room. Different materials were also used: stone blocks of varied size and ceramic bricks. Various mortars were also used. The layout of the interior was

The outer walls of the caldarium were in poor condition. Most of the limestone blocks it was built of were seriously and deeply eroded. The blocks from the northwestern and southwestern corners, that is, from the side of courtyard 4, were almost completely destroyed. Similarly, the blocks from the highest preserved layers were crumbling away. The filling in of joints in the facade had started in some sections in 2009 already, but for the wall as a whole it would not have been enough just to add another course of blocks to protect it. Sockets for the patches were cut in the eroded surfaces of blocks. The process concerned the outer facade of the part of the caldarium added later, that is the one to the west, housing *alveus* 7a. It was restored from the west, north and south, and the damaged corners were also reconstructed. One or two layers of blocks were added on the top of the walls. Of course, it was impossible to replace all the blocks in the walls, hence the task was limited to only the most needy ones in the top courses of the south and north walls of the caldarium further to the east.

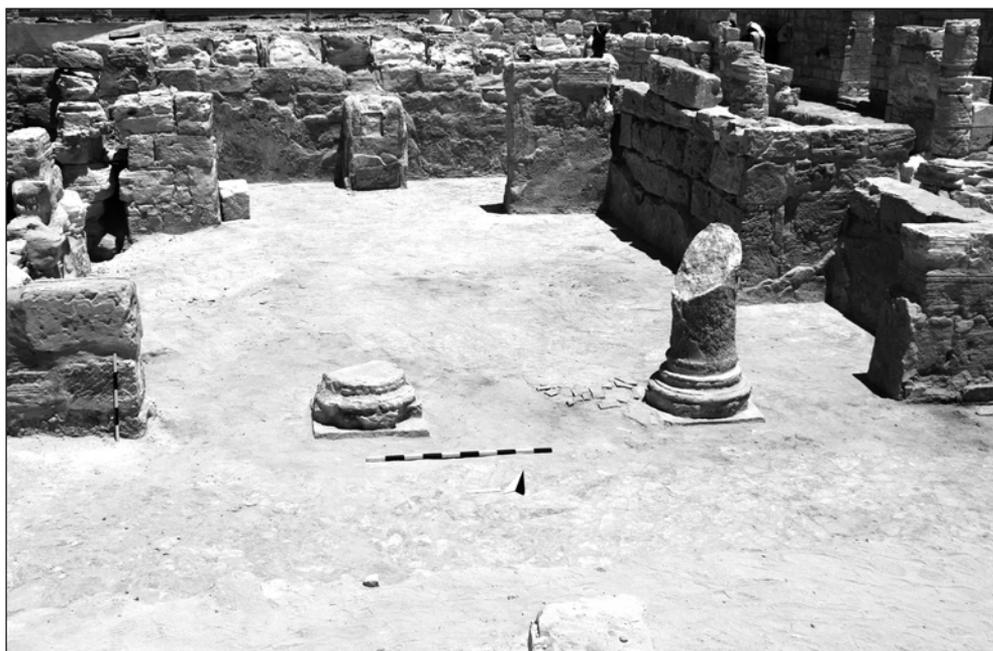
Fig. 5. Southern baths, rooms 8a and 8b after conservation in 2012  
(Photo R. Czerner)

Hall 8, formed of the two joined interiors (8a to the north and 8b to the south), is the biggest of the rooms in the bath excavated so far [Fig. 5]. It ran 15.95 m from north to south. Its width increased with several recesses, beginning

**Rooms 8a and 18.** Room 8a had been excavated partly in the 2011 season. Two marble columns had once separated room 8a from room 8b [*Fig. 5*]. The floor now was cleared for a section measuring 2 m south of the columns. A low course of marble revetment, 0.10 m high, was observed on the east wall. On a corresponding level on the west wall there was only a thick layer of mortar. A small hearth stood in the northeastern corner. A large iron hook, small potsherds, glass vessels and pieces of windowpanes, as well as animal bones were found in the fill on the floor.

Building and conservation work other than the protection of the northwestern corner proceeded in room 8 [see below and *Fig. 5*]. The east wall was partly protected by replacing damaged blocks and building over it. Two marble bases and

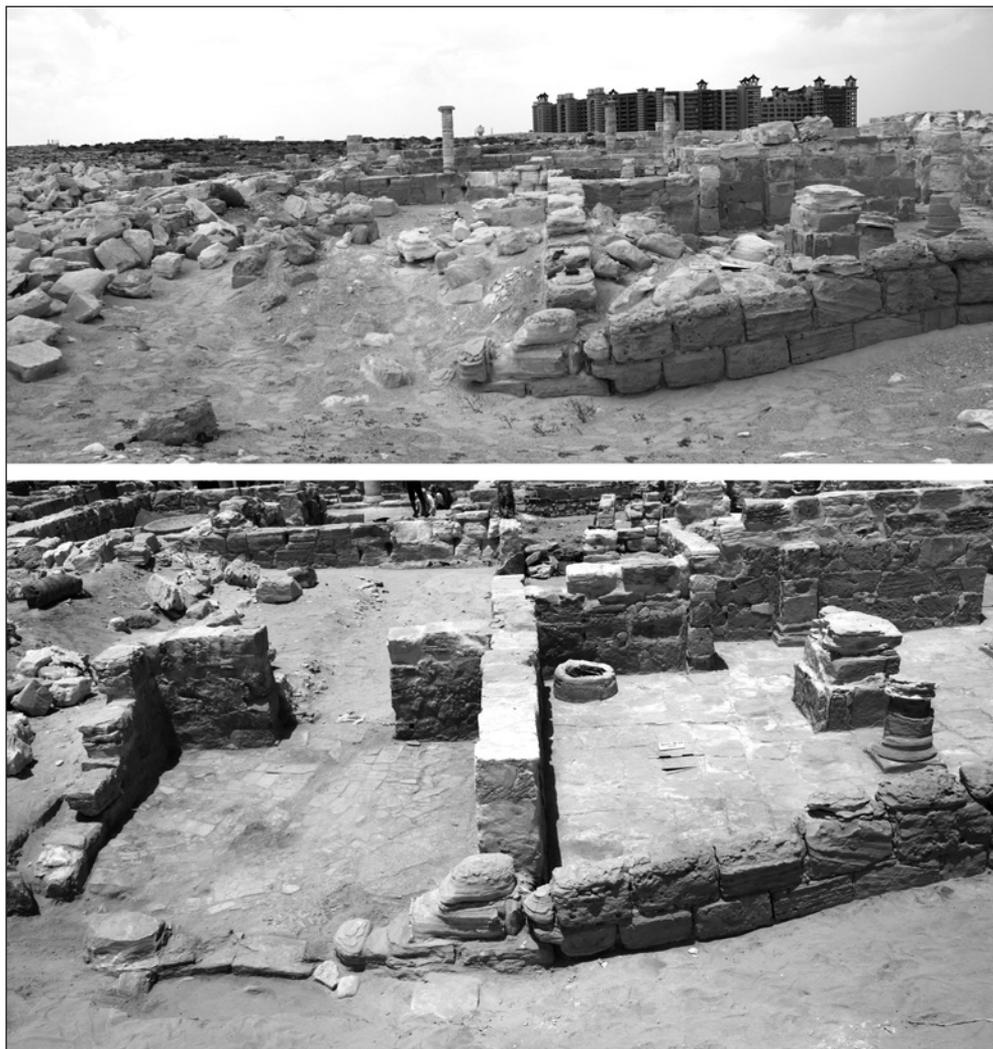
*Fig. 6. Southern baths, room 9 and the southern part of the civic basilica, before (top) and after (bottom) conservation in 2013 (Photos R. Czerner)*

a cistern under it. Water flowed from the roof and was channeled down a ceramic pipe in the southeastern corner of the room, while it was brought up through an encased opening in the southwestern corner. Cleaning of the adjacent room 9 to the south revealed a similar grey marble floor as in room 8 [Fig. 6].

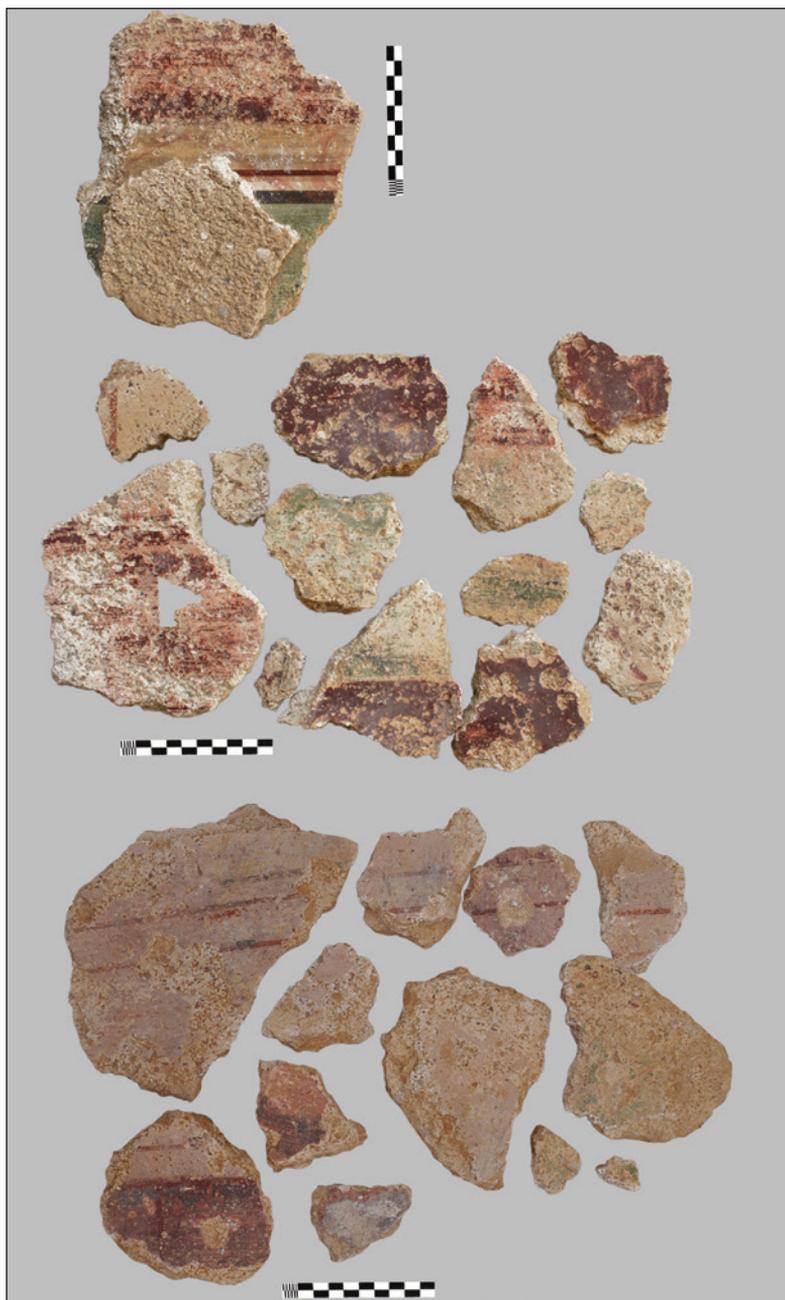
*Fig. 8. Fragments of painted plaster  
(Photos R. Czerner, W. Wójtowicz)*

The floor of the latrine was covered with marble slabs of various size. The largest were 1.26 m by 0.72 m, the smaller ones measured 0.28 m by 0.45 m. Long thin marble slabs (0.46 m by 0.10 m) in the southeastern part suggested repairs to the floor in this spot. Marble tile revetment was preserved fragmentarily on the lower parts of the east wall (up to a height of 0.24 m). Above that the wall was painted (there were probably three layers of paint). Pieces of painted plaster found in the latrine documented wall decoration referring in design to the structural style [Fig. 8]. Plant motifs were also apparent in the assemblage.

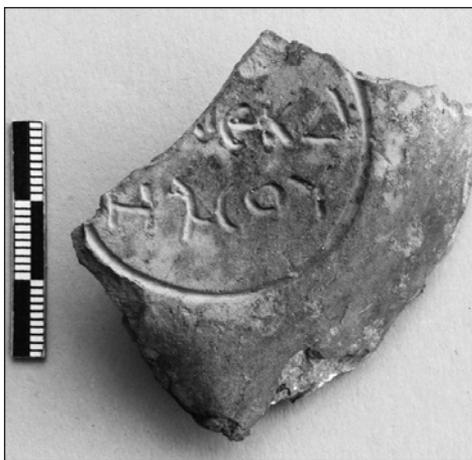
Fig. 9. Inscribed base of a clay lamp, inscription reading *Synekdemou* (Photo R. Czerner)

Small pieces of plaster painted red, pottery and glassware, as well as a fragmentary inscribed base of a clay oil lamp were found clearing the layer on the floor [Fig. 9]. The inscription on the lamp is probably the name of the lamp producer: Synekdemou (Synekdemos means “traveling companion”, A. Łajtar, personal communication).
