PRELIMINARY REPORT ON THE 2012 AND 2013 EXCAVATION SEASONS AT JIYEH (PORPHYREON): WORK IN SECTOR D (RESIDENTIAL QUARTER)

WORK IN SECTOR D (RESIDENTIAL QUARTER)

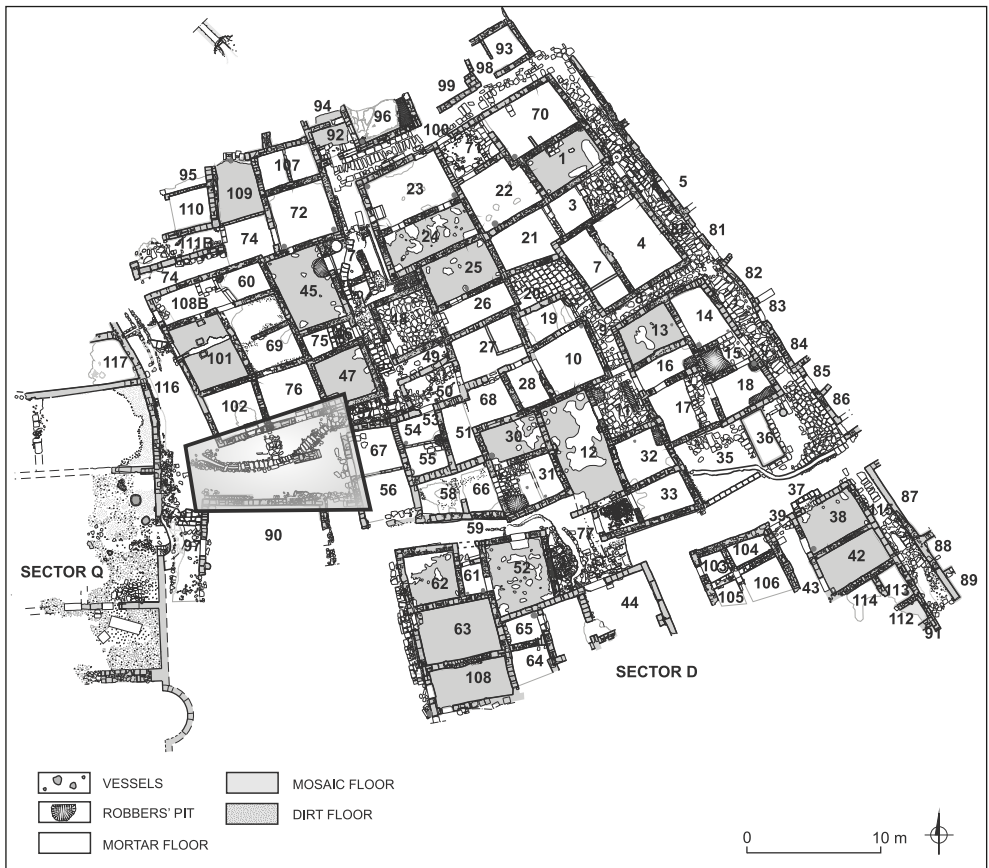
Fig. 1. Plan of sector D with marked location of trenches excavated in 2012 and 2013 (Drawing M. Puzkarski)

D116 [Fig. 1], delimited by the walls of residential buildings (rooms D56, D67, D76, D90, D102) and neighboring on the Christian basilica in this part of the ancient

corner in the 2012 season as well as an extension to the north. The season in 2013 was dedicated to a study of the building stratigraphy and a test in the north-eastern part of room D72 adjoining on the west that from the 2012 season (2.44 m by 2.30 m). Research questions concerning architectural development in this part of the quarter led to a new test, D/T4 (3.66 m by 1.55 m on the N–S axis and 4.15 m by 1.85 m on the E–W axis) being opened outside the east wall, specifically on the intersection of street 100 and street 073 [see *Fig. 1*].

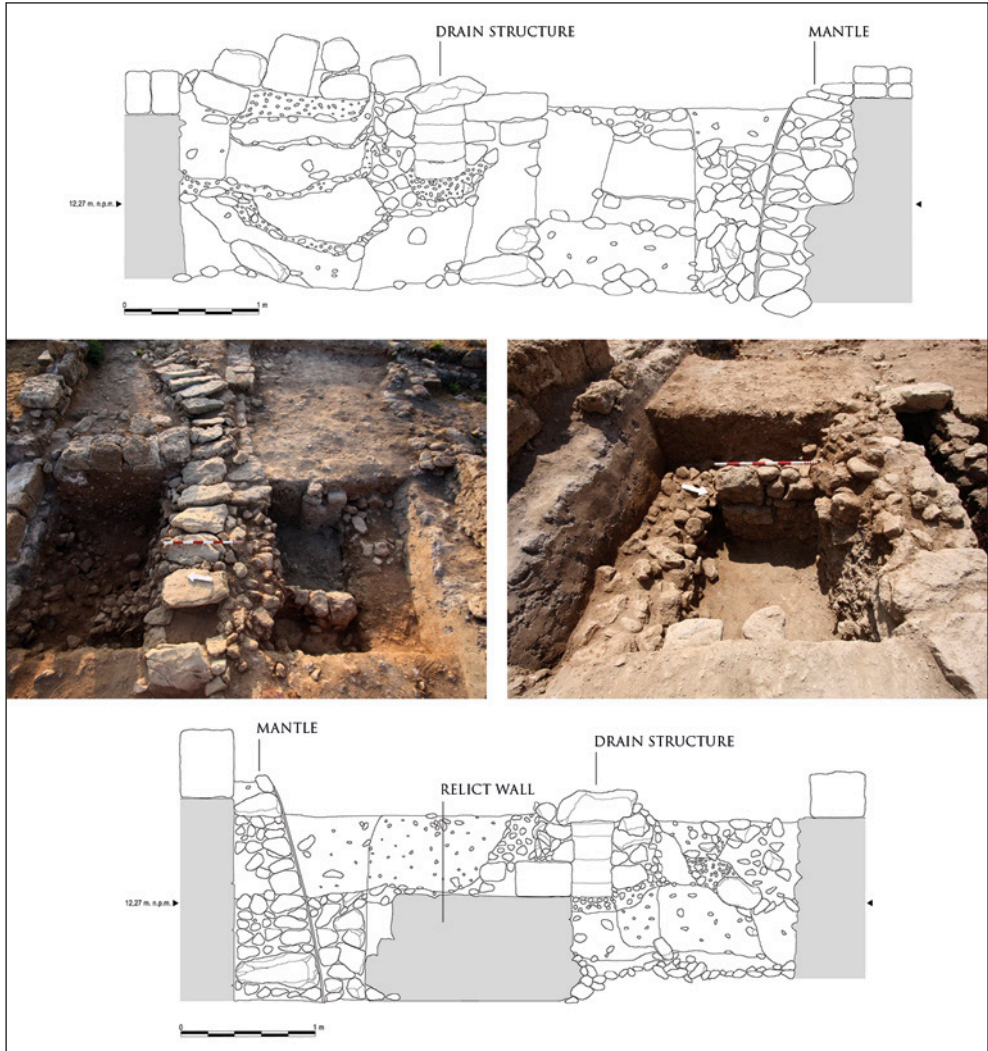
Fig. 2. D47 test trench: top, eastern section; center left, exposed structure of drain still covered with stone slabs in the test pit during excavations, view looking east; center right, features inside the part of the trench to the south of the central drain, view to the west; note the mantle wall against the wall at the left edge of the photo; bottom, western section (Drawing P. Jaworski; photos A. Pawlikowska)

The drain proved to be 0.50–0.60 m deep and approximately 0.40 m wide [Fig. 2]. The bottom was of lime mortar on a clay bedding. The structure of the south side made use of large roughly dressed blocks from a relict wall under the street surface, the blocks on the north side were not as carefully arranged. The sides of the drain were reinforced externally by a facing of stones about 10–15 cm in size poured with clay mortar. Earth mixed with small stones comprised the street fill on either side of the installation. The drain contained four distinct accumulation layers characterized by abundant and very fragmented pottery.

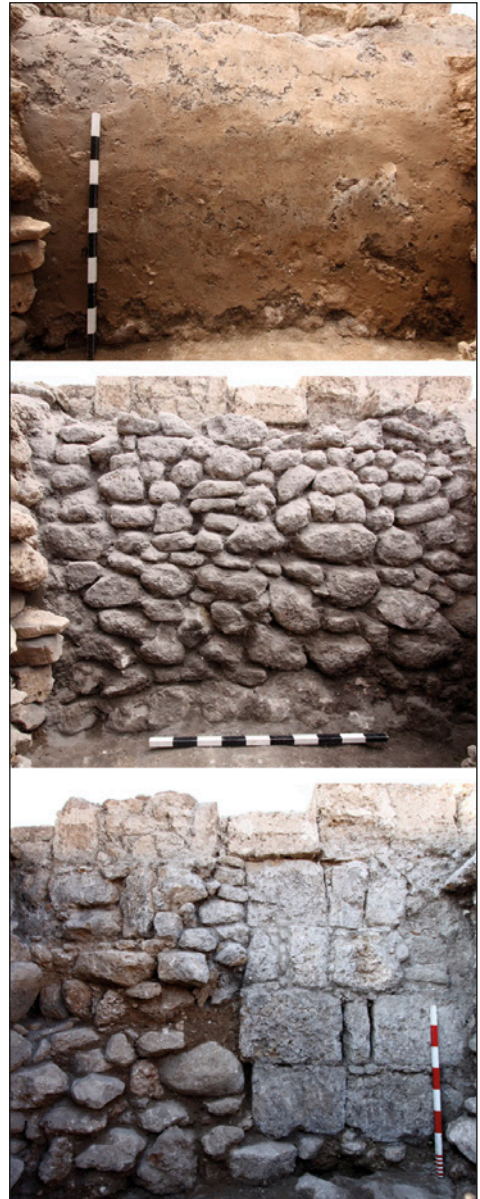
Fig. 3. Mantle against the north wall of building D90: top, clay plaster on the surface; center, stone surface under the plaster; bottom, original wall surface (Photos P. Jaworski)

Remains of D90 and D102 date from this phase, albeit the evidence is much disturbed by later building activities. The wall of D90 is a solid feature made of sandstone ashlars (approximately 0.20 m by 0.35 m by 0.45 m) [see Fig. 3 bottom], but D102 survives only as a rough substructure

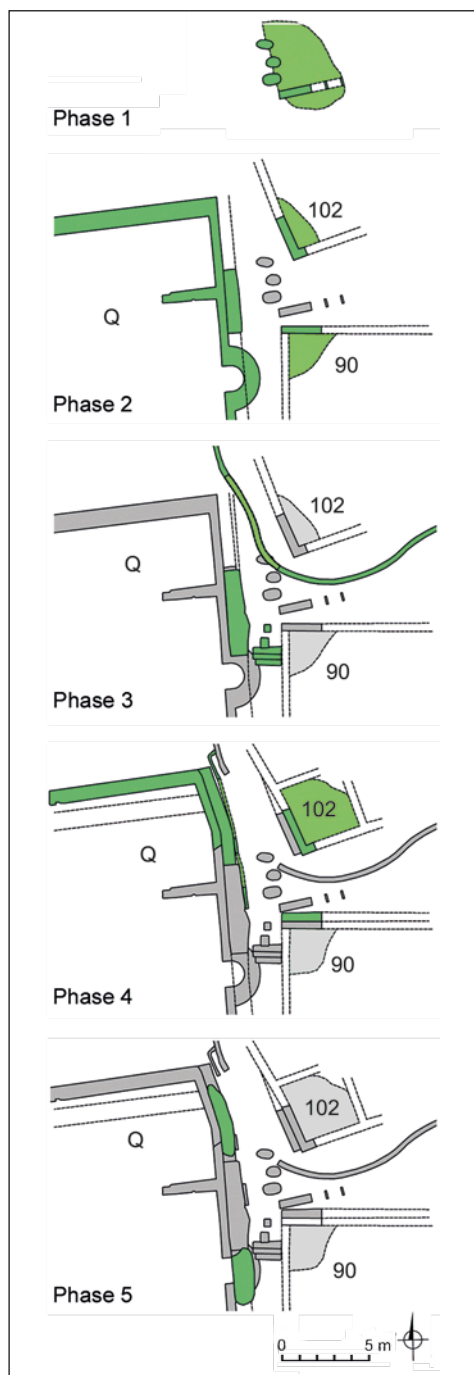
Fig. 4. General plan of structures in trench T1: from the top, phases 1 to 5 (Drawing R. Solecki)

Phase 1. The earliest feature in the trench was a wall aligned E–W in the southern part of the trench, its top recorded at 12.05 m a.s.l. [Phase 1 in Fig. 4]. It was made of rough, local sandstone conglomerate blocks, approximately 0.20–0.40 m in size, bonded probably with clay mortar. A wall of sandstone ashlars (0.25 m by 0.45 m by 0.60 m) with similar alignment and elevation was discovered in D42 (approximately 2 m to the east of T1) in 2012. These two walls probably represented two phases of the same structure. A line perpendicular to this wall (azimuth approximately 346 degrees) was marked by three postholes (diameters 0.40–0.60 m) and a fourth that was damaged. They may have been remains of some kind of partition wall that was attached to the northern face of the stone wall [Phase 1 in Fig. 4].

made of sandstone and limestone [Phase 2 in *Fig. 4*]. A gutter was built in this phase as well. It was made of a thick layer of lime mortar blended with ashes. The two directions of incline of the drain (which is 3 degrees overall) indicate that water was drained away from the wall of the basilica to the east and then southward generally to be carried away from the street and building.

Phase 3. A drain was built to collect water from the surface of street D116 [Phase 3 in *Fig. 4*]. It had a U-shaped trench approximately 1.60 m wide and 0.60 m deep. Two parallel walls approximately 0.50 m high were formed of rough sandstone blocks; they were wider at the bottom and tapering slightly toward the top. The gap between them formed a channel 0.20–0.35 m wide. The faces were irregular, although the stone surfaces of the inner one were slightly smoother. A few flat stones on the bottom bore traces of lime mortar with sand and ashes, indicating possible primary use as paving slabs. Most of this mortar was probably washed out. Covering slabs of the drain were part of the street pavement made of limestone and sandstone slabs (top at 12.50 m a.s.l. and 12.20 m a.s.l. respectively) [*Fig. 5*].

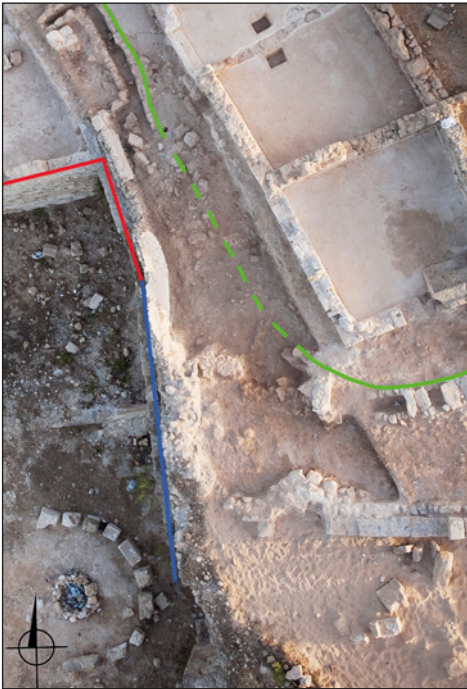
Fig. 6. Street D116, top view. The line of the drain marked in green; the missing part with a dashed line. Blue traces the original back wall of the basilica, whereas the reconstructed part is in red (Photo M. Bogacki)

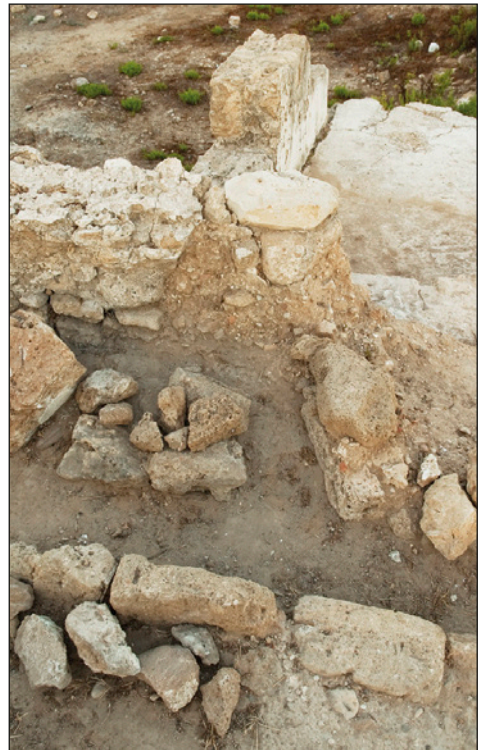
Fig. 7. Two troughs of the drain: lower from phase 3, upper from phase 4, running along the back wall of the basilica (Photo R. Solecki)

of the basilica are evident, from the original 4.25 m to 5.60 m. The foundation trench connected with the reconstruction of the basilica destroyed part of the drain, which reappeared to the north of the northeastern corner of the basilica [Fig. 6]. This does not necessarily mean that the drain went out of use. It could have continued to operate and collect water from street D116, discharging water through a new section built along the new back wall of the basilica [Fig. 7].

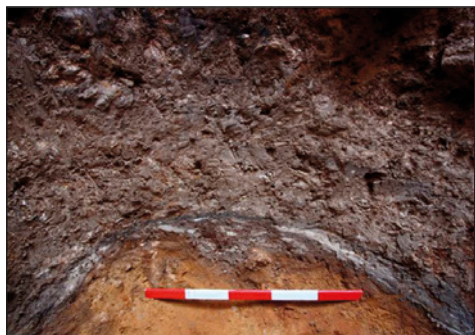
*Fig. 8. Western section of the test trench in room D20 (contexts 44–46)
(Photo A. Pawlikowska)*

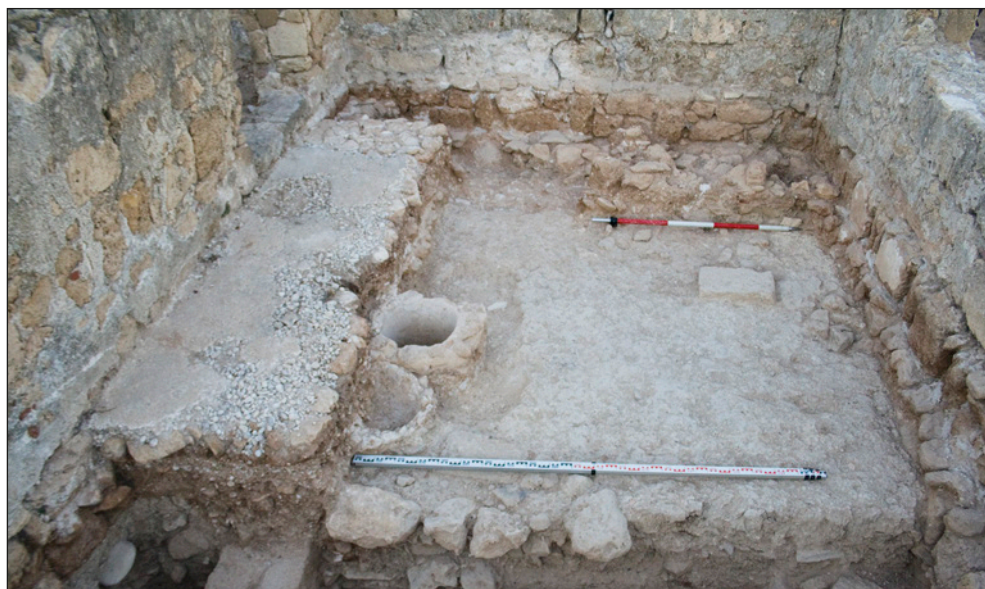
Fig. 9. Late Hellenistic/early Roman occupational level in the western part of D23 (phase 6); view from the east (Photo M. Wyżgół)

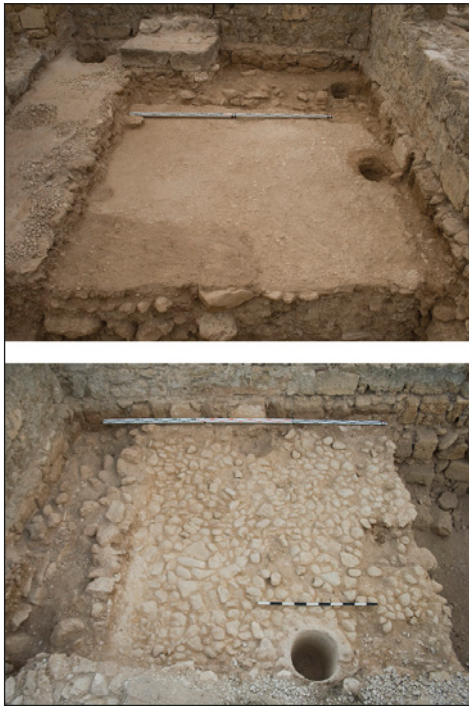
Fig. 10. Floor in D23 (phase 8): top, lime-mortar floor, view from the east; bottom, cobbled substrate under the lime-mortar floor, view from the south (Photos M. Wyzgół)

was constructed (11.50–11.70 m a.s.l.), its top surface (055) of gravel in lime mortar, resting on tightly set cobbles (066) laid over a layer of clayey floor substrate (063) [Fig. 10]. The north wall (042) was superposed on wall 040, its foundation trench piercing the floor of the previous level. The other walls followed the course of (or were identical with) those from the earlier phase.

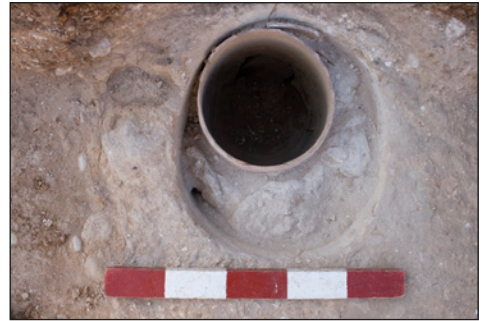
Fig. 11. Installations embedded in lime-mortar floor: vat with vessel inside it (Photo M. Wyzgół)

The room was equipped with an installation in the form of a ‘cement’ vat, its top flush with the floor surface. Two such installations, marking occupational sub-phases, were found in the southeastern part of the excavated space, both projecting from the south trench section. The older one (077) was badly damaged. Its interior was shaped like a round-bottomed basin (preserved depth 0.15 m, maximum

inner diameter 0.30 m). The younger one (072) was completely preserved (cylindrical interior roughly 0.34–0.38 m in diameter, 0.47 m deep) [Fig. 11]. However, it looks like it did not serve its purpose well enough, because a cut-off(?) bottom half of an amphora (installation 069)² was eventually fitted inside it. The vessel was cracked when found, which might explain why yet another amphora half (061) had been installed Russian doll-fashion inside the first one. In each case, the edges of the vessels were secured with plaster, but the topmost one projected slightly over the locally replastered floor. One more half-amphora (051) was fixed in the floor near the middle of the north wall. Here, the diameter of the hole made in the floor for this purpose was larger than necessary, with no preserved traces of repairs to the

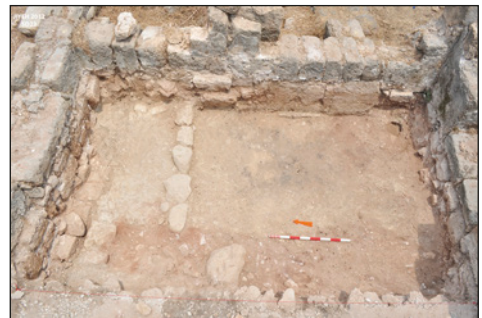
Fig. 12. Foundation of a partition wall in D23; fill of a quarrying ditch in the foreground (Photo J. Brochocki)

The structures ascribed provisionally to phase 8 in the eastern room were limited to a tamped-earth occupational level(?) (011+012). The unit was subdivided in phase 9 with a row of boulders appearing just over a meter away from the north wall and parallel to it [Fig. 12]. It may have been a foundation for a wall made of a lighter

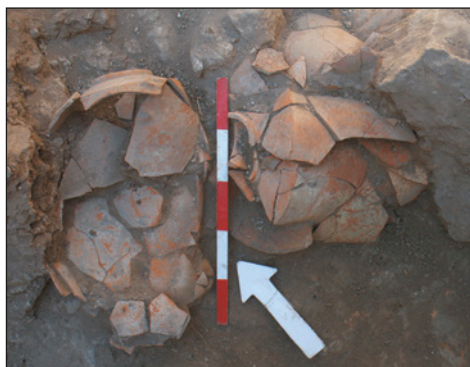
Fig. 13. Deposit of Phoenician-period vessels from context 036 in area D4 (Photo A. Zawadzińska)

the oldest settlement structures, built on native rock, and dated based on pottery evidence to the Iron Age II. These remains [Phase 1 in *Fig. 14*] consisted of thick walls (035) made of irregular blocks of limestone bonded in earth and clay mortar. The structure when it collapsed sealed a deposit (036) of 23 broken cooking pots and tableware from the 8th–7th century BC in the center of the floor (phases 2–3) (Waliszewski and Wicenciak 2015: 161–162, *Fig. 7*) [*Fig. 13*]. Apart from the brief event in the Persian period, more intensive activity in the area started in the late Hellenistic period, involving presumably some kind of metallurgical activity to judge by the remains of slag (024). After a rather short-lived revamp in the Hellenistic period (phase 4), the area was abandoned quickly and a layer of minor building detritus formed on top of the Hellenistic-period walls (phase 5). The latest phases of activity involved leveling of the ground and new architecture built in the late Roman and early Byzantine periods (phases 6–7). The construction technique of the walls did not differ significantly

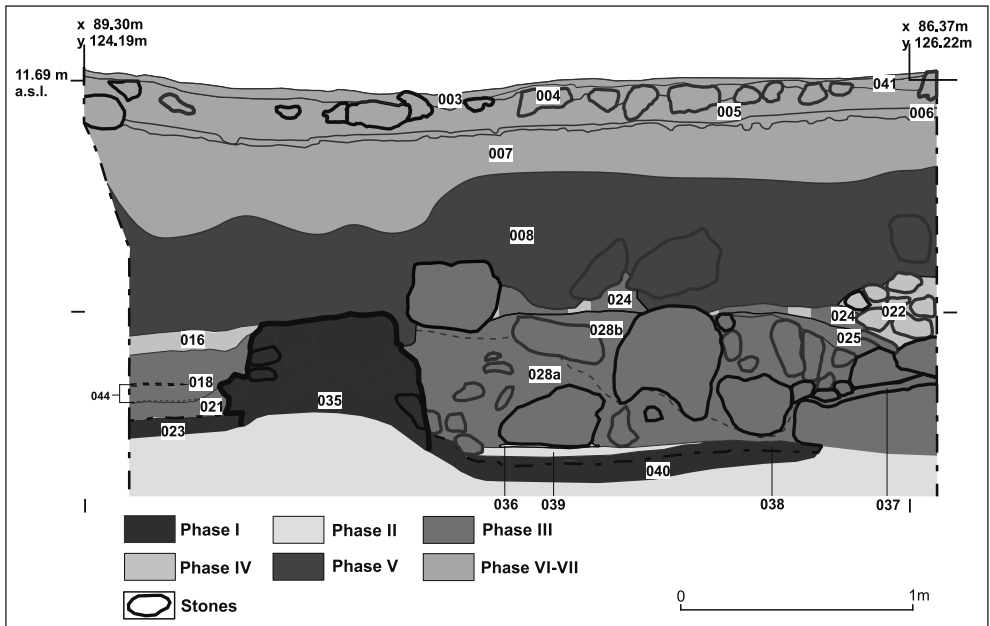
Fig. 14. Section through area D4, looking east (Drawing M. Romaniuk)

In trench T3 (which was an extension of D4 to the east and south), two subsequent levels of late antique lime-mortar floors with substrate (003–007, 041) [Fig. 14] were removed uncovering walls built in the “Phoenician” ashlar-piers-and-rubble technique on which the late antique walls of area D4 had been founded, repeating a situation already noted by the trench supervisor in this sector, for example the north and east walls of area D63 in the southwestern part of the quarter and the east and south walls of area D68 in the central part. The finds shed light on the extent of the earlier settlement on this site

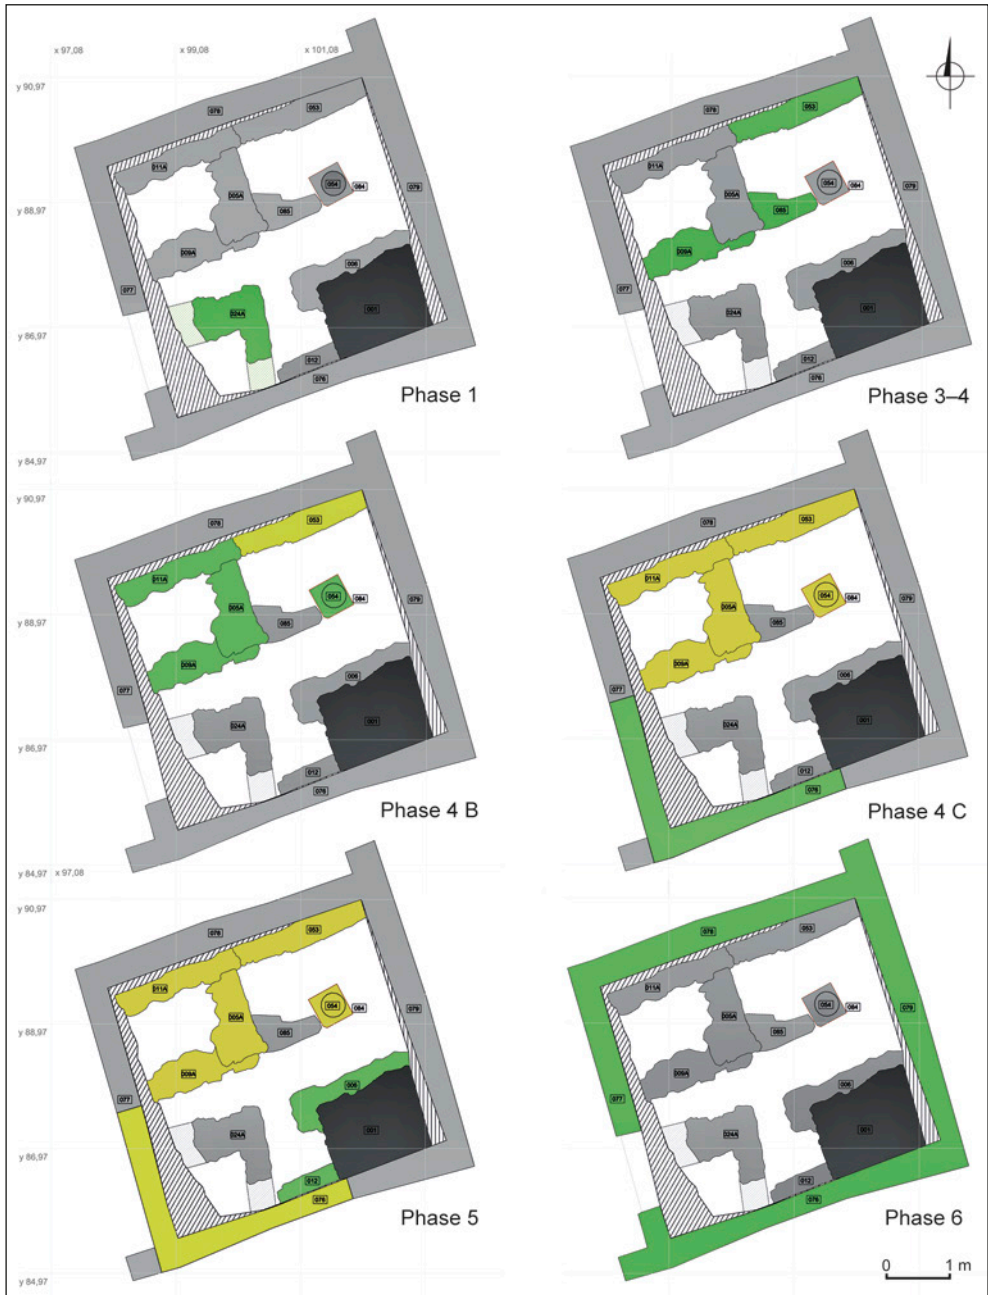
Fig. 15. General plan of structures uncovered in room D72: from top, phases 1 to 6 (Drawing M. Antos)

Area D72. The oldest of the registered structures is a corner wall in the southeastern part of the room (discovered in 2009) [Phase 1 in *Fig. 15*], built of dressed *ramleh* in a clay binder (preserved top at 9.82 m a.s.l.). The stratigraphic relations of accompanying contexts and the pottery evidence suggested a date in the Persian period.

In the Hellenistic period, as indicated by the archaeological evidence, different walls were introduced from an elevation of 10.12–10.10 m a.s.l. [Phases 3 and 4 in *Fig. 15*]. They were built of irregular and dressed blocks of stone, both limestone and local *ramleh*, bonded in clay mortar. The older phase of wall C009 was preserved to a height of about 30 cm and was probably related to other structures from the Hellenistic period which have not survived (two coins dated to this period were found between the stones of the second course). Afterwards, it was reused to build new structures in the northern part of room D72. The contexts which accompany the wall could mark potential levels of use. Just like in phase 2, a layer of humus was found between them which shows that the space went out of use for a period of time.

Three subphases were distinguished in phase 4 [see *Fig. 15*]. The first (A) was a layer of accumulated or leveled deposits and should be probably associated with the degradation or part-demolition of one of the walls (085) and the preparation of this area for the building of new structures. The fill in the uppermost layers consisted predominantly of fine and middle-grained silty sand consisting of fragmented and mixed pottery material dated to the Persian–Hellenistic period. A deposit of partly painted terracotta plaques with busts and numerous large pottery fragments was found in the northwestern part (elevation 10.05 m a.s.l.). In some of the broken vessels there were traces of ashes with burnt animal bones and organic material. The second subphase (B) witnessed transformation and reuse of some of the older structures, forming a kind of platform in the northwestern quarter of the area which was then filled with

Large-scale construction works occurred in phase 5 [see *Fig. 15*]. A wall (C012) reinforcing the south wall of room D72 (from phase 1) was built from this level as well as a wall perpendicular to it (C006) which closed off from the south the area with the column and the platform-like structure on the west side. It was built of large dressed blocks of limestone conglomerate which were bonded with a lime-and-ash mortar with clay fractions, fine sand and small stones added. Traces of a lime render under plasterwork were noted on the face of this wall. Stratigraphic relations and architectural analysis suggest this structure was probably built in the early Roman period and was in use concurrently with the older structures.

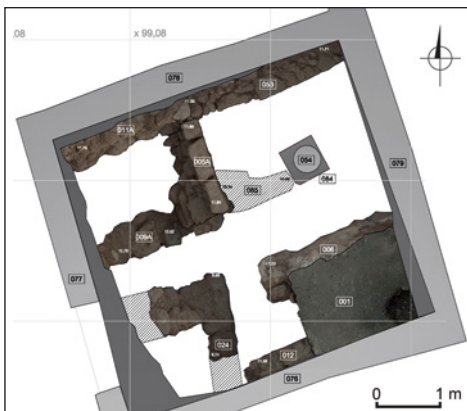
*Fig. 16. Orthophotoplan of structures in D72
(Photo and processing M. Antos)*

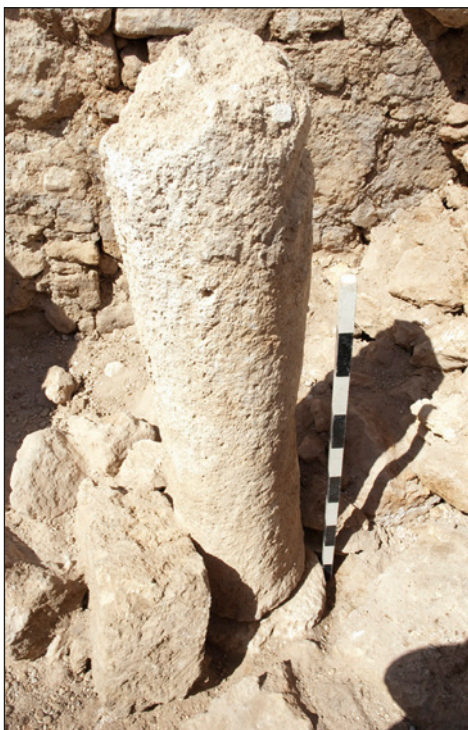
*Fig. 17. Column shaft
(Photo M. Antos)*

ing the column base and shaft, made of porous *ramleh*, found in place in the north-eastern part of the room. The shaft was 0.33 m in diameter, 1.20 m preserved height; the base 0.54 m and 0.30 m respectively diameter and height, of rectangular shape with an irregular torus [Fig. 17]. An intact oil lamp dated to the Hellenistic period was found in late antique fill. The almost complete lack of glass and metal finds, including coins, is the most striking.

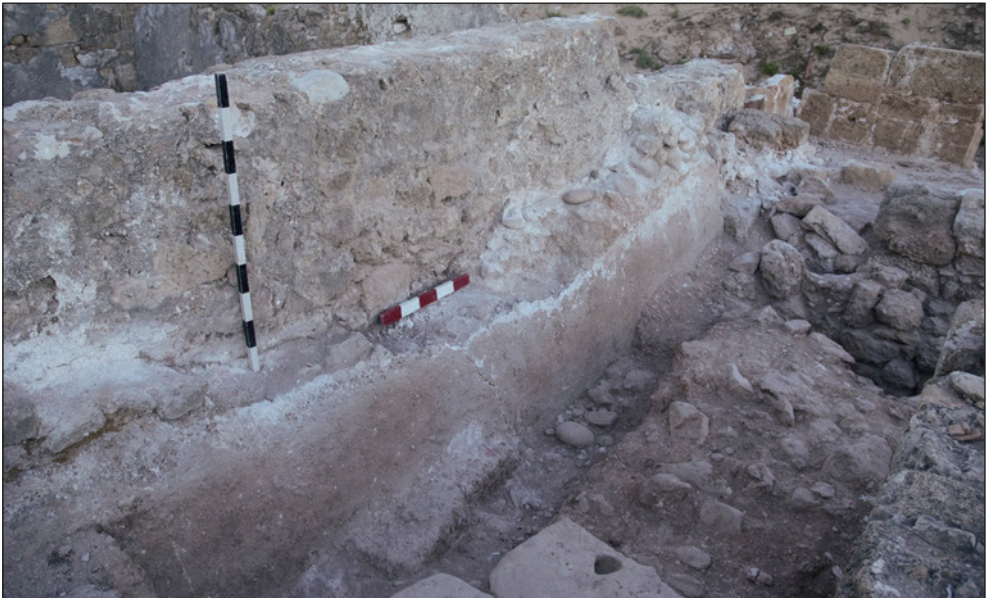
Fig. 18. Structure reinforcing the east wall of room D72 in trench D/T4, general view from the west (Photo M. Antos)

Test D/T4. Phase 1 identified in the trench was connected with rebuilding in late antiquity. The east wall of room D72 was reinforced with a structure from 0.60 m to 0.80 m high, 0.24 m thick in its northern part, built of dressed *ramleh* blocks [Fig. 18]. Its smooth, slightly bulging face was covered with hard lime plaster with middle-grained gravel and quartz mixed in and trace quantities of

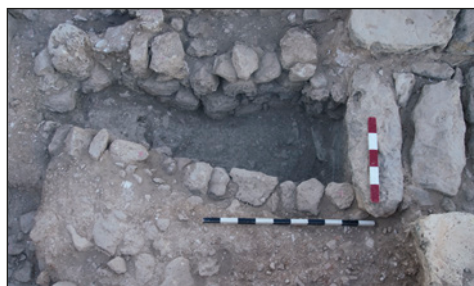
Fig. 19. General view of D/T4 in phase 1 from the top of the east wall (Photo M. Antos)

Large limestone slabs of roughly rectangular shape formed a pavement more or less level with the foundations of the reinforcing structure described above and the limestone floor inside room D72. They could represent the first level of occupation after the rebuilding of the area. Partly on top of them was a layer of *ramleh* and limestone blocks of different sizes which may have been the next occupational level or a leveling layer. A foundation trench was dug from this level for the drain running along street 100 [Fig. 19].

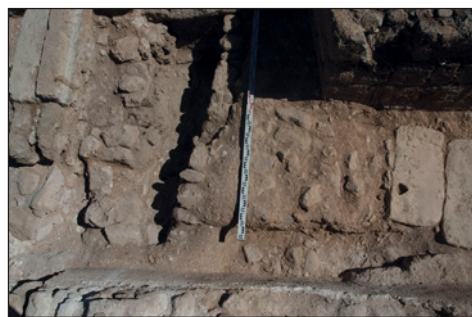
Fig. 20. Drain in street 073 in the northern part of the area (Photo M. Antos)

forming a channel from 0.40 m to 0.60 m wide, covered with rectangular limestone slabs [Fig. 20]. Traces of plastering, probably washed away by water, were noted on the walls, as were numerous sediments on and between blocks and in the fill of the drain. The pottery material found in the fill of the pit and in the drain is not homogenous, ranging in date from the Hellenistic to the early Byzantine periods. However, most of the finds are of a later date, which sets a *terminus post quem* in the 5th century AD, already after room D72 was built. The ceramic assemblage is fragmented and mixed, typical of leveling layers and dated to the 4th–5th century AD. Layers interpreted as occupational levels yielded mostly utility wares and a few fragments of glass, animal bone and shells.
