Research and architectural conservation in Marina el-Alamein in 2018 (Polish–Egyptian Conservation Mission)

Abstract: Activities undertaken by the Polish–Egyptian Conservation Mission to Marina el-Alamein in 2018 comprised research and conservation mainly in the public district of the ancient town and, additionally, in private houses. Work focused foremost on research and presentation of remains of two streets, running east and south of the southeastern corner of the main town square, and the adjoining monuments. Research and conservation continued also on the remains of public Roman baths dating from the 1st to the 3rd century AD, located in the area south of the square. Maintenance conservation was carried out in Houses H21c and H1 and in the ancient town center. Land grading to enhance exhibition value and ensure rainwater drainage was carried out in some areas.

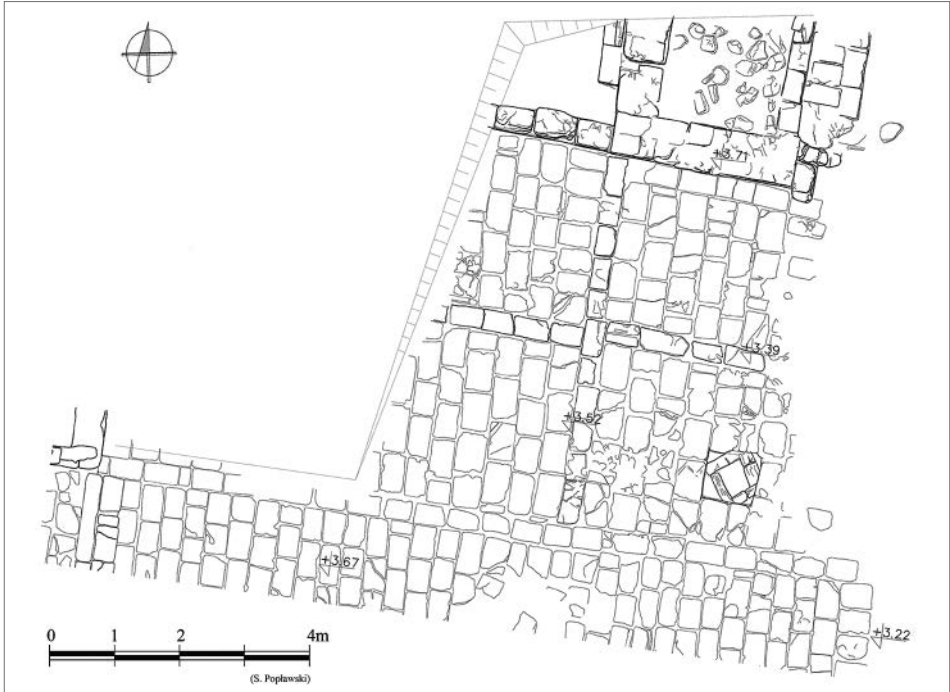
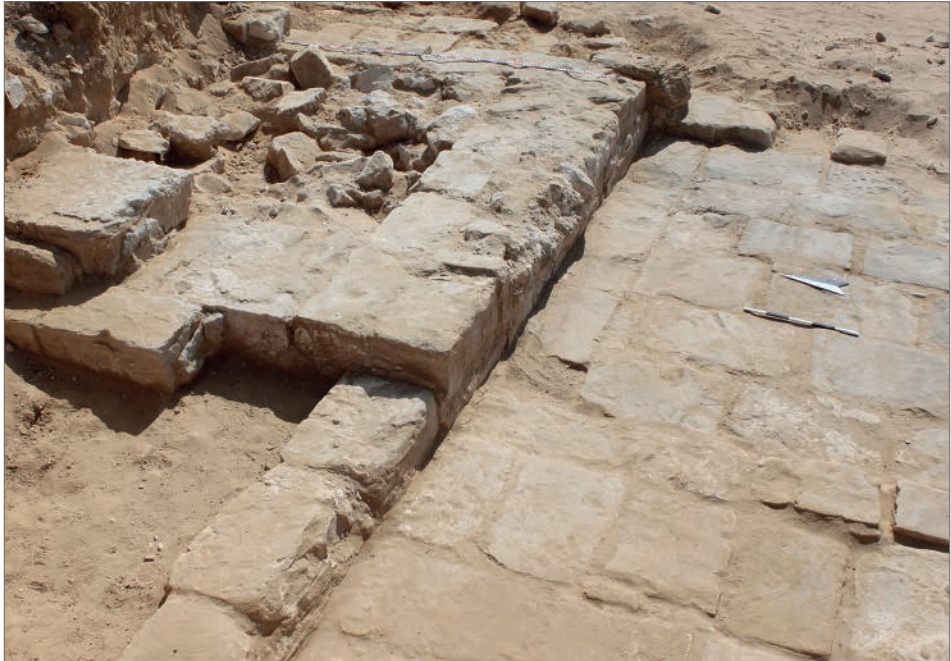
The uncovered remains constituted the southeastern corner of a building, in which several elements can be distinguished [see *Fig. 3*]. The south wall is roughly aligned with the stylobate of the southern portico of the peristyle adjoining the forum, situated about 20 m to the west [see *Fig. 2*]. Assuming that the north wall of the building would be aligned with the northern portico of the peristyle, the building would stretch for 7.80 m from north to south. However, the alignment is only approximate and the direction of the wall is slightly inclined in relation to the stylobate discussed. Further research is necessary.

Fig. 3. Part of the square and remains of structures siding the street running east from the forum: top, plan; bottom, the northern part after cleaning, looking east (Polish–Egyptian Conservation Mission Marina el-Alamein | photo R. Czerner, drawing S. Popławski)

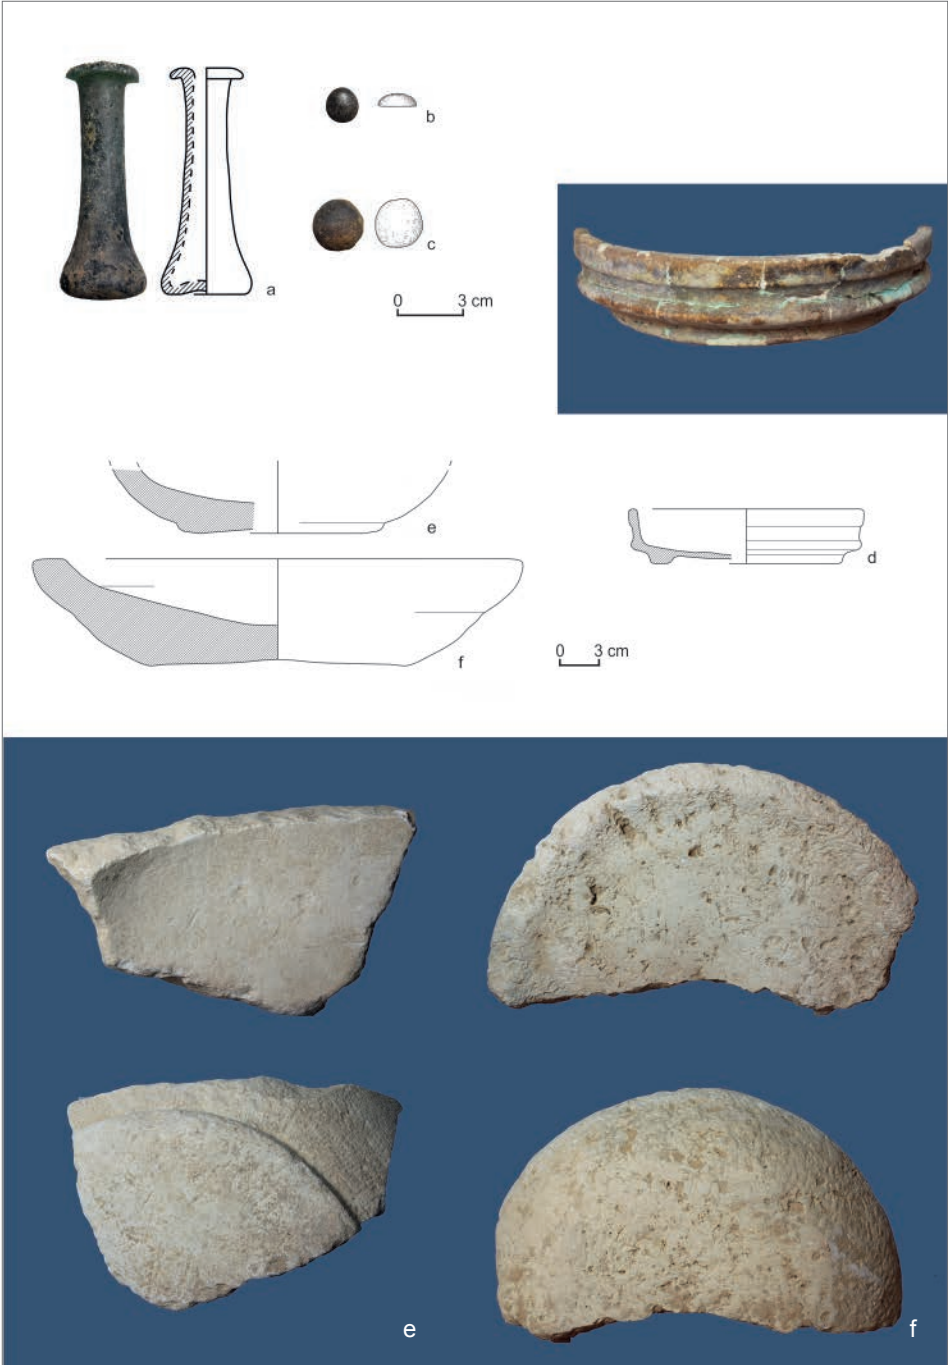
Finds from the room behind the wall lining the south side of the street, recovered during the reconstruction work on the wall, included a glass pawn [Fig. 4:b] and a mortarium fragment [Fig. 4:e]. Oval pawns of this kind, slightly convex with black shiny surface (Dia. 1.6/1.4 cm, H. 0.6 cm), are fairly common (e.g., Nuțu and Boțan 2009: 148, 151, Pl. 2, Nos 2–4). The small fragment

of a limestone mortar has a base 15 cm in diameter and body walls smoothed inside with traces of treatment on the outside. The bottom was slightly concave, the foot profiled. The pottery from this context was dated to the 2nd through 3rd century AD (G. Majcherek, personal communication). In Marina, pawns and mortaria are frequent finds. Most of the mortars discovered in Marina date from this period.

Fig. 4. Glass, faience and stone finds: a – glass unguentarium; b – glass game pawn; c – glass marble; d – faience plate; e, f – stone mortaria (Polish–Egyptian Conservation Mission Marina el-Alamein | drawing R. Bąkowski, photos R. Czerner)

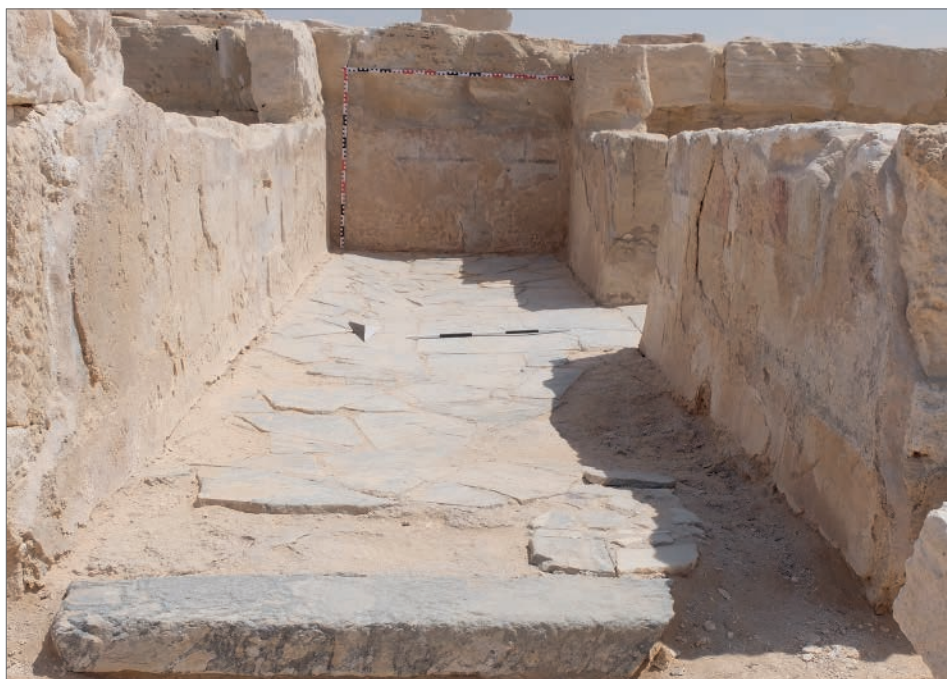
In 2018, Room 13 [Figs 9, 10], which used to be an entrance corridor to Latrine 12, was explored, revealing painted wall decoration on the lower parts of all the walls. The excavation of this unit had been postponed from 2013 (for the earlier research, see Czerner et al. 2015: 126; Bąkowska-Czerner and Czerner 2017: 181) in order for a painting restorer to be present during the investigation.

Fig. 9. Rooms 12 (latrine) and 13 of the Roman baths south of the main square: top, view from the west; bottom, view from the north (Polish–Egyptian Conservation Mission Marina el-Alamein | photos R. Czerner)

Maintenance conservation and protection work was carried out in several units of the bath, protecting the edges of original plaster, which had become detached (for a discussion of this work, see Selerowicz and Zambrzycki 2019, in this volume). [RC]
