The North-East living quarter of the medieval pilgrim centre in Banganarti. Archaeological research in 2015 and 2016

Michał Dzik

Abstract: Two seasons of fieldwork in the northeastern part of Banganarti site brought significant data on its stratification, as well as the architecture of medieval dwellings. This paper presents a summary of the results. Special attention was focused on the layout of the buildings and on vault usage. Remarks concern the functionality of the explored space, based on an interpretation of the stratigraphy. Evidence of strong water erosion in the early stages of the settlement is also discussed.

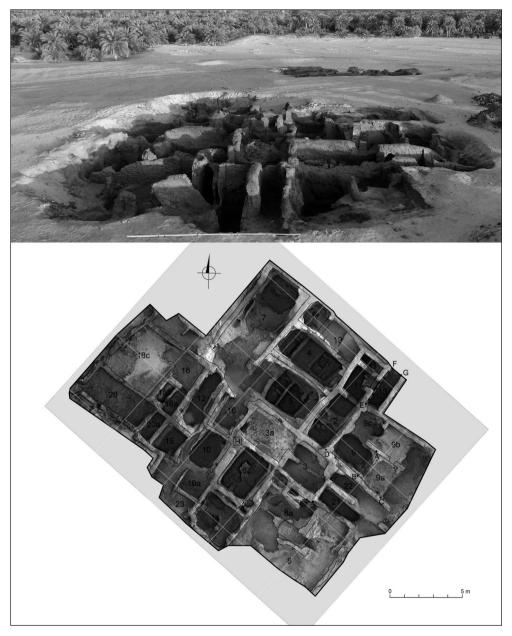
Fig. 2. Trench I in the NECH sector: top, view from the southeast; bottom, orthophoto generated from a digital elevation model based on photos taken in February 2016. A–G – section views in Figs 5, 8, 9; H – location of a burial; 1–23 – numbering of areas (Photos and measurements M. Dzik, R. Łopaciuk; processing M. Dzik)

Trench I was opened on the northeastern side of the church, near an area explored in part between 2010 and 2014 (Żurawski 2016: 354, 355, Fig. 2). It covered an area of about 350 m² [*Figs 1, 2*]. The tops of medieval walls from the last phase of the existence of the settlement were exposed under a layer of sand that was 0.10–0.50 m thick. Altogether 33 different areas were distinguished: potential rooms, streets and units of unknown purpose [*Fig. 2* bottom]. This division became the basis for further exploration and documentation.

Most of the finds are from a domestic or craft context with the exception of a grave dug in the coping of the wall between areas 6 and 10 (No. 1), related to the last phase of use of this space [see *Fig. 2* bottom]. Only a small part of this burial, which lay directly on the wall, was preserved: a fragment of a hip bone, the vertebra and bones of the right forearm. The bones were found lying at an elevation of 151.73 m a.s.l., in a pit 0.50 m wide. The skeleton position was supine, oriented to the southeast, the right arm straight and the hand on the right hip.

The apparently chaotic building layout [see *Fig. 2* top] is the result of a multiphase development with rebuilding of single units, evolution of house layout and changes in street setting. Buildings discovered in the upper part of trench I can be associated with eight or nine dwellings [*Fig. 3*]. They were in use during the late phase of the settlement, which however was not the final one, as part of the discovered architecture was overbuilt with younger walls, the preservation of which is vestigial. In some cases, these upper structures formed second floors of two storey houses, whose well-retained ground floors were documented. In other buildings, they were founded on the level of the preserved wall

Other distinguished features included partitions made of mud brick, stock pits, dump pits, postholes and also fireplaces and ovens. Amid the latter, three ovens were made in walled up areas made just for them, 1.50–2.00 m long, 0.60–0.80 m wide, 0.94–1.60 m² in area (Nos 18a, 18b, 20a; see Fig. 2 bottom). The ovens were domed with mud bricks and finished with hard mud. The height of the chambers was 0.40-0.50 m. These were probably cooking ovens. Layers of ash and charcoal were found at their bottom, along with a few dozen potsherds apiece, mostly cooking wares, also a few fragments of animal bones, including a burnt one (area 18a), and single pestles (areas 18a, 18b). Another oven of different construction, rather poorly preserved, stood on the same level in the east corner of area 18.

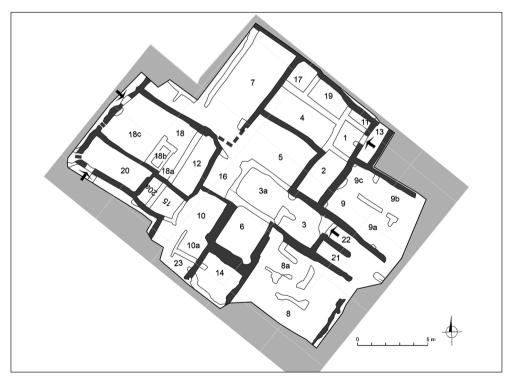
Fig. 3. Wall tops in trench I after removal of the upper layer of sand. Dark grey – boundaries of dwellings from a late phase; arrows mark the entrances to dwellings; 1–23 – numbering of areas (Drawing M. Dzik)

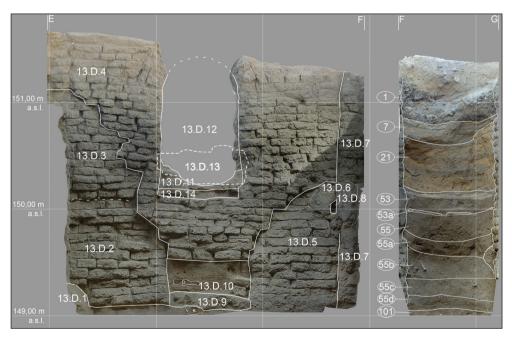
Fig. 4. Photogrammetric documentation of the north wall and east section cut (on right) of area 13 (Processing M. Dzik)

An example of such continuity is the south wall of House A, visible from area 13, that is, from the street [*Fig. 4*]. This wall was bricked up directly on top of older structure 13.D.1 and kept its course. One of the last investments to be seen on the wall face is its overbuilding with wall 13.D.4. At the same time, the level of the entrance to the house was raised by 0.95 m and a new opening 13.D.12 with threshold 13.D.14 was built (this was undertaken from a ground level at the top of layer 55b, which is 0.60 m below the threshold). In this case, not only the line of an older wall was kept, but also the location of an entrance, which remained the same despite changing ground level and repeated rebuilding of the dwelling. A similar situation was observed in area 5. The east wall, built partly on top of cultural layers 0.40–0.50 m thick, keeps the line of a wall of a much older building, found 2.10 m underneath.

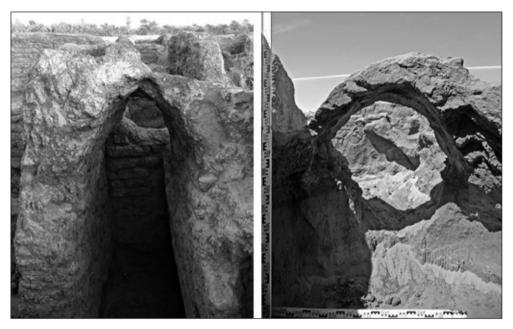
Fig. 5. Examples of arched architecture in trench I (2015): left, staircase in area 8a and right, vault in area 4 (Photos M. Dzik)

in the NECH sector [*Figs 5, 6*]. The form of arches over openings varies considerably, from semicircular to segmental and even pointed. Arches were made of mud bricks, complemented sometimes with larger sherds or red bricks. Within trench I, baked bricks were found only in arches above the entrances from the street, as in areas 1 and 18, or from the inner yard (area 7 in an earlier phase). It seems that red bricks were used mainly for decorative purposes. Nevertheless, an apotropaic function cannot be excluded, being probable because of the red colour, the durability of the material and perhaps even a sacred provenance (the only building in Banganarti with red brick walls was the church).

Vaults, made of mud bricks exclusively, were unearthed in 14 areas. In comparison, unequivocal proof of flat roofing resting on wooden beams was found in just one room (area 20). The span and rise of the vaults varied. The inner width of rooms covered with arched ceilings ranged from 1.10 m (area 12) to 2.50 m (areas 5 and 7), and their maximum heights from 0.90 m (area 17) to 2.10 m (area 5). The skewbacks of vaults from the discussed trench were placed 0.30-0.70 m up from the first floor of the room (for the skewback of vault 9.C.5 on top of wall 9.C.4, see Fig. 7 top). It resulted in a significant reduction of space along the bearing walls, which is unarguably a disadvantage of vaults compared to flat roofs. The advantage, however, was surely the resistance to the vertical load of such construction. Using bricked vaults in dwellings is closely connected with issues of the external shape of their roofing and the presence of twostorey houses. One issue to be considered is whether vaults were used in Banganarti as roofing only in cases of an upper storey being planned.

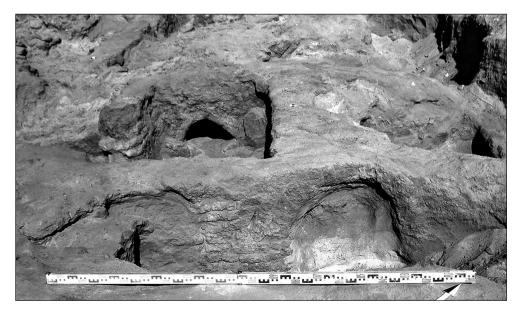
Fig. 6. Examples of arched door openings in trench I (2015), areas 13 (foreground) and 1 (background) (Photo M. Dzik)

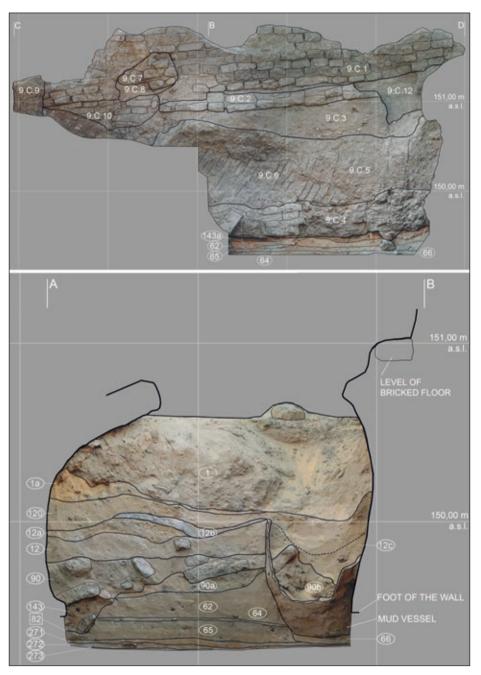
Fig. 7. Photogrammetric documentation in areas 9 and 9b: top, west wall; bottom, east–west profile cut (Processing M. Dzik)

The upper part of the backfill of the described basement, namely contexts 1 and 1a, consisted of aeolian sand with debris from the collapsed parts of a vault and with mixed archaeological material [see Fig. 7 bottom]. Similar fill was found in nearly all the areas destroyed by modern digging. These post-settlement layers include more or less numerous potsherds and animal bones, sometimes droppings of domestic animals (mainly goat, less often donkey). They are evidence that the rooms, once abandoned, were used as animal pens and rubbish dumps. The latter is suggested also by the extensive fragmentation of the ceramic material typical of such deposits.
