# Archaeological and geophysical survey at the site of Khirbat as-Sar (Sara), Jordan

**Abstract:** Archaeological and geophysical prospection of the site of Khirbat as-Sar (Sara) in Jordan, carried out by a team from the Polish Centre of the Mediterranean Archaeology (PCMA), University of Warsaw, has resulted in a comprehensive plan mapping all visible architectural remains. A Roman-period sacred compound appears to be a central feature of this site. Pottery collected from the surface has given a time range for the settlement from the late Iron Age through the Mamluk period. The electrical resistivity method using a probe array that allowed ground penetration to a maximum depth of approximately 1.50 m revealed meaningful information on the spatial organization of the site. Numerous high-resistance anomalies were interpreted as a reflection of building remains.

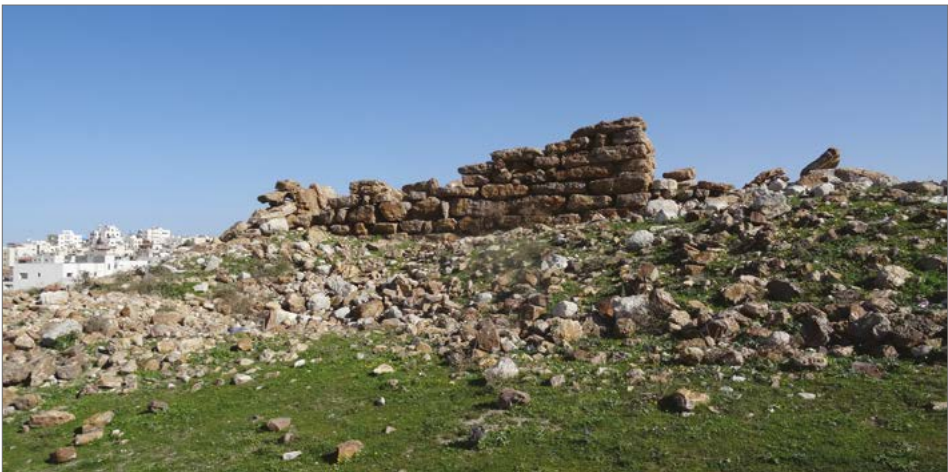
Fig. 1. The “qasr” seen from the south (PCMA UW Khirbat as-Sar Project/photo J. Młynarczyk)

the ground. The compound situated in the highest spot of the site constituted the focal point; it was composed of a square building, commonly described as a “qasr” or “Ammonite tower” [*Fig. 1*], and a courtyard with two rows of arches on the northern and southern sides [*Fig. 3*]. This architectural complex has been identified provisionally as a temple compound. Several walls were recognized and mapped in the other parts of the site, an especially dense concentration occurring in the southeastern and southern sectors. Combining data from the mapping and the electric resistivity prospection has given a more complete picture [*Fig. 2*]. It is to be noted, however, that there are several large and deep hollows in the ground, filled with stone blocks of different sizes, situated in the

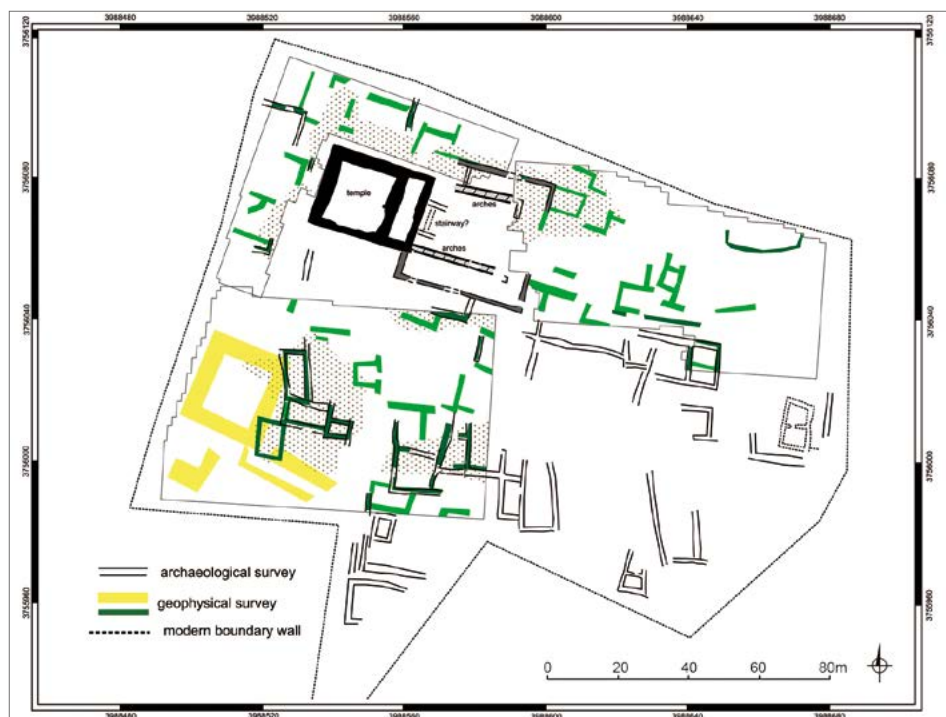
Fig. 2. General plan of the site of Khirbat as-Sar: combined results of archaeological and electric resistivity surveys (PCMA UW Khirbat as-Sar Project/drawing M. Burdajewicz, M. Gostkowski and R. Ryndziejewicz)

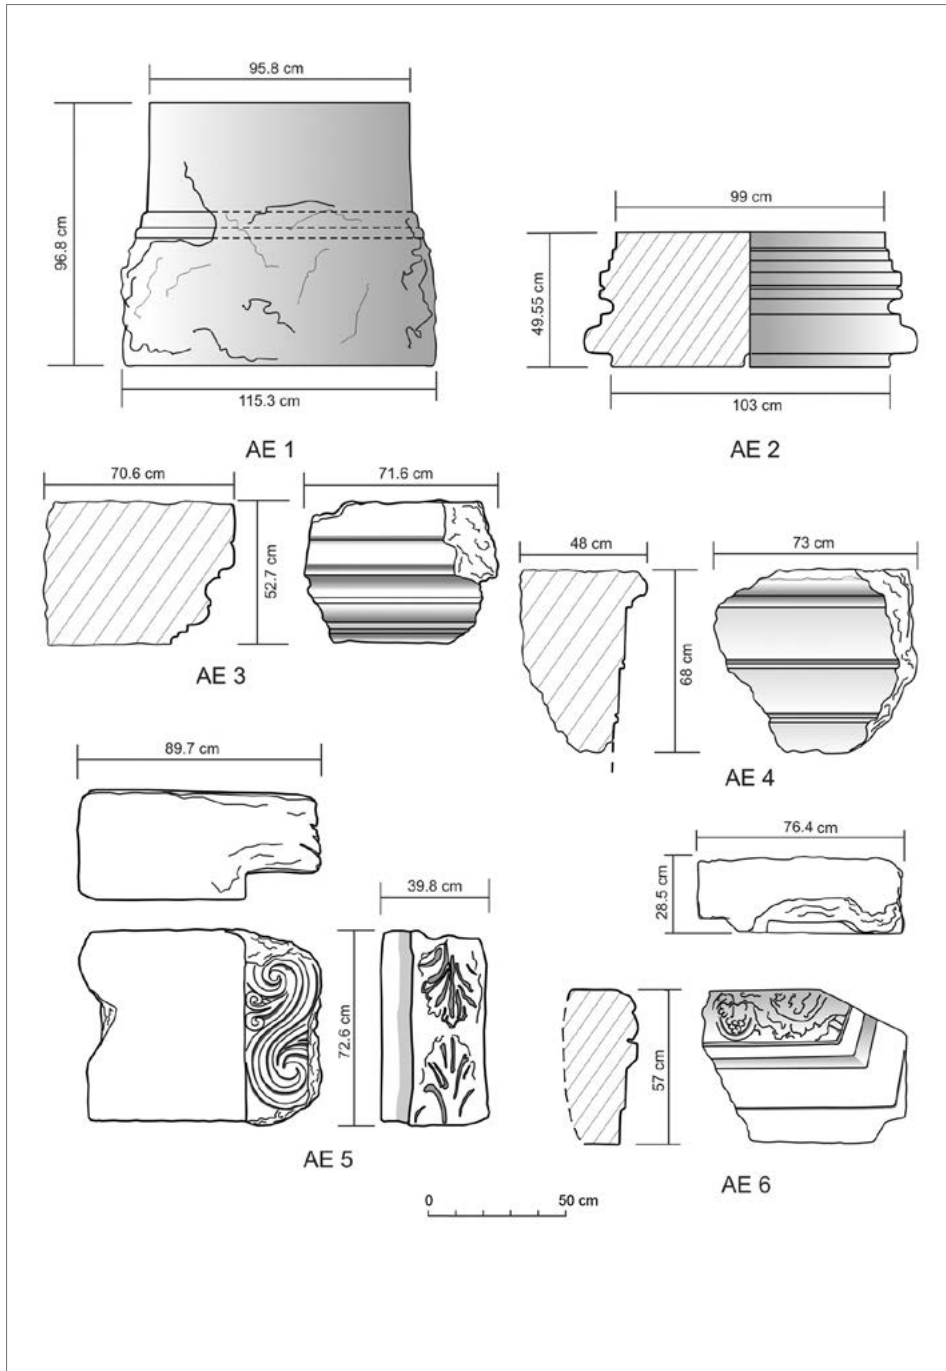
Fig. 4. Selected architectural fragments in limestone (PCMA UW Khirbat as-Sar Project/drawing and digitizing M. Burdajewicz)

The data were subsequently compared with information from the past reports of Claude R. Conder, Howard C. Butler, Nelson Glueck, and Chang-ho C. Ji. Single elements of architectural decoration, pertaining mostly to the temple compound, were measured, drawn and photographed (for a selection, see *Fig. 4*). The surface collection of artifacts

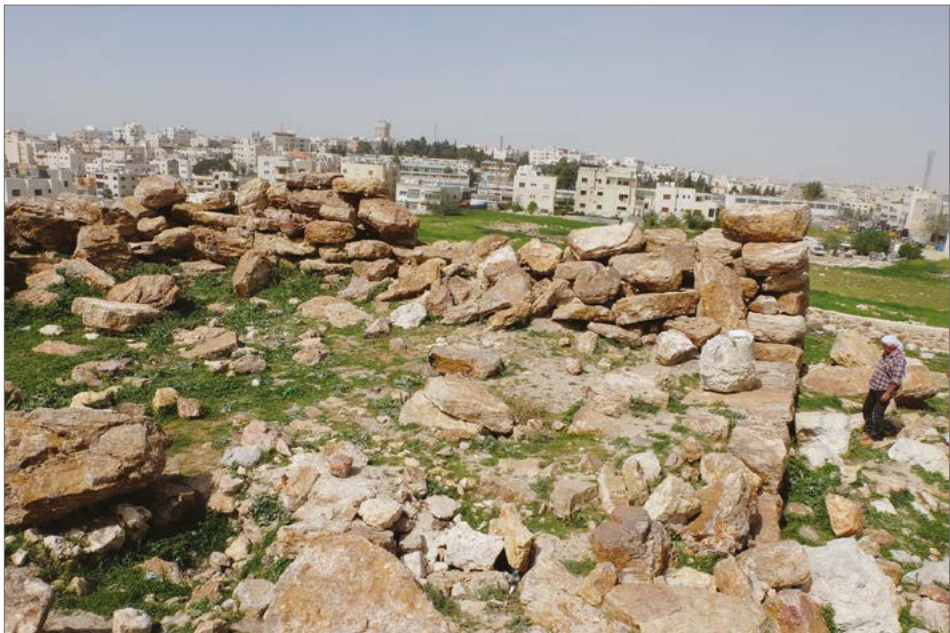
Fig. 5. Interior of the “qasr” looking northeast (PCMA UW Khirbat as-Sar Project/photo M. Gostkowski)

pound consists of the “qasr”, a vestibule and courtyard with two side aisles sectioned off by rows of arcades. The “qasr” was square, built of semi-dressed blocks of flint conglomerate, from big to huge in size [*Fig. 5*]. Its dimensions as measured by the survey, 19.37 m (north–south)

by 19.34 m (east–west), corresponded to the measurements given by Glueck (20 m by 19.80 m) and Butler (19.50 m by 19 m), while differing substantially from those reported by Chang-ho C. Ji (16 m north–south by 17 m east–west). Two displaced column bases were found inside the “qasr” [see *Fig. 4:AE 2*] along with a monolithic base carved together with the column drum [*Fig. 6*; see *Fig. 4:AE 1*], standing perhaps *in situ* in the eastern entrance to the “qasr”. Unlike the walls of the “qasr”, these elements were made of limestone. It should be noted that more than one hundred years ago Butler saw, inside the building, as many as four large column bases “not *in situ*”, while Glueck mentioned only three.

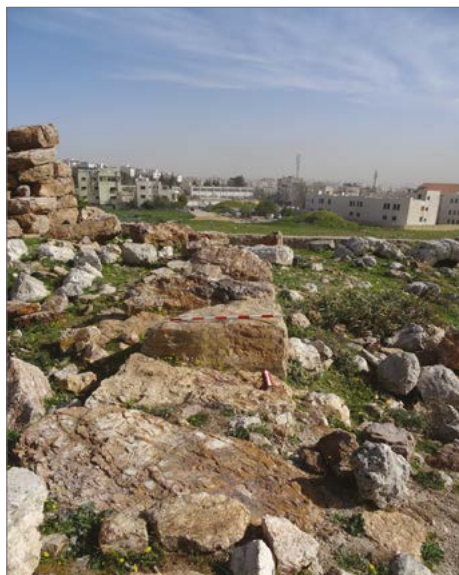
Fig. 7. East wall of the vestibule looking north (PCMA UW Khirbat as-Sar Project/photo J. Młynarczyk)

The eastern side of the “qasr” is preceded by a vestibule (or *pronaos*). This feature was described by Glueck as a “platform” 6.80 m deep (from east to west), including its east wall, which is 1.80 m wide [*Fig. 7*]. According to survey measurements, the depth of the vestibule (that is, the space inside the parallel north–south walls) amounts to 4.50 m. The walls of the vestibule are constructed of mixed material: huge blocks of flint conglomerate completed with smaller dressed blocks of limestone. It was never noted before that the vestibule is sunk well below the floor level of the “qasr” [*Fig. 8*] and it is not possible to determine how the latter was accessed.

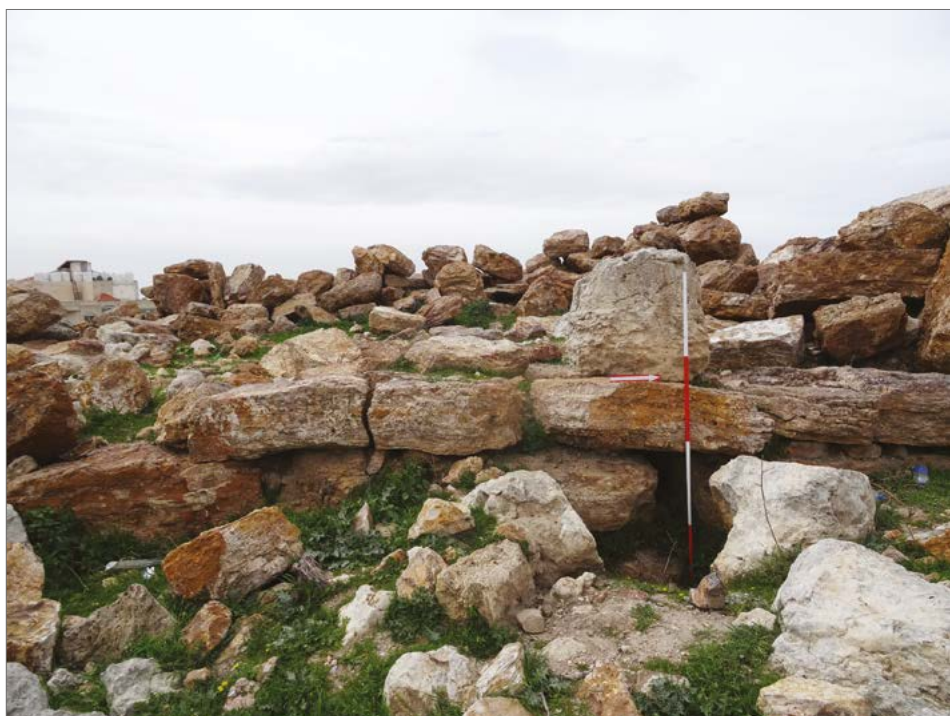
Fig. 8. Sunken area of the vestibule looking west (PCMA UW Khirbat as-Sar Project/photo J. Młynarczyk)

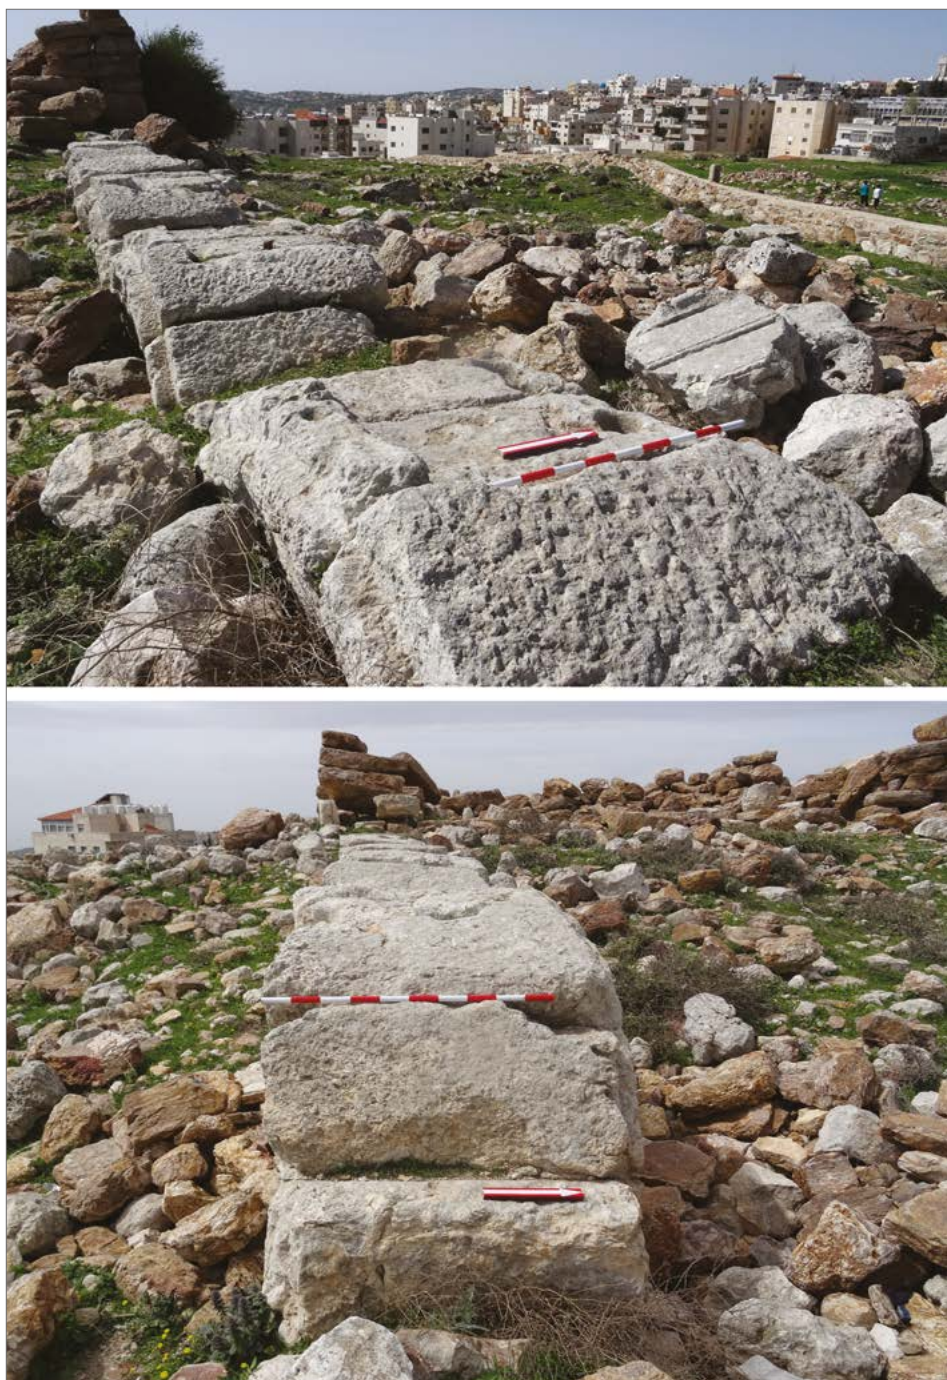
Fig. 9. Arcades: top, northern row looking west; bottom, southern row looking west (PCMA UW Khirbat as-Sar Project/photo J. Młynarczyk)

As for the number of arches, Chang-ho C. Ji (2000) counted six arches on the south and five arches on the north of the courtyard. Our survey ascertained that originally there were seven arches in each row, as first noted by Butler. Today, the westernmost arcade in the northern row is missing, while the easternmost one apparently sank; in the southern row, the second arcade from the east is missing.

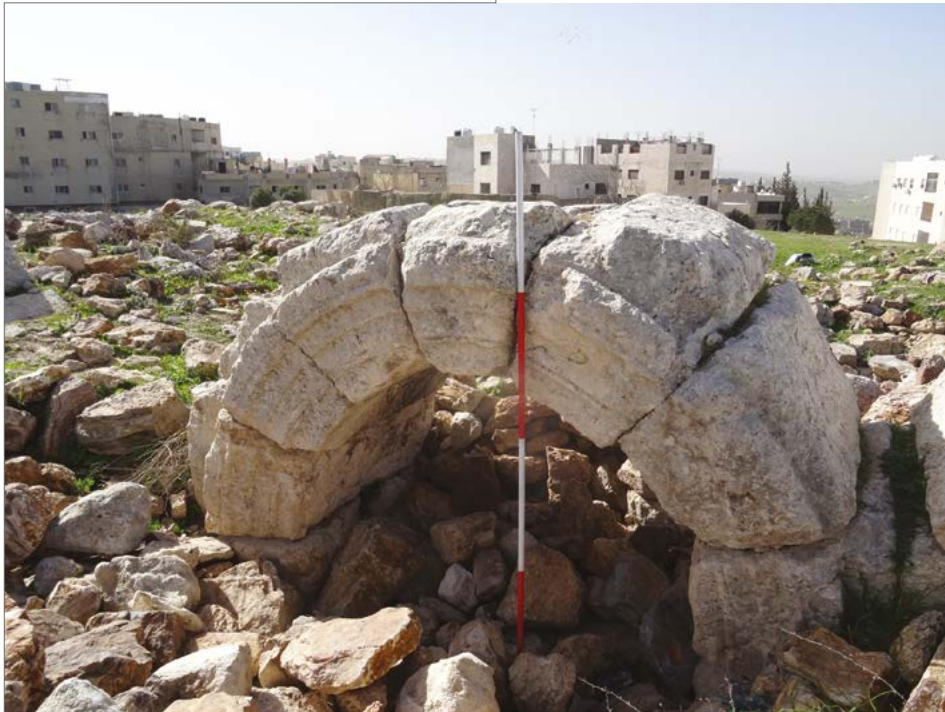
Fig. 10. Third arcade (counting from the east) in the southern row, looking southeast; top, view and section (PCMA UW Khirbat as-Sar Project/photo J. Młynarczyk, drawing and digitizing M. Burdajewicz)

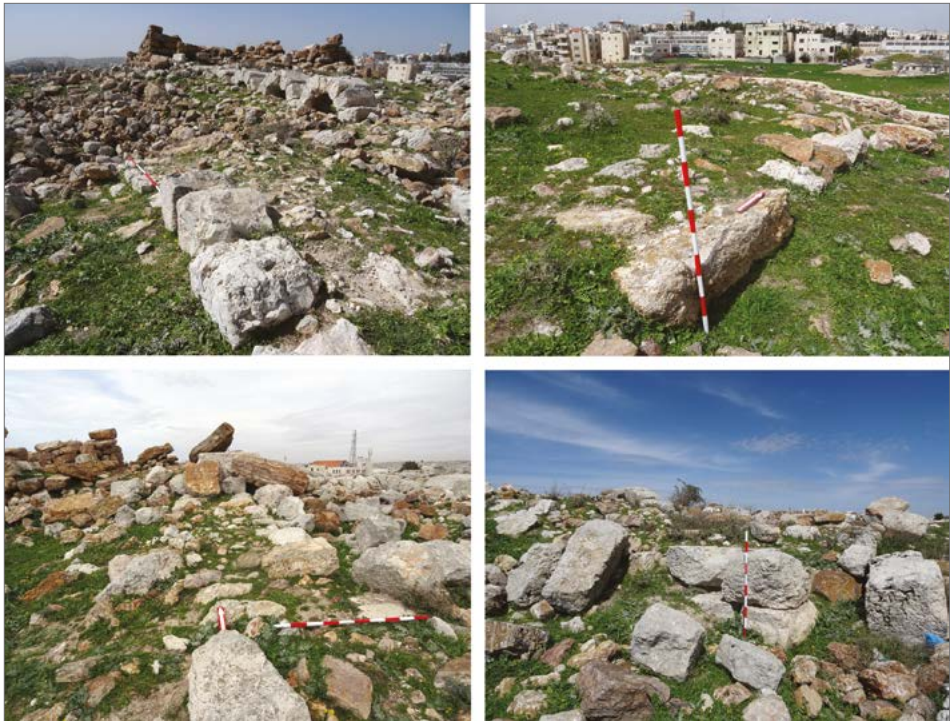
Fig. 11. Temple courtyard: top left, south wall looking northwest; top right, east wall near its northeastern end, looking northwest; bottom left, southwestern corner looking north; bottom right, southeastern corner looking north (PCMA UW Khirbat as-Sar Project/photos J. Młynarczyk)

walls on the outer side of each row of the arcades [Fig. 11 top left, see Fig. 2]. This design formed side aisles, of which the southern one was about 6 m wide,

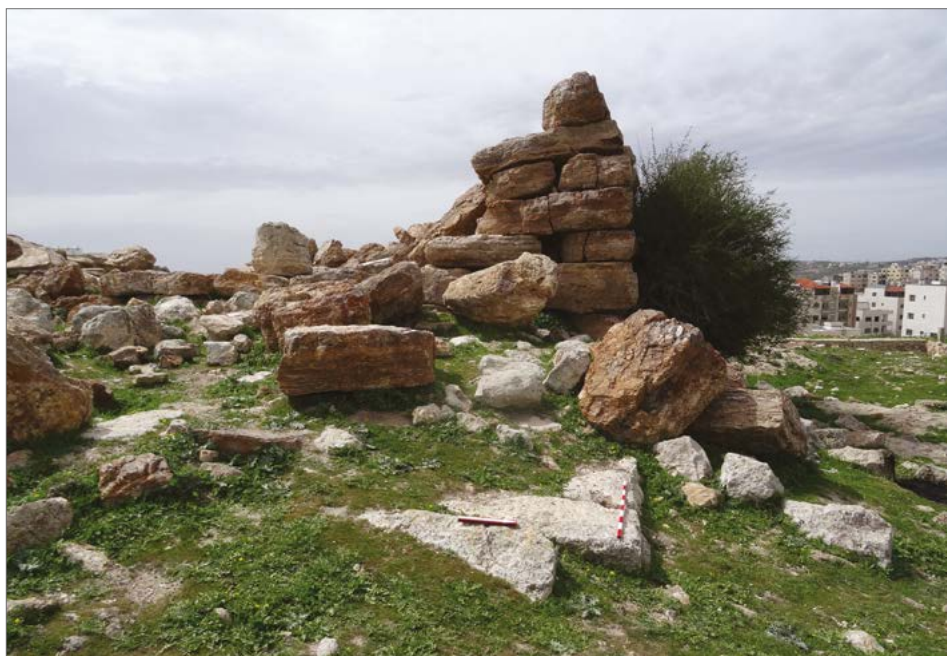
Fig. 12. Temple vestibule: northeastern corner looking west (PCMA UW Khirbat as-Sar Project/  
photo J. Młynarczyk)

[Fig. 12]. Measurements during the survey indicated that the “basilical courtyard” was planned as a perfect square, approximately 31.50 m to the side [see Fig. 2]; it was entered from the east, doubtlessly on the long axis of the compound. To reach the level of the vestibule from that of the courtyard (which in antiquity must have been about 3(?) m below the present-day ground level), there must have existed a stairway, as Glueck pointed out already, its location still visible today [Fig. 13].

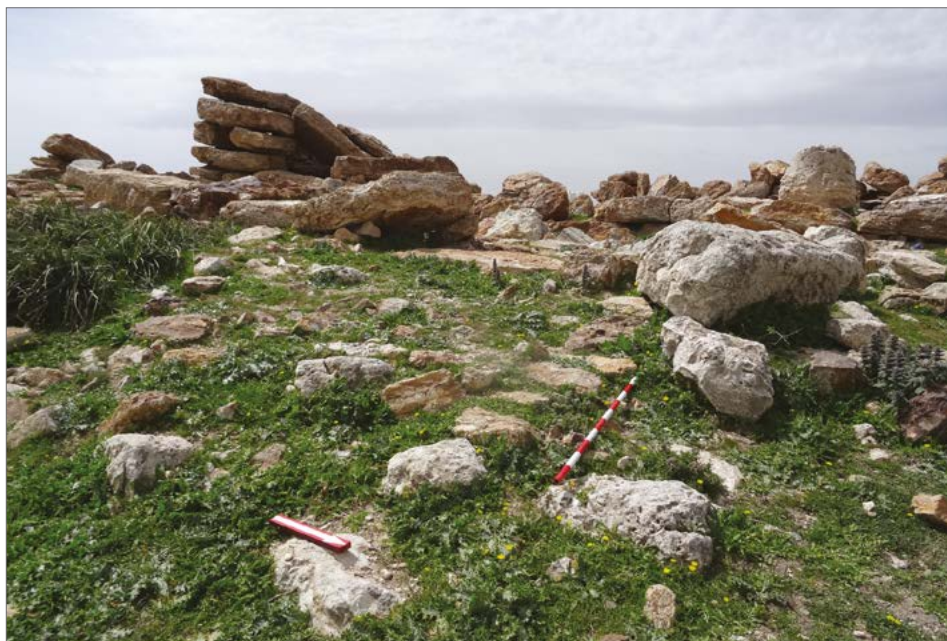
Fig. 13. Remains of a stairway from the level of the courtyard to the vestibule, view looking west  
(PCMA UW Khirbat as-Sar Project/photo J. Młynarczyk)

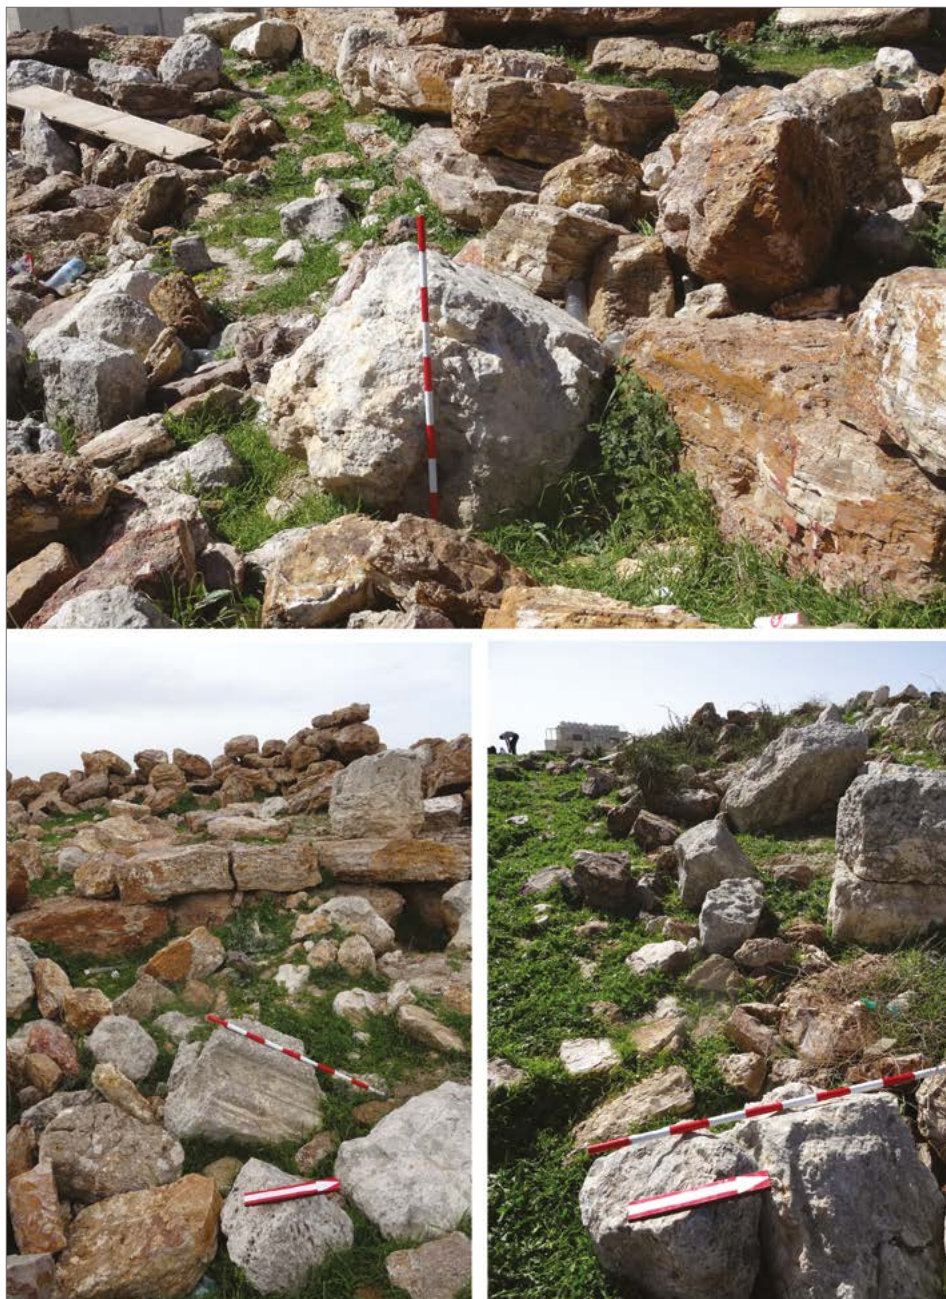
Fig. 15. Architectural elements: top, badly weathered Corinthian capital from a column in the sunken vestibule, view looking south; bottom left, fragment of a cornice (AE 3 in Fig. 4) and column (AE 1 in Fig. 4), view looking west; bottom right, displaced "rusticated" block (probably Hellenistic) found by the southeastern corner of the temple courtyard, view looking west (PCMA UW Khirbat as-Sar Project/photo J. Młynarczyk)

one possible exception: a very weathered Corinthian capital(?) found upside down in the sunken vestibule to the “qasr” [*Fig. 15* top]. In the same spot there is a molded cornice block [*Fig. 15* bottom left, see *Fig. 4:AE 3*], probably coming from the monumental entrance to the “qasr” (either to the vestibule or the temple cella), and in the westernmost part of the courtyard, right in front of the vestibule, a long block which might belong to the framing of the monumental entrance to the vestibule [*Fig. 14*]. A decorated bracket [see *Fig. 4:AE 5*], found on the surface in the eastern part of the courtyard, must have supported a lintel of a very big doorway.

is a feature characteristic of Hellenistic masonry, especially of a defensive nature [Fig. 15 bottom right]. Since only a few examples have been noted, it should be assumed that such blocks come from an earlier (Hellenistic?!) architectural phase and were reused in the walls of the courtyard from the Roman period.

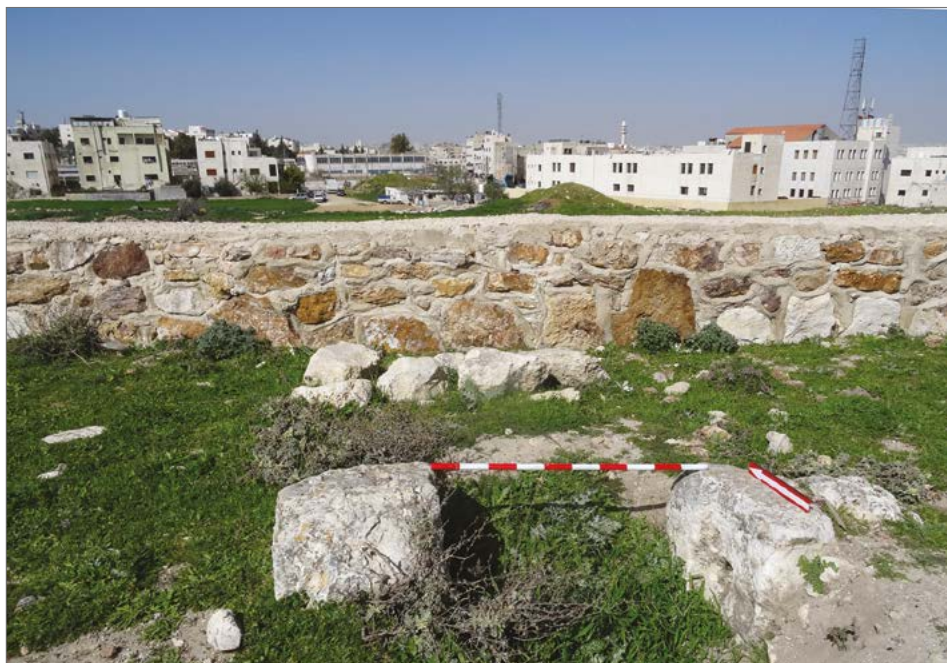
Fig. 16. Remains of a north-south wall(?) added to the northern row of arcades in the courtyard, view looking west (PCMA UW Khirbat as-Sar Project/photo J. Młynarczyk)

Walls mapped outside the “temple compound” cannot be interpreted prior to regular excavation. There is a doorway (1.00 m wide) north of the compound, apparently *in situ* [Fig. 17]; the same can be said of a north–south wall perpendicular to the third arch from the west, undoubtedly added at a later date [Fig. 16]. Of the remains of a “considerable settlement” mentioned by Glueck in 1937 the part southeast of the “qasr” [Fig. 18] was identified and mapped, while the section northeast of the “qasr” is probably already

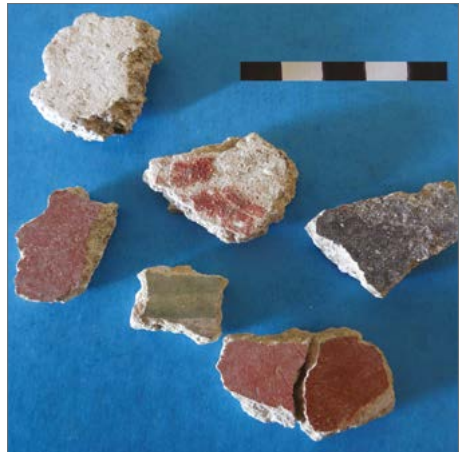
Fig. 19. Pieces of wall plaster apparently of Roman date, found north of the “qasr” (PCMA UW Khirbat as-Sar Project/photo J. Młynarczyk)

of earlier pottery (Roman through Early Islamic). A different picture emerges with regard to the southern, western and northern areas, where Mamluk pottery sherds were definitely fewer, while Roman and Byzantine wares were prevalent. The area to the north of the “temple compound” yielded some small sherds of Hellenistic and early Roman date, as well as a few fragments of high quality wall plaster, both white and painted red, green and black, found outside the northern wall of the “qasr” [Fig. 19].

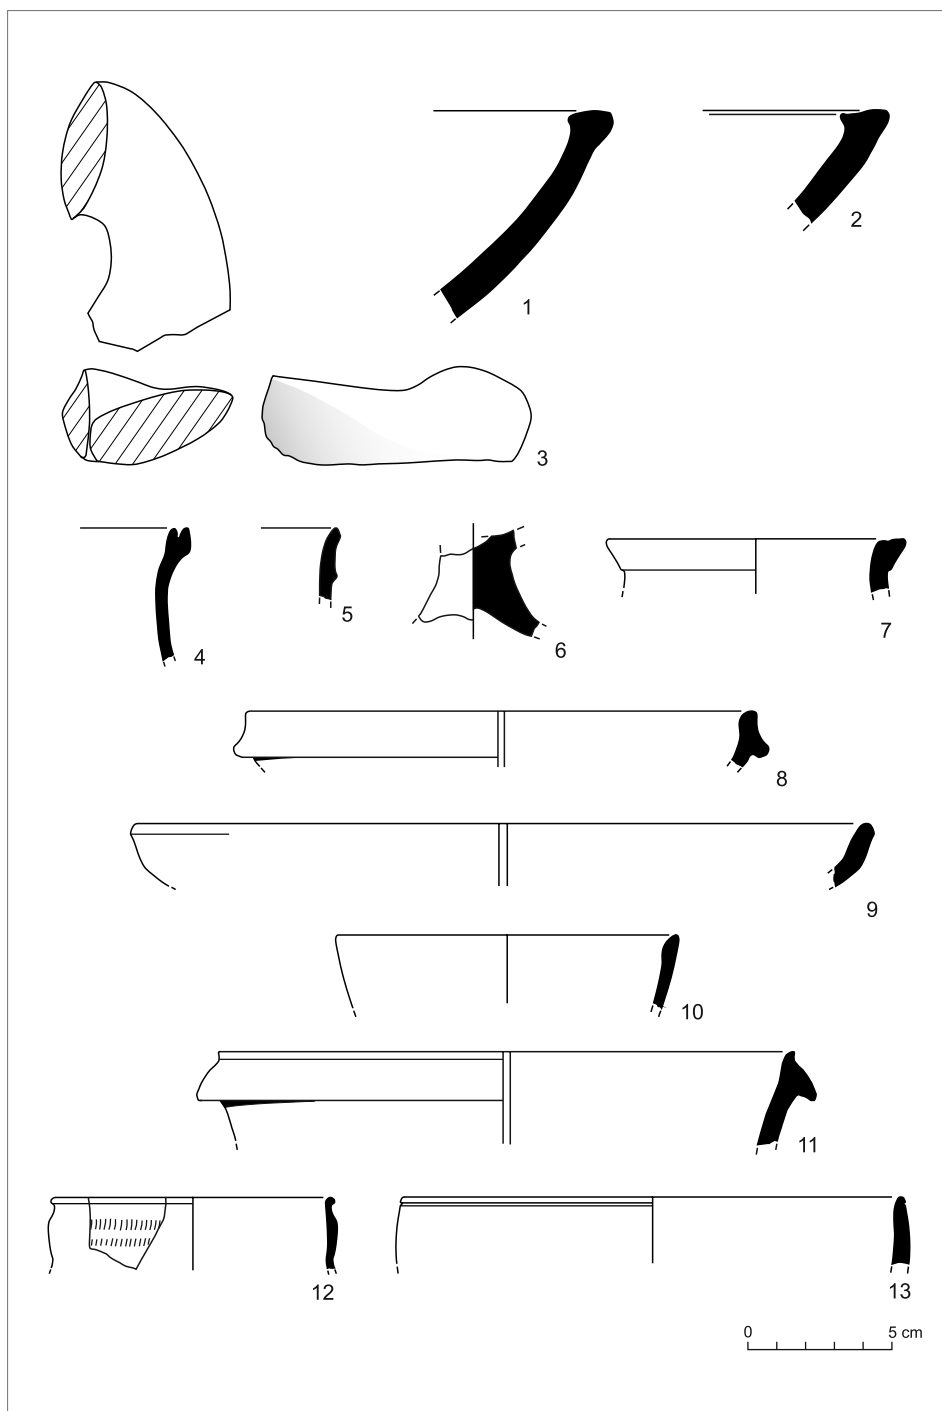
Fig. 20. Iron Age pottery (1–3); plain wares: Roman and Hellenistic (4–7), fine wares: Roman and Byzantine (8–13) (PCMA UW Khirbat as-Sar Project/drawing and digitizing M. Burdajewicz)

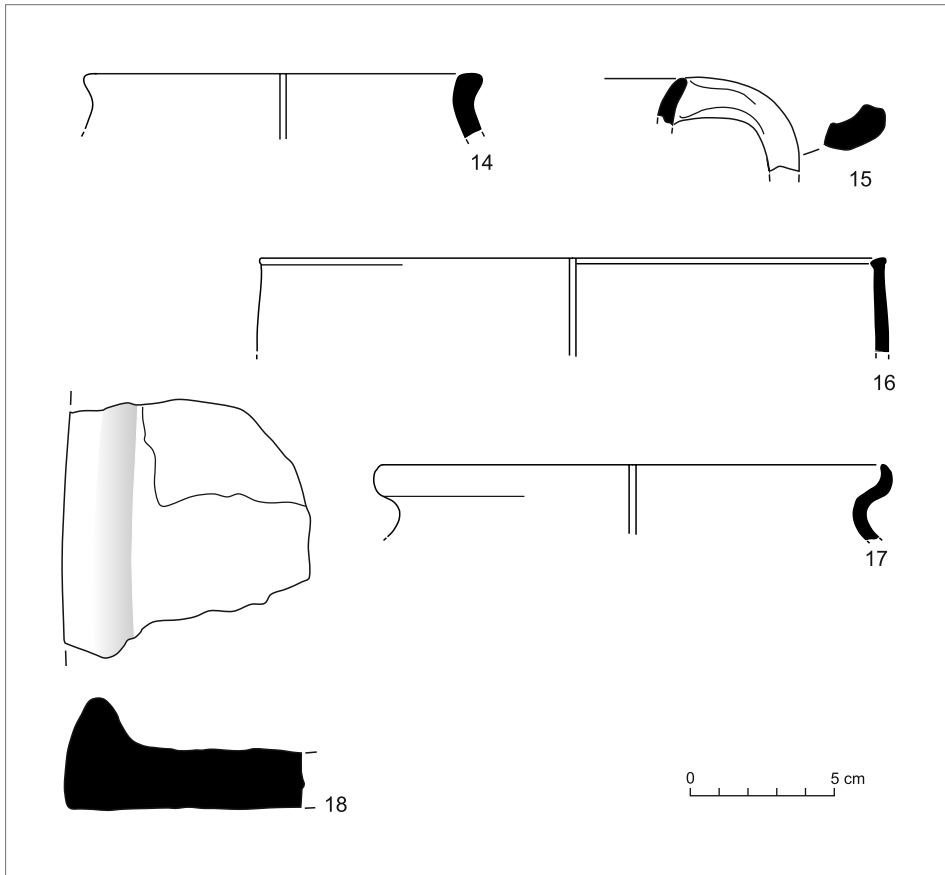
Fig. 21. Cooking vessels of Roman and Byzantine date (14–17); fragment of Roman roof tile (18) (PCMA UW Khirbat as-Sar Project/drawing and digitizing M. Burdajewicz)

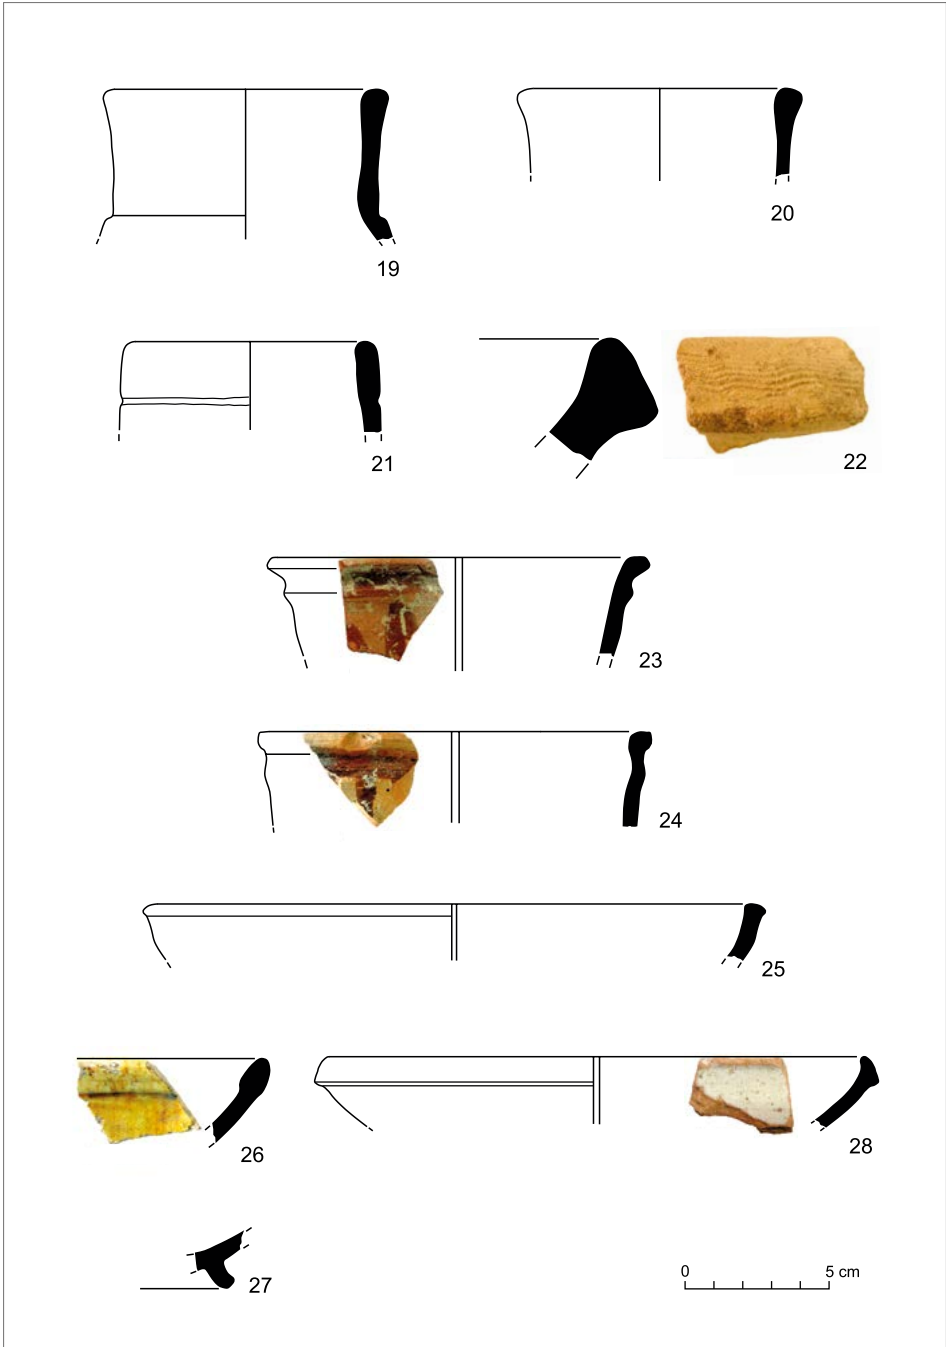
Fig. 22. Late Roman/Byzantine to Umayyad(?) (19–22); Umayyad (into Abbasid?) painted pottery (23–25); medieval glazed pottery (26–28) (PCMA UW Khirbat as-Sar Project/drawing and digitizing M. Burdajewicz)

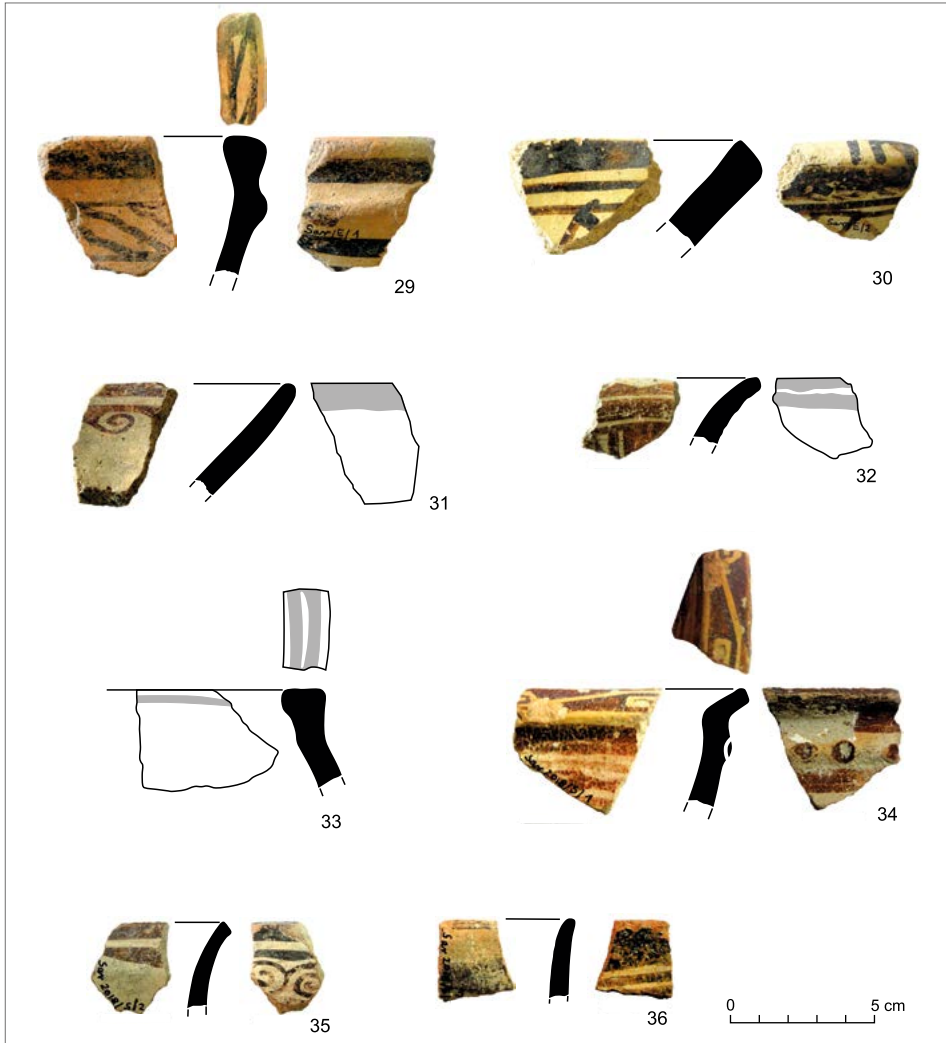
Fig. 23. Painted pottery (Mamluk) (29–36) (PCMA UW Khirbat as-Sar Project/drawing and digitizing M. Burdajewicz)

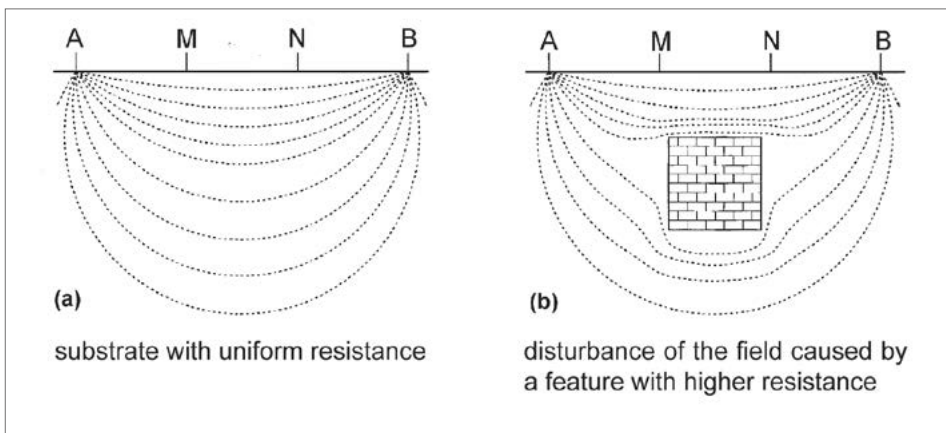
Fig. 24. Model of the distribution of the electric field in the ground (After Herbich 2011: Fig. 1)

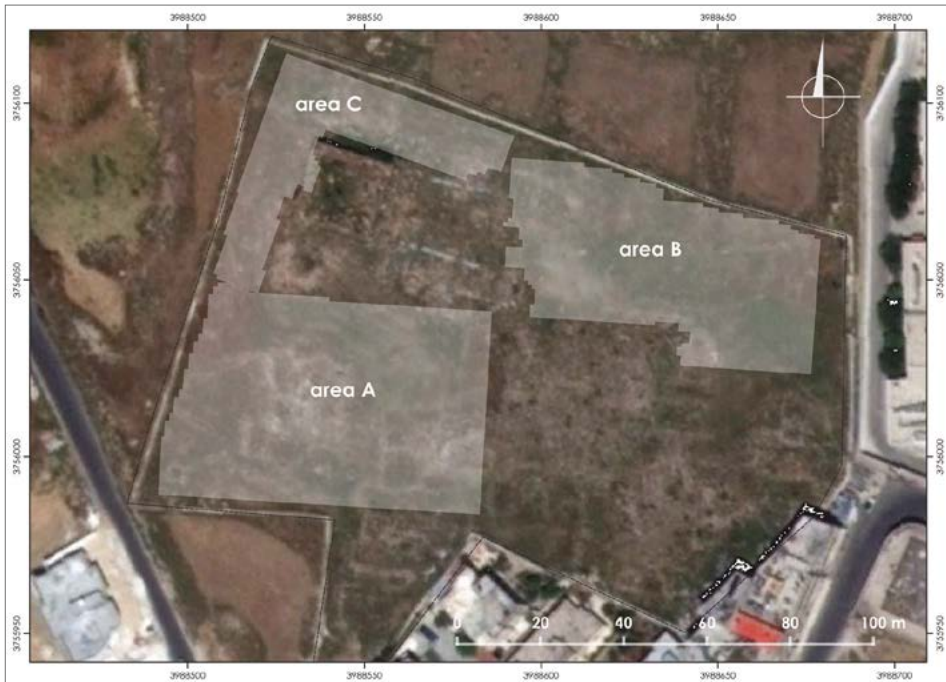
Fig. 25. Location of surveyed areas (PCMA UW Khirbat as-Sar Project/processing R. Ryndziewicz, satellite imaging Google Earth)

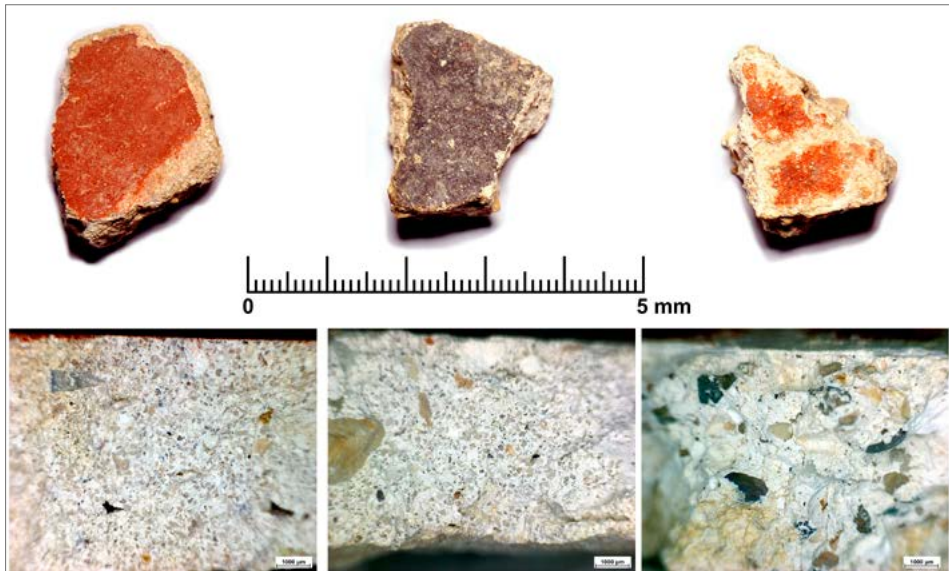
Fig. 28. Three fragments of plaster and corresponding photographs of their sections taken under a portable digital microscope (TPL 1,3MPix 1x-40x/200x) connected to a laptop computer. From left to right: sample KHS 001, KHS 002, KHS 003 (Photos J. Burdajewicz)

Several fragments of painted plaster were found on the surface during a survey conducted at the site of Khirbat as-Sar (Sara). The fragments were scattered over an area of about 4 m<sup>2</sup>. Three samples were collected for preliminary petrographic examination (KHS 001, KHS 002, KHS 003) [Fig. 28].

All samples consist of a single layer of plaster; no remains of preparatory mortar have been noted. The plasters appear to have been spread evenly, as they measure 7–9 mm. The samples are compact and hard. The sections of samples KHS 001 and KHS 002 show very fine, densely packed aggregates which can hardly be discerned with the naked eye [see Fig. 28]. Sporadic larger mineral inclusions and

Sample KHS 003 is slightly different. Its section contains gray, beige, and dark brown stone-like grains the size of which ranges from a fraction of a millimeter to 3 mm [see Fig. 28]. The plaster surface is not as smooth as in the two former cases. The fragment of a red design painted against white background seems abraded, although the remains of the paint suggest that it was once thickly applied.

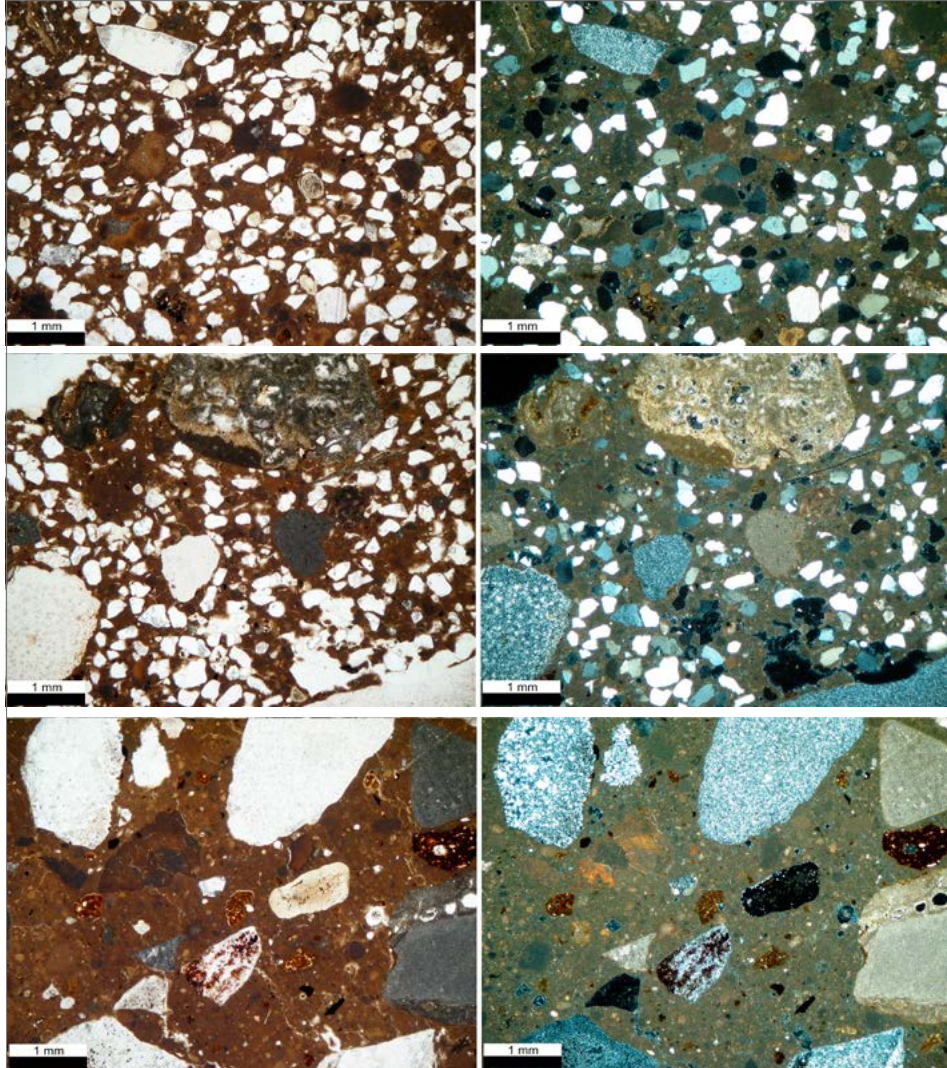
Fig. 29. Microphotographs of samples, from top, KHS 001, KHS 002 and KHS 003, viewed under one polarizer (left) and two crossed polarizes (right) (Photos W. Bartz)

Examination of petrographic thin sections revealed that calcium carbonate acts as a binder of all three samples (61.5% by volume in sample KHS 001, 58% in sample KHS 002, and 63% in sample KHS 003)

[Fig. 29].<sup>2</sup> The micrite matrix is heterogeneous, showing distinctive clusters of micrite and aggregates of sparite, possibly from incomplete calcination of the limestone rock in lime kiln. The matrix

Sample KHS 003 differs from the first two samples described primarily because it lacks quartz [see *Fig. 29* bottom]. The only type of filler used in this render are rock fragments (36%). They comprise the same types of rocks as in the case of the two former samples: there are fragments of silica rocks (chalcedony) or gypsum rock, micro-sparite limestone with ooids, as well as numerous orange-brown particles of what appears to be claystone. As already noted during the macroscopic examination, the sizes of these aggregates vary. The largest are the fragments of silica or gypsum rock (1–2 mm), followed by limestone fragments (approx. 1 mm), and claystone particles (approx. 0.5 mm). The latter aggregate has rounded grains, whereas the former two tend to be angular.
