CHRISTIAN SETTLEMENT AT FAILAKA, QUSUR SITE (KUWAIT): EXCAVATIONS IN 2011 AND 2013

Magdalena Żurek

Abstract: Excavations of the Qusur complex in the center of Failaka Island in Kuwait commenced in 2011 and were continued in 2013, carried out by a team from the University of Warsaw. A magnetic prospection preceded the fieldwork. In the course of two seasons three of nine units in the northernmost part of the site were investigated. Stone enclosures and small houses with white mortar floors were discovered and dated provisionally to the late pre-Islamic and early Islamic period. The settlement was cleared of practically all finds save for some refuse pottery in the courtyards.

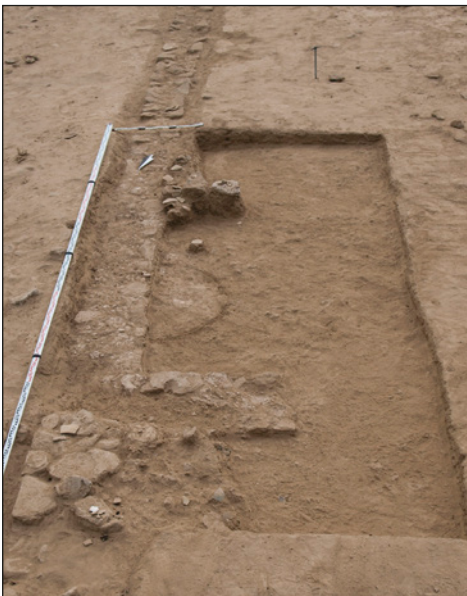
Fig. 5. Potsherds by the west wall of the enclosure, view from the north
(Photo Ł. Miechowicz)

A collection of potsherds was found dumped against the west wall [Fig. 5] and by the south wall, as well as scattered throughout the courtyard area, similarly as the pottery by the east enclosure wall. The pottery had evidently been discarded there after use.

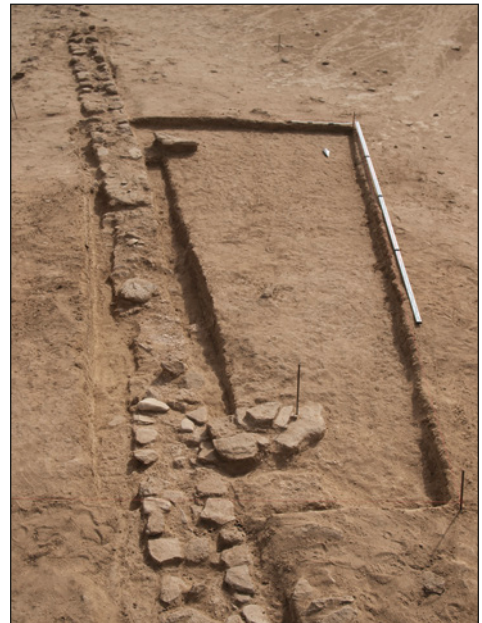
Fig. 6. East enclosure wall, view from the north
(Photo Ł. Miechowicz)

Further to the north the enclosure wall was 0.45–0.47 m wide [Fig. 6]. It was built of fairly regular pieces of beachrock with a core of smaller and rougher flat stones or crushed beachrock. Some potsherds were found collected against the wall. A narrow (W. 0.62 m) gap appeared in the wall, finished on the northern side with a rather big and well-dressed block of beachrock. A layer of mud with limestone inclusions, evidence of standing water, could suggest a drain. This feature needs to be explored further.

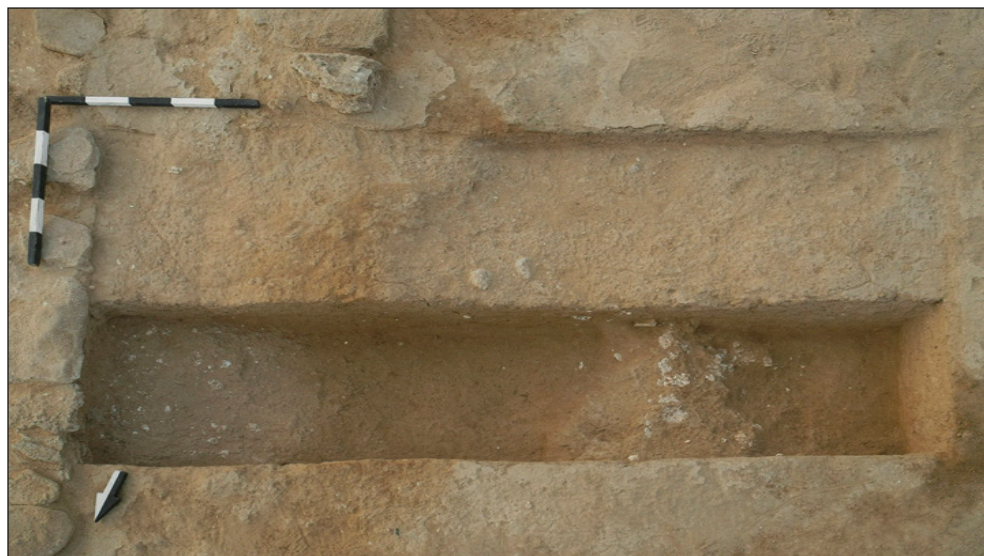
Fig. 7. Earlier phase of the Unit III enclosure
(Photo Ł. Miechowicz)

Two layers, presumably from a destroyed stone structure, were found below it. The mud-brick wall was built on top of a low and narrow embankment [Fig. 7], which could represent an earlier phase of construction.

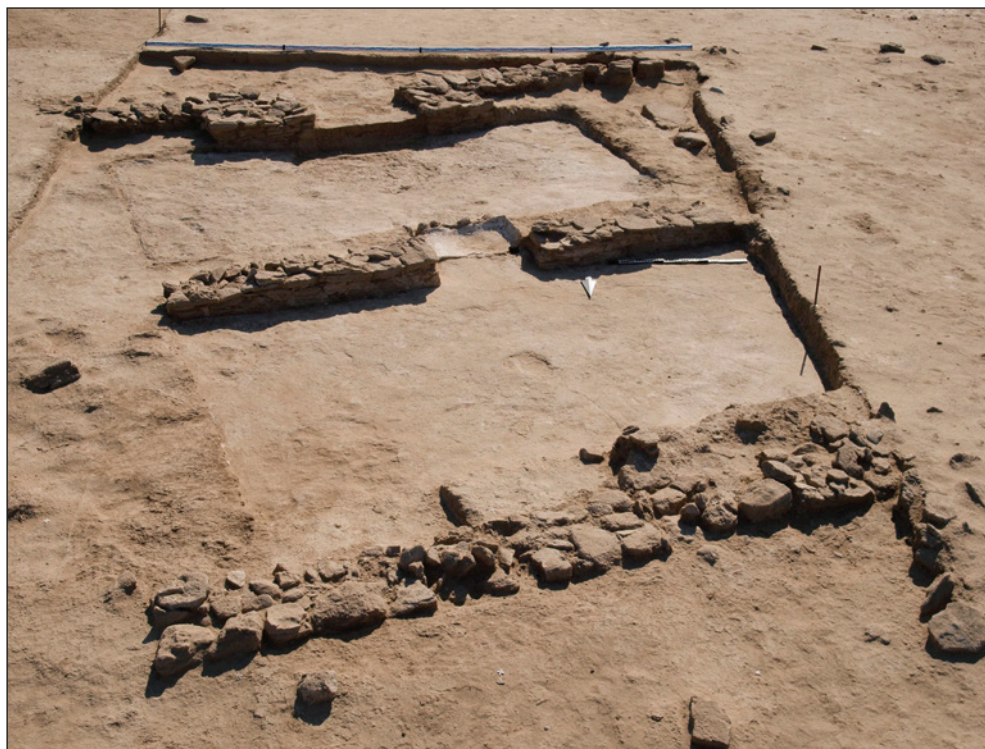
Fig. 8. Units III.A.1 (in the background) and III.A.2, early stages of exploration; view from the north (Photo E. Miechowicz)

Room III.A.1 measured 3.74 m E–W by 1.91 m N–S [*Figs 8, 9*]. The walls were

of big mud bricks, nearly square in shape (0.43–0.46 m to the side). Traces of white plaster were observed. A beachrock wall was added to the mud-brick wall on the northern side of the north wall and the partition wall, as well as on the southern side of the south wall. The entrance, 0.89 m wide, was in the south wall. The floor was made of white mortar and the walls were built on top of this base. Rainwater damage was noted in the central part of the room, close to the entrance. Another white mortar floor was observed underneath.

0.70 m wide, in the middle of the south wall [Figs 8, 9]. The dimensions of this room were 3.79 m E–W by 2.05 m N–S. The walls were of mud brick and covered with fine white plaster. They were 0.46–0.47 m thick. The floor was made of white mortar. The only installation associated with this first phase was a threshold between the rooms, made of plastered beachrock and mud brick.

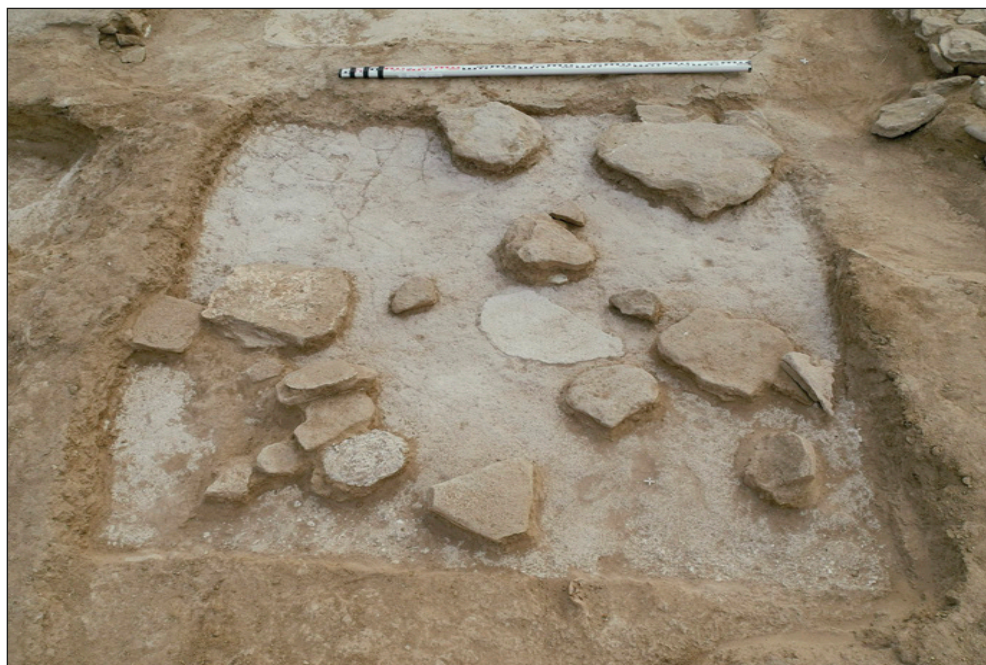
Fig. 12. Room III.A.8, later phase, view from the west
(Photo Ł. Miechowicz)

In the area west of House A (rooms III.A.1 and III.A.2) two long dark traces observed on the surface were deemed to be the vestiges of mud-brick walls enclosing two more rooms of the house. **Room III.A.8**, to the south, was a small, rectangular room with a white mortar floor [Fig. 11]. The east and west walls were nearly completely destroyed. None of the walls bore traces of plaster. A thick layer of silt in the eastern and central

part of the room attested to standing water; embedded in this layer were some beachrock slabs and animal bones in the northeastern corner, mixed with the rubble of the destroyed east wall. The slabs formed two semicircular structures, poorly constructed, in the western part of the room. There was evidence of ashes inside them, suggesting their function as fireplaces or ovens. The fill over them was burnt. The structures were in use after the west wall of the room had collapsed. The assemblage collected from the layer on the mortar floor, around and under the

slabs included shells, fragments of two corroded iron nails, some potsherds and many fragments of a glass flask, completely crushed under one of the slabs.

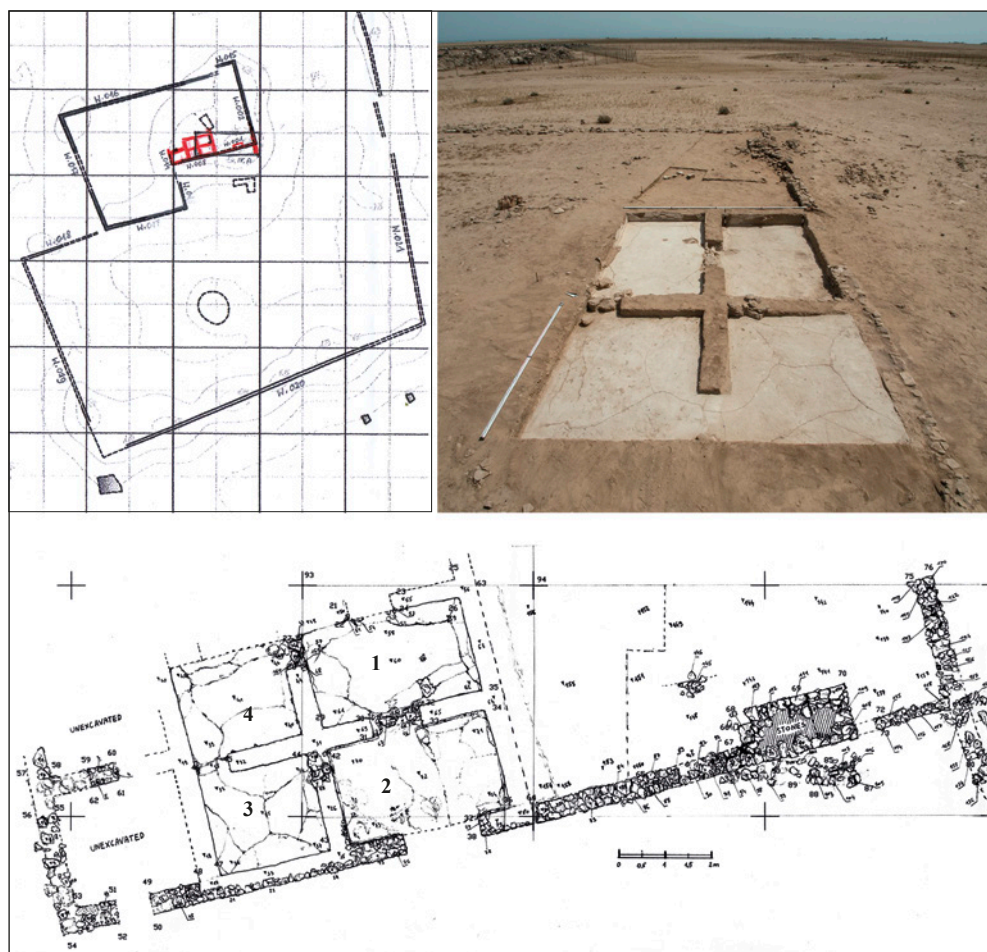
Fig. 13. Unit IV: top left, plan of the unit; top right, general view of the house from the west; bottom, plan of House A (Drawing M. Woźniak; plan R. Łopaciuk; photo Ł. Miechowicz)

Unit IV is a big complex of courtyards and a house [*Fig. 13*; see *Fig. 3*]. The courtyards were rectangular in shape and their function is still unclear. The enclosure walls were of different width and were constructed in different ways. The course of the walls was not traced in full.

Four chambers of the house in the central part of Unit IV were cleared. Other rooms probably extended to the north and west [Fig. 13]. The inner walls, and the west and east walls were approximately 0.50 m wide, built chiefly of mud brick and thickly plastered. The west wall was reinforced with a line of stones. The floors were of white mortar of good quality.

Room IV.A.1 in the northeastern corner [Figs 13, 14] measured 3.50 m E–W by 2.00 m N–S. Doorways in the north, south and west walls led to other rooms or outdoors (north of this room the area still remains unexcavated). Doorways were well-done, with plastered thresholds of stone. The floor was smoothly plastered and white in color. To the south was **Room IV.A.2**, also rectangular in shape,

West of IV.A.2 was **Room IV.A.3** [Fig. 13]. It was a small, rectangular room, 2.15 m N–S by 2.40 m E–W, with a white mortar floor, relatively smooth with only some cracking. The walls were of mud brick, the south outer wall being reinforced externally with beachrock. There

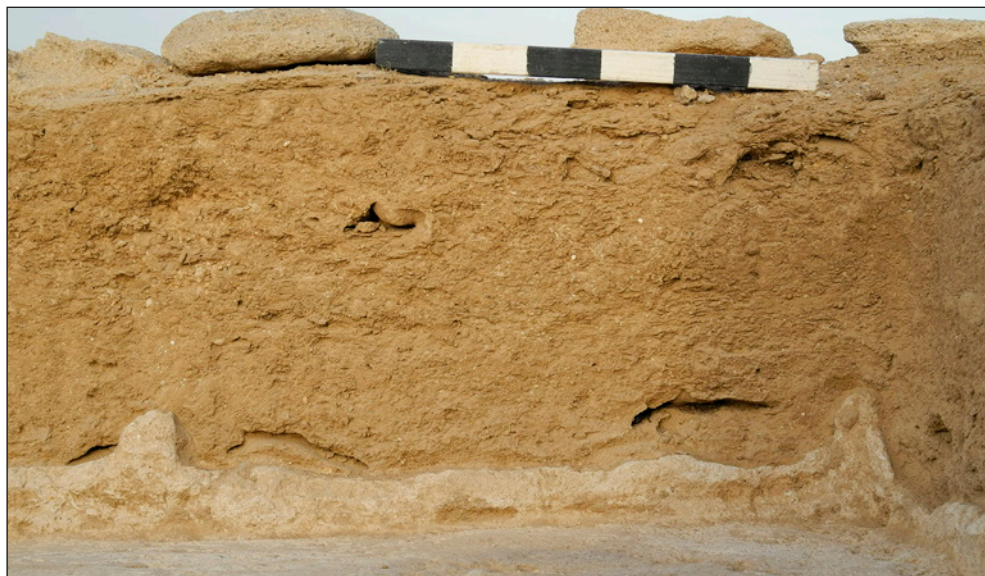
*Fig. 15. Room IV.A.2, traces of earthbrick on walls
(Photo Ł. Miechowicz)*

3.50 m E–W by 2.50 m N–S. The east wall was thickly coated with white plaster in places. The floor was of white mortar as well. A large doorway (1.66 m wide) in the south wall led directly into courtyard γ . A thicker layer of mortar was observed on the walls, about 0.46 m long with nearly perpendicular ends; this recalled mud bricks of this length [Fig. 15], corresponding with similar traces observed on a wall in House A of Unit III.

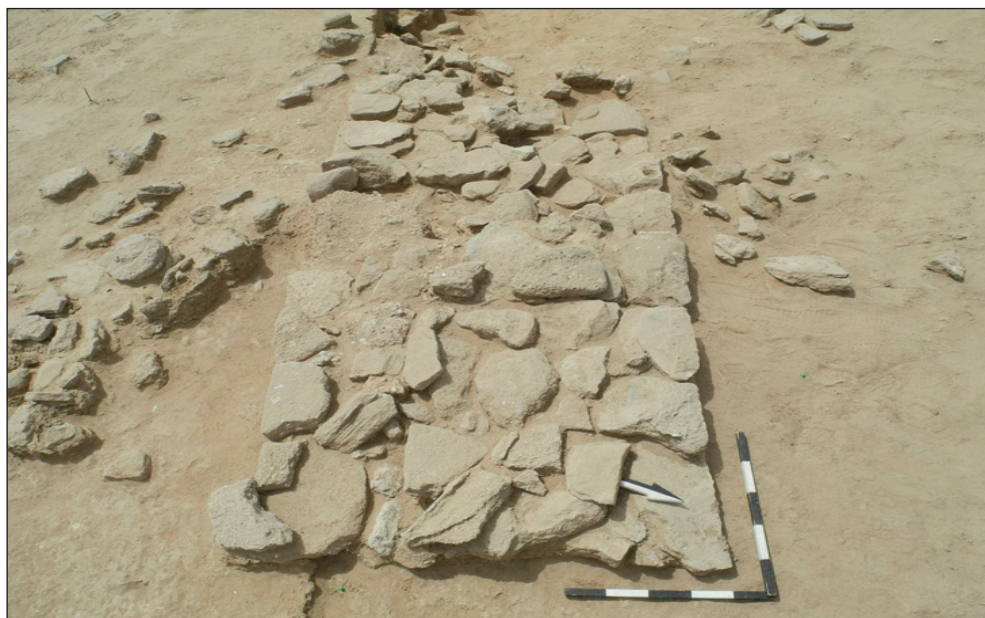
*Fig. 16. Beachrock structure ("mastaba")
(Photo Ł. Miechowicz)*

engaged pillar against the enclosure wall, between courtyards α and γ , situated close to the corner [Fig. 16]. It may have been

a kind of mastaba; more can be said about it when excavations of this feature are completed.
