# BANGANARTI AND SELIB IN 2011/2012 AND 2013

Bogdan Żurawski

**Abstract:** In the course of two seasons in 2012 and 2013 the team carried out excavations and research on the living quarters alongside the fortifications of Banganarti, including a large building (E.1) and eastern tower. Work on the restoration/conservation of the Upper Church progressed according to plan, combined with limited iconographic studies. The team also worked at the sites of Selib and Soniyat. At Selib explorations continued at three locations. The phasing of the church at Selib 1 was established (separate report by A. Cedro), leading to a reconstruction of the plan of the earliest two buildings. A Meroitic(?) structure was investigated at Selib 3 and the Meroitic settlement at Selib 2 continued to be investigated (separate report by R. Hajduga and K. Solarska). A tachymetric plan and magnetic map of the environs of the Kushite temple at Soniyat was accomplished, recording a huge building (palace?) of apparently Kushite date (Napatan ceramic forms and Egyptian imports dating from the Third Intermediate Period) to the north of the temple. A separate team undertook a reconnaissance in regions scheduled to b

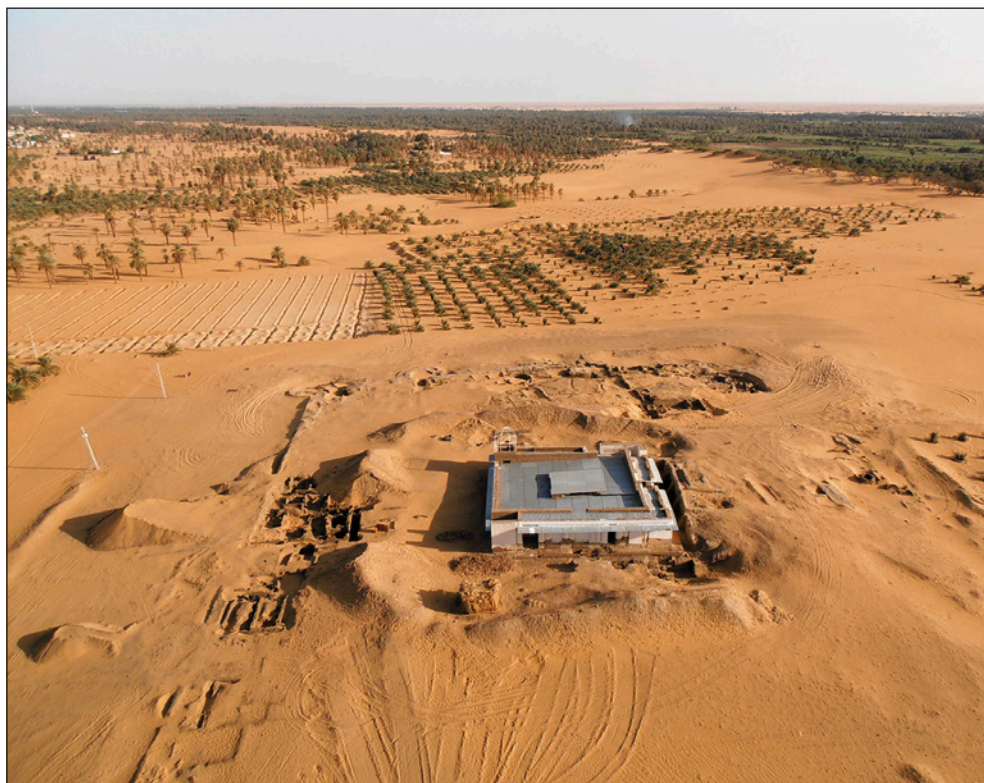
Fig. 1. Enclosure at Banganarti as seen on an oblique kite photograph taken in March 2013  
(Photo B. Żurawski)

(especially where the horizon line was important). The aerial (kite) photographs showed the excavated structures in their natural context, revealing many features that otherwise go unrecorded [Fig. 1].

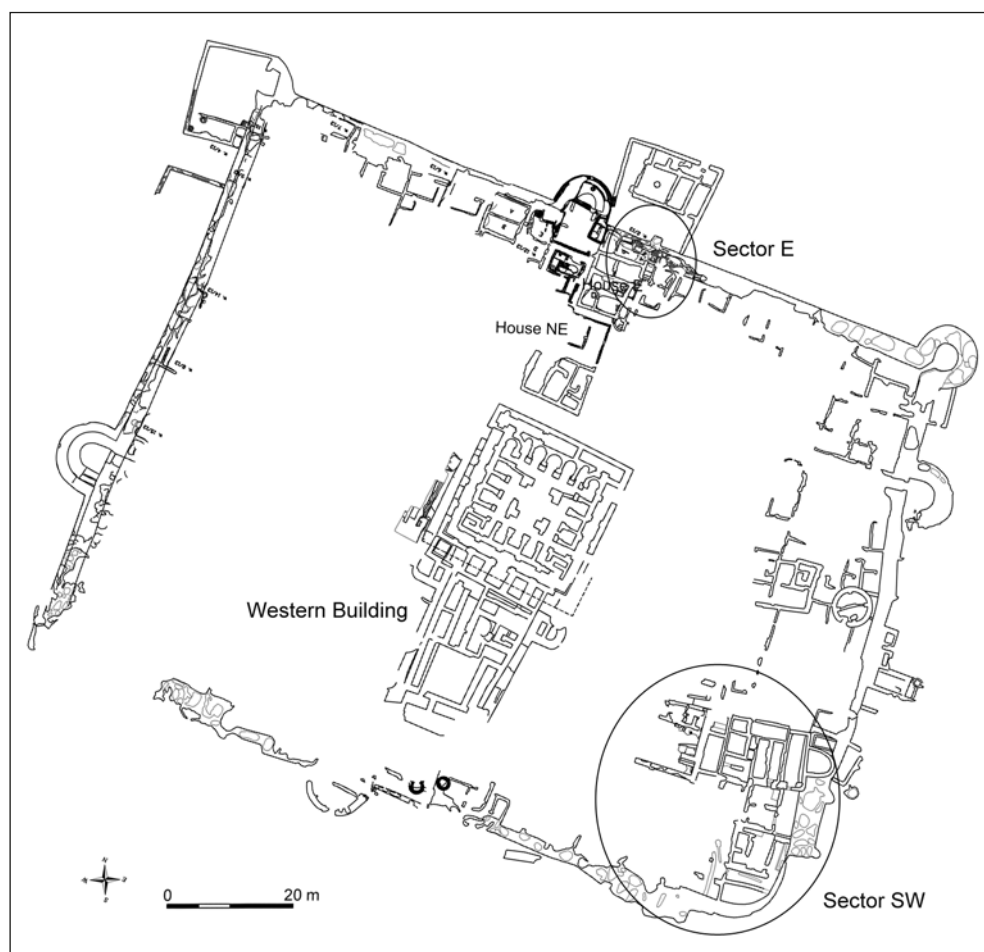
Fig. 2. Baganarti enclosure after the 2013 season  
(Drawing R. Łopaciuk et al.)

A tachymetric survey of brushed and trowel-enhanced wall tops was juxtaposed with aerial kite photographs to produce an improved site plan [Fig. 2]. This procedure was limited in 2011/2012 to the southern and southwestern section of the enclosure and applicable only to the parts of walls where the overlay was thin (less than 0.50 m). By the end of the season, part of the living quarter extending from the

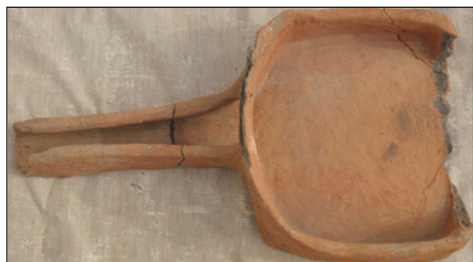
Fig.3. Ceramic urinal (BNG 57/11-12)  
(Photo A. Deptula)

as well as a communal latrine by the south wall of the earliest fortifications and in it, a ceramic urinal set partly in the enclosure wall that was reduced in thickness in that section [Fig. 3].

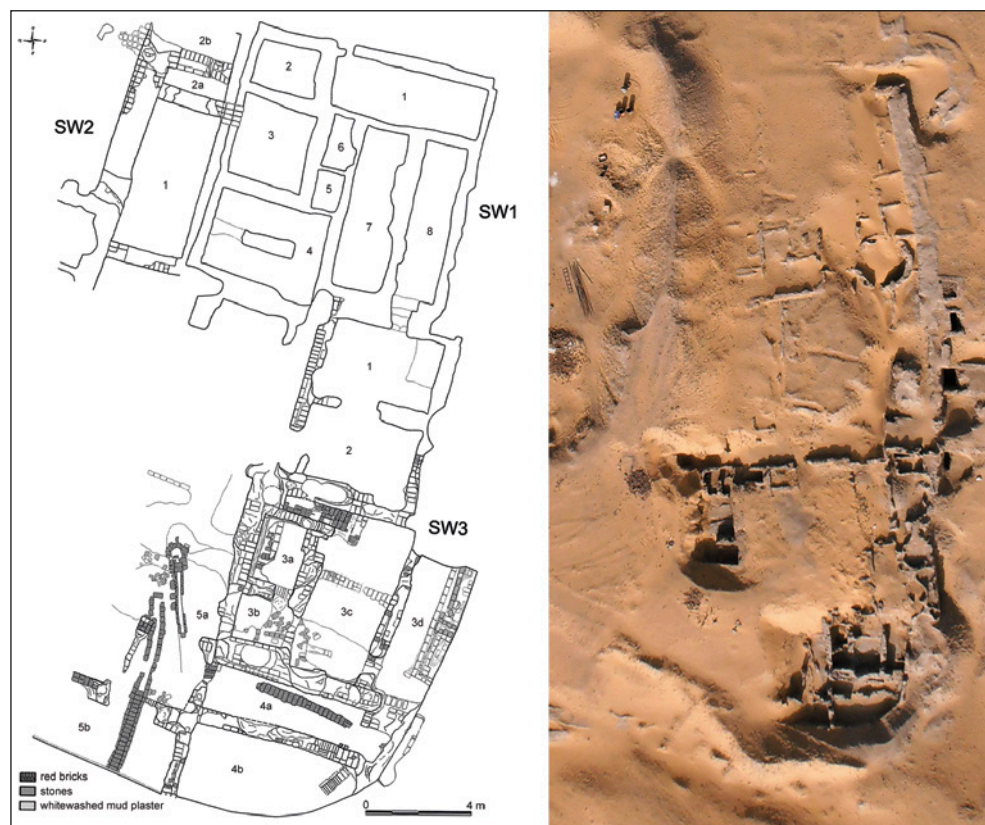
Fig. 4. Southwestern living quarter after the 2011/2012 season; right, vertical aerophotograph of the southwestern sector in February 2012 (Drawing B. Wojciechowski; photo B. Żurawski)

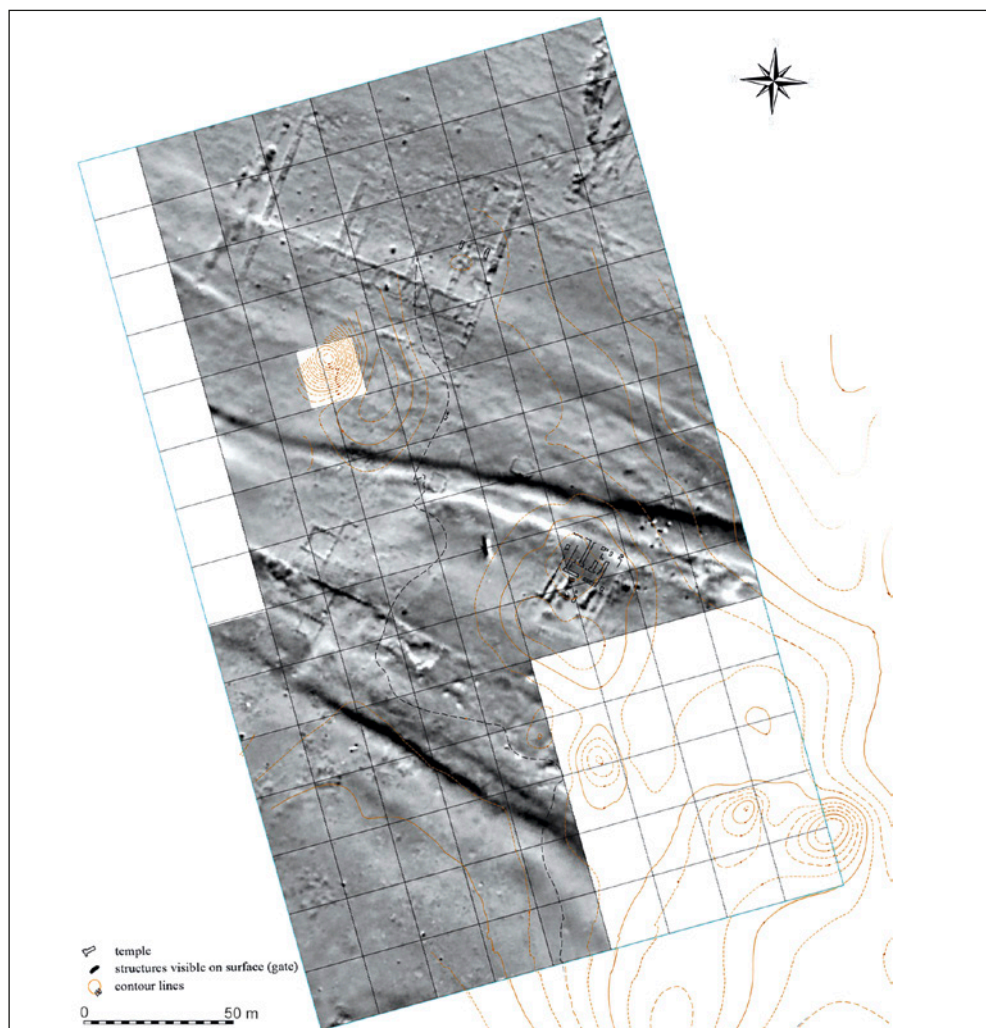
Fig. 6. Magnetic map combined with contour plan of the Soniyat temple and its surroundings (Processing T. Herbich, R. Łopaciuk)

The environs of the Kushite temple at Soniyat, discovered during the Dongola Reach Survey in 1998 (Żurawski 2003: 89, 243–250), were mapped and a magnetic survey was implemented. The prospection revealed the outlines of a large building

(at least 82 m east–west) located north of the temple. The internal arrangement is suggestive of a Kushite palace(?). Two huge sandstone blocks found within the walls shared the orientation, but belonged probably to a different phase than the

suggest a royal residence, assuming it is indeed a Kushite structure. Perhaps Soniyat should be identified with one of the Kushite administrative centers mentioned in reports of Psamtik II's expedition to Nubia (Żurawski 1998: 80) [Fig. 6].

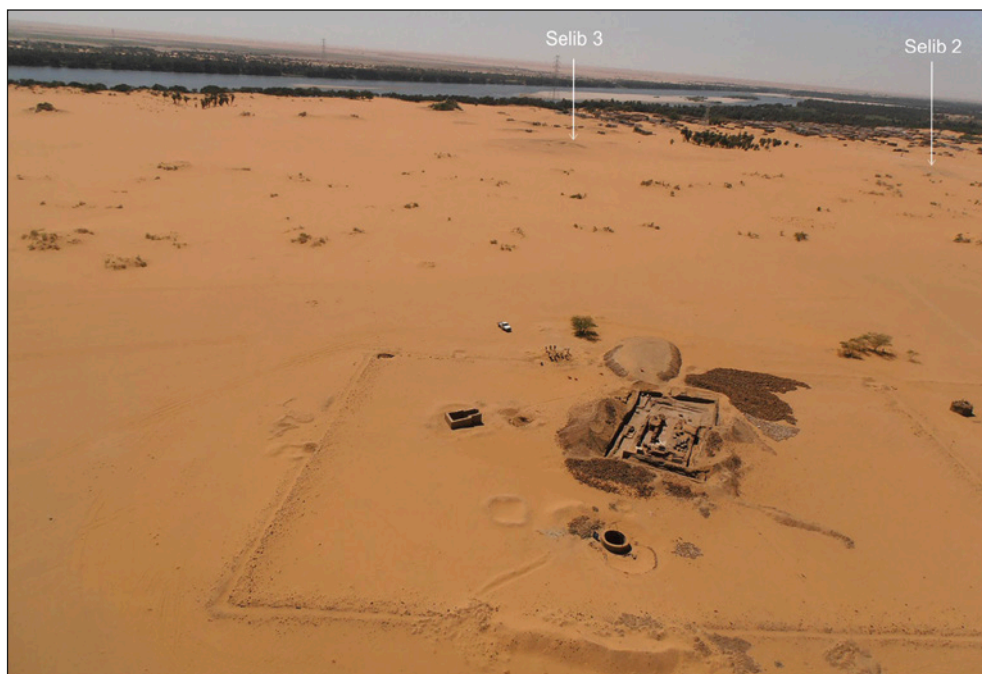
Fig. 7. Selib sites 1, 2 and 3 seen in 2011/2012 on oblique kite photographs; the church at Selib 1 in the foreground (Photo B. Żurawski)

The progress of work on the five superimposed churches at the site was regularly documented with kite photography [Fig. 7]. Investigations in the 2011/2012 season led to the reconstruction of the plans of the two earliest, superimposed churches at the site (for an extensive report on this work, see Cedro 2015, in this volume).

The key to Selib as a settlement may lie buried under a huge kom located half a kilometer from the peribolos of Selib 1 toward the river, on the other side of a palaeochannel of the Nile [see *Fig. 7*]. The mound is referred to locally as *gubbab nasrani* (although no graves have been found there) and worked stone blocks are reported to have come from the kom (Grzymski 1987: 9). The shape of the mound, scatters of potsherds and also some relics of mud-brick walls seen on the surface suggested a squarish enclosure

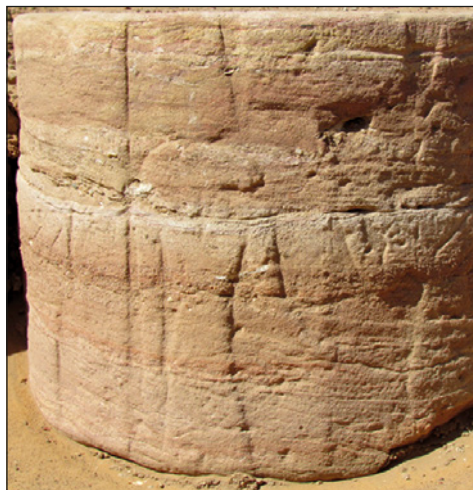
Fig. 9. Meroitic column drum probably dragged in from a temple dismantled somewhere nearby(?) (Photo A. Cedro)

probably was provided with a gallery. It was necessary to accommodate the rapidly growing number of Christians in the region. Arguing for a higher western part of the church is a broad mud-brick mastaba abutment that was added to strengthen and protect its foundation. The south wall of this mastaba was lined with a row of eleven Meroitic column drums and a broken granite column shaft. Some of these drums are still covered with lime render; on two (without plaster) relief decoration represented scenes of royals offering to the gods [Fig. 9].

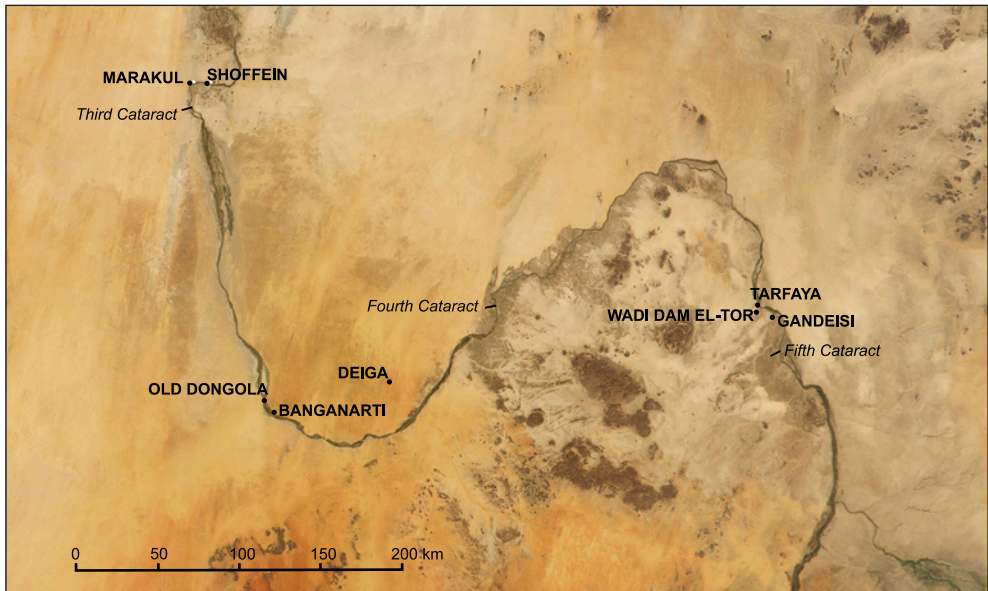
*Fig. 10. Map of the reconnaissance marking locations discussed in the text (Processing B. Żurawski)*

Bayuda to the Fifth cataract (fortresses of Tarfaya and Wadi Dam el-Tor) [Figs 10, 11]. Aerial photographs were taken of the above fortresses, either in the early morning

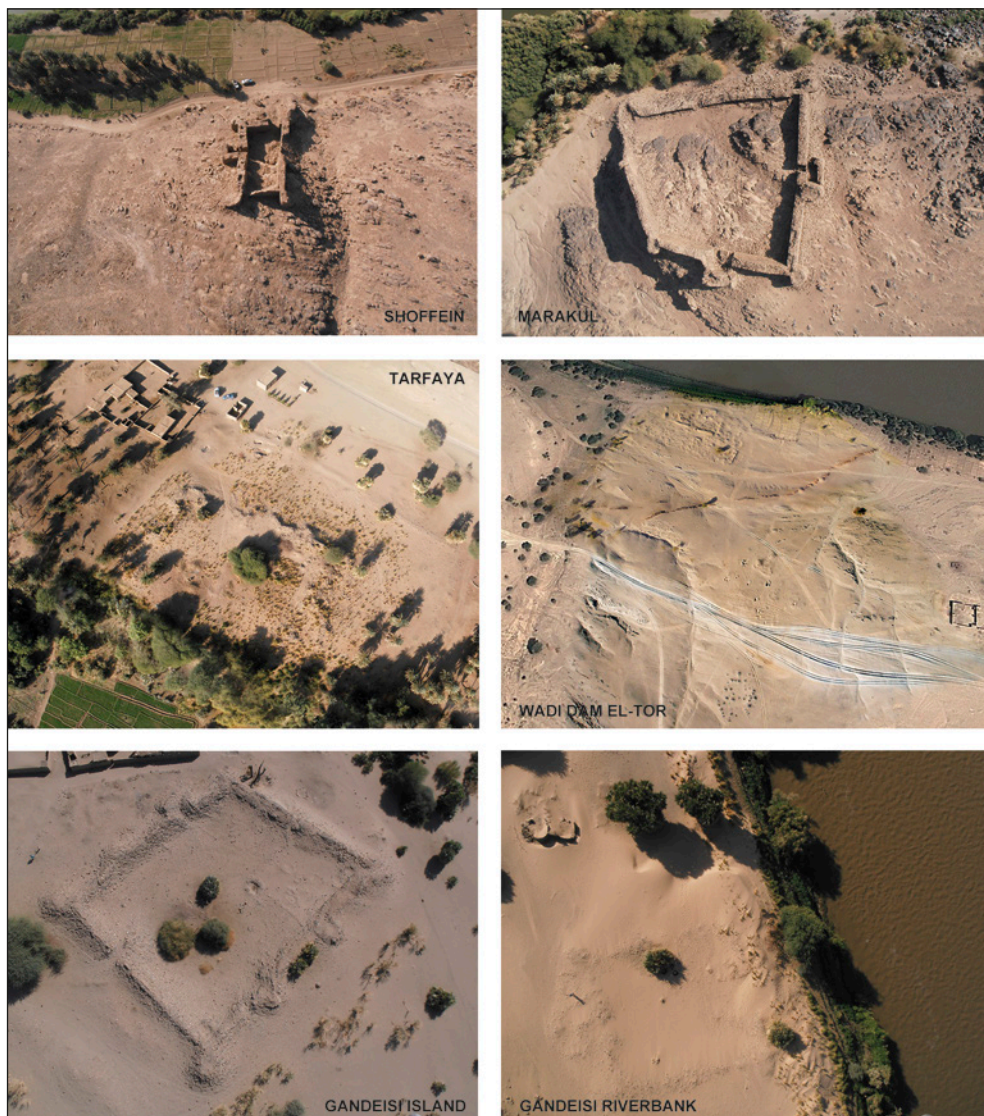
Fig. 11. Aerial views of fortresses in the area of the 2013 reconnaissance, January 2013: Shoffein, Marakul, Tarfaya, Wadi Dam el-Tor, Gandeisi Island and riverbank near ferryboat station to Gandeisi (Kite photographs B. Zurawski)

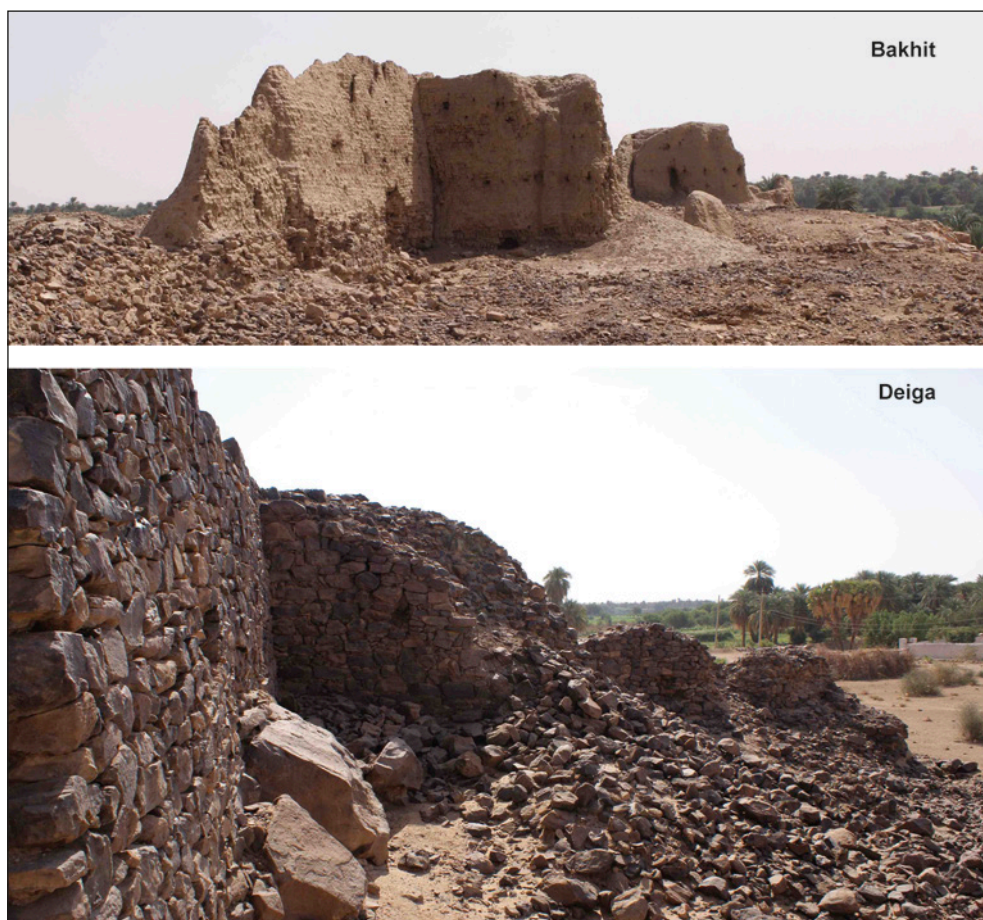
Fig. 14. *Views of strongholds in the Fourth cataract area: top, Bakhit, south curtain wall with bastions and gates; bottom, Deiga, north curtain wall with bastions* (Photos B. Wasik, M. Wiewióra)

cataract region (fortresses of Shofein and Marakul), moved by the Maheila desert shortcut to the region of Karima (Bakhit and Deiga [*Fig. 14*]) and then across the
