# RESEARCH AND CONSERVATION IN MARINA EL-ALAMEIN IN 2014 AND 2015 (POLISH–EGYPTIAN CONSERVATION MISSION)

## *Part one: The Southern Bath and central town square*

**Abstract:** Activities undertaken by the Polish–Egyptian Conservation Mission to Marina el-Alamein in 2014 and 2015 included research and conservation in the public district of the ancient town as well as in private houses. The emphasis was foremost on research, conservation and exhibition of monuments in the area north of the central town square, especially the remains of public baths dating from the Hellenistic period. Research and conservation continued also in the area south of the central square, concentrating on the remains of Roman baths in use from the 2nd to the 4th century AD. Current maintenance and conservation were carried out in private houses and in the area south of the central square.

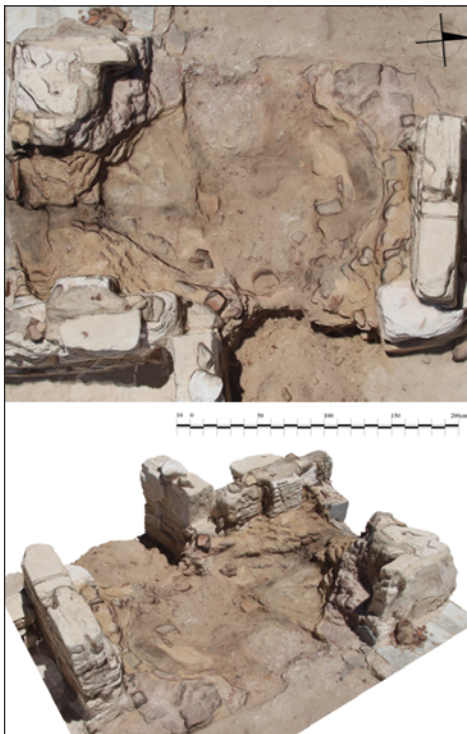
Fig. 4. Furnace in annex 7d in the Southern Bath, top view and oblique view (Documentation M. Grzegorek)

The annex (7d) in the southeastern part of the caldarium is rectangular in plan. It is 1.83 m (E–W) by 1.91 m (N–S). It lies above the praefurnium, approached from the east via an underground corridor, under the floor of the neighboring room (8a). The furnace was built of bricks and had the form of a tunnel covered with a barrel vault, running from east to west, the internal width being about 0.47 m. It heated the hypocaust of room 7. Annex 7d was a part of this heating system [*Fig. 4*]. The brick structure of the annex was supported from below and encased the sides of a metal water-heating tank, which was probably situated in this spot. The tank was oval in plan, approximately 1.20 m

(E–W) by 1.83 m (N–S); its impressed traces have survived. Bricks in the outer parts of the structure were bonded in lime mortar, whereas those in the furnace zone and immediately around and under the tank were bonded in clay mortar.

**Room 7.** Relics of the furnace (7d; 1.91 m by 1.83 m) were cleaned. It was built of baked bricks bonded with clay mortar. A brick vault was excavated on the east. Several fragments of blackened terracotta pipes used as flues were found.

The function of annex 7d, which was sectioned off in the southeastern part of the caldarium (7) in the second phase of the operation of the complex, was clarified [see *Fig. 4*]. The annex was built of red bricks above the location of a praefurnium from the second phase. The results of research in 2014 showed that a metal water-heating tank was probably placed here, directly above the praefurnium proper, thus making it one structure.

Relics of a brick structure (7d) once encasing the water-heating tank were conserved and reinforced. The outer brick parts, originally built using lime mortar, were partly filled in and thus made slightly higher. This also enabled rainwater to flow away from the surface, providing at the same time a casing for the rest of the relic (built with clay mortar), which was covered with geotextile and covered with sand.

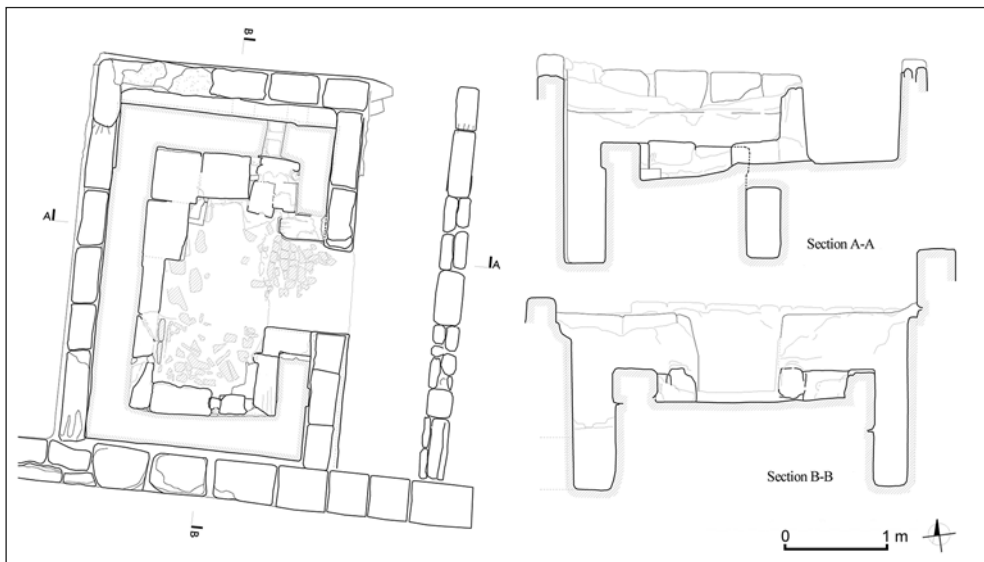
Fig. 6. Latrine (14) with vestibule (15) in the Southern Bath, plan and sections (Drawing M. Grzegorek)

**Room 14.** Partly excavated in 2013 (Czerner, Bąkowska-Czerner, and Majcherek 2015: 128), the room was now cleared completely (3.53 m by 2.17 m) [see *Fig. 6*]. It was identified as a latrine, the second one in this bath complex, somewhat smaller and made less carefully than the one discovered in the previous season (12) (Czerner, Bąkowska-Czerner,

and Majcherek 2015: 126–127). In its east wall, a door opening 0.93 m wide and leading to a vestibule (15) was discovered. A drain emerged under a layer of sand and rubble. Big stone blocks, broken off from the walls, were found there. Pieces of painted plaster were found under the stone blocks of the southern drain. They were probably collapsed from the latrine walls. Below, in a layer of sand 0.30–0.40 m thick, there was a big pottery assemblage (including sherds from several amphorae and a fragment of a vessel filled with shells), as well as pieces of windowpanes and animal bones. At the bottom of the latrine lay a layer of dark sand about 0.10 m thick, mixed with heavily fragmented ceramics. The drain, 0.30–0.40 m wide and about 0.85–1.00 m below the latrine floor, was divided in its northern part by a stone wall that was 0.18 m wide; this repeated the situation from latrine (12) discovered in the earlier season. The wall separated two drain openings, 0.56 m by 0.20 m, visible in the north wall. Fresh water was supplied to the latrine through the eastern drain, while sewage was carried off through the western one. The drain was observed to slope slightly from south to north. Its walls were covered with waterproof mortar. A socket approximately 0.30 m by 0.15 m was noted in the south wall above the drain, 1.40 m from its bottom. A seat would have been fixed there. A projection of the north wall (0.12–0.16 m wide) had the same purpose.

The flooring made of irregular grey marble tiles survived only in the southern part and in the passage from the vestibule (15). Stones lining the edge of the drain to the north and in the northwestern corner were much bigger than the rest. A fragment of a rectangular vessel of stone can be seen under them. Ceramics found in

The most interesting rooms in the bath complex that underwent conservation in 2014 were rooms 14 and 15, incorporating a latrine and a narrow corridor leading to it. Marble flooring which has survived in good condition in both interiors, as well as elements of the latrine drain casing, may become appealing display items in the future. Some preservation and partial reconstruction of this flooring were required. Protective bands were also put on the edges of the remains of plaster which had started to peel, while the joints on the remaining parts of the walls were filled with mortar. Some sections of the walls, separating rooms 12–15, and the outer walls of the bath complex west and south of rooms 12–14 were topped with one new layer of original blocks. This protects the complex of two latrines relics from being covered up by sand.

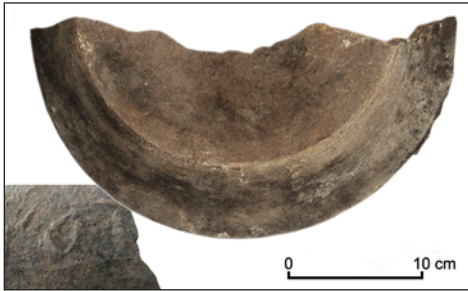
Fig. 8. Fragment of a frying pan with a stamped inscription on the bottom (close-up at bottom left) (Photo G. Bąkowska-Czerner)

Three kitchen vessels, partly preserved, were found in a layer of compacted soil, greasy to the touch, with traces of a hearth. The finds included fragments of a jug with trefoil rim and cooking pots [Fig. 7] as well as half of a frying pan with an inscription [Fig. 8], pieces of a lamp and sherds of amphorae, animal bones, a fragment of fish skeleton and eggshells. A flooring made of irregular pieces of grey marble tiles, just like in the latrine, was found here. It was covered with a layer of sand 0.10 m thick, containing potsherds. A structure 0.35 m high stood on it. In the northern part of the corridor, a layer of sand (0.20 m thick)

products from the northwestern coast. All represent a similar form: globular body, rather heavily ribbed, with two small strap handles and reverted, otherwise plain rim. Some vessels of Aegean origin were also recognized in the assemblages. They are usually larger, with plain, upright rim, sometimes grooved on top [Fig. 10:3]. All have globular, slightly sagging carinated bodies with two small handles attached under the rim. All these examples belong to the 1st–2nd centuries AD series. However, some earlier vessels made from Egyptian (Nile silt) fabric, given a folded lip apparently intended to be topped with a lid, were also recorded [Figs 7 top right; 10:4]. Although usually dated to the early 1st century AD, their manufacturing tradition goes back to the Late Hellenistic period. Several similarly dated splayed-out plain rims of imported, thin-walled pots were also found [Fig. 10:5]. Surprisingly many examples of fine alluvial fabric bowls, closely imitating imported *pareti sottili* bowls on low solid foot, were also found in the channel [Fig. 10:6]. Meriting particular note, however, is a specimen of imported (Aegean?) flat-based frying pan (from room 15), with standard thickened rim [Figs 8; 10:7]. On its underside, there is a partly preserved stamp with indistinct Greek lettering (probably retrograde) in raised relief: .]TOY. Similar stamps have been recorded in, among others, Berenike-Benghazi, particularly in the early 2nd century AD context (Riley 1979: 253–256). Frying pans of this type had wide distribution in the eastern Mediterranean, including Egypt, although stamped examples are rather rare in Marina. So far, three have been recorded (Łajtar 2001: 65–66).

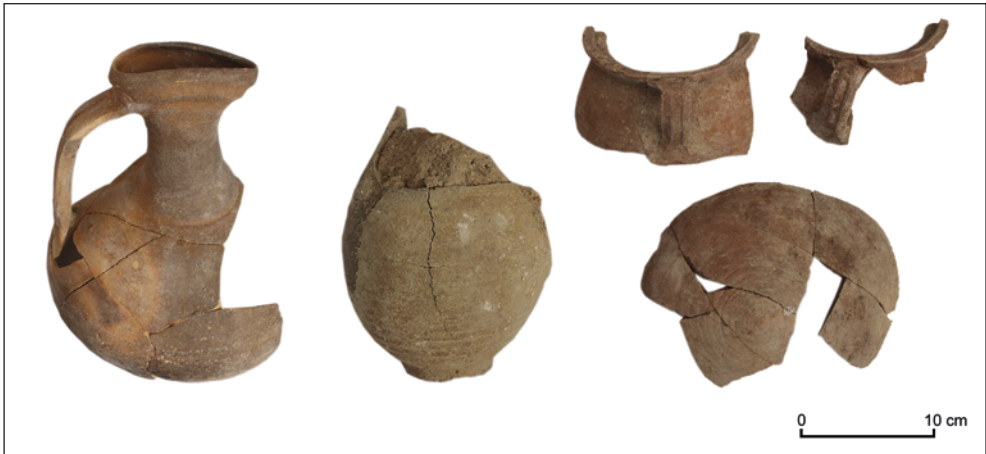
Fig. 7. Kitchen vessels from corridor 15 (Photos G. Bąkowska-Czerner)

Closed vessels, although scarce, were also present in the assemblage. They include an imported Aegean jug with trefoil mouth [*Figs 7 left; 10:8*], and some ribbed marly clay jugs on ring bases, most probably originating from the Marmarica [*Figs 7 bottom right; 10:9*].

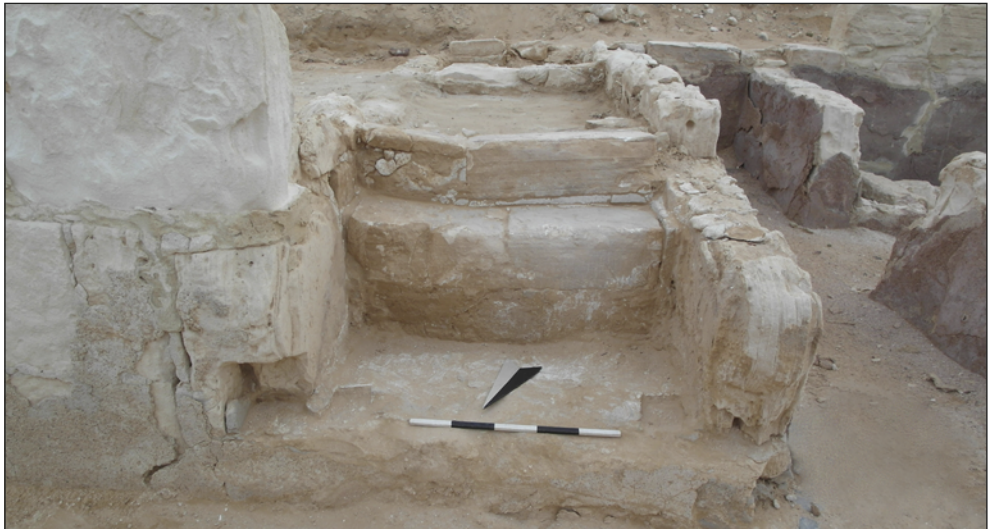
Fig. 9. Entrance and stairs 16 in the Southern Bath  
(Photo R. Czerner)

Rooms 16 and 17 were partly uncovered. Narrow room 16 turned out to be a staircase with the first three steps made of stone blocks preserved in the northern part. Imprints of the elements fixing the door hinges were also preserved [Fig. 9].

**Room 16.** Wall tops were unearthed to a depth of 0.25/0.26 m. The room was divided by a wall into a smaller southern part measuring 1.10 m by 0.98 m, and a bigger northern one sized 1.10 m by 1.30 m. A stairway, 0.90 m wide and 0.77 m high, was installed in the northern part [Fig. 9]. There were three steps leading upstairs (the bottom one did not survive) and a door that gave onto it. Remains of

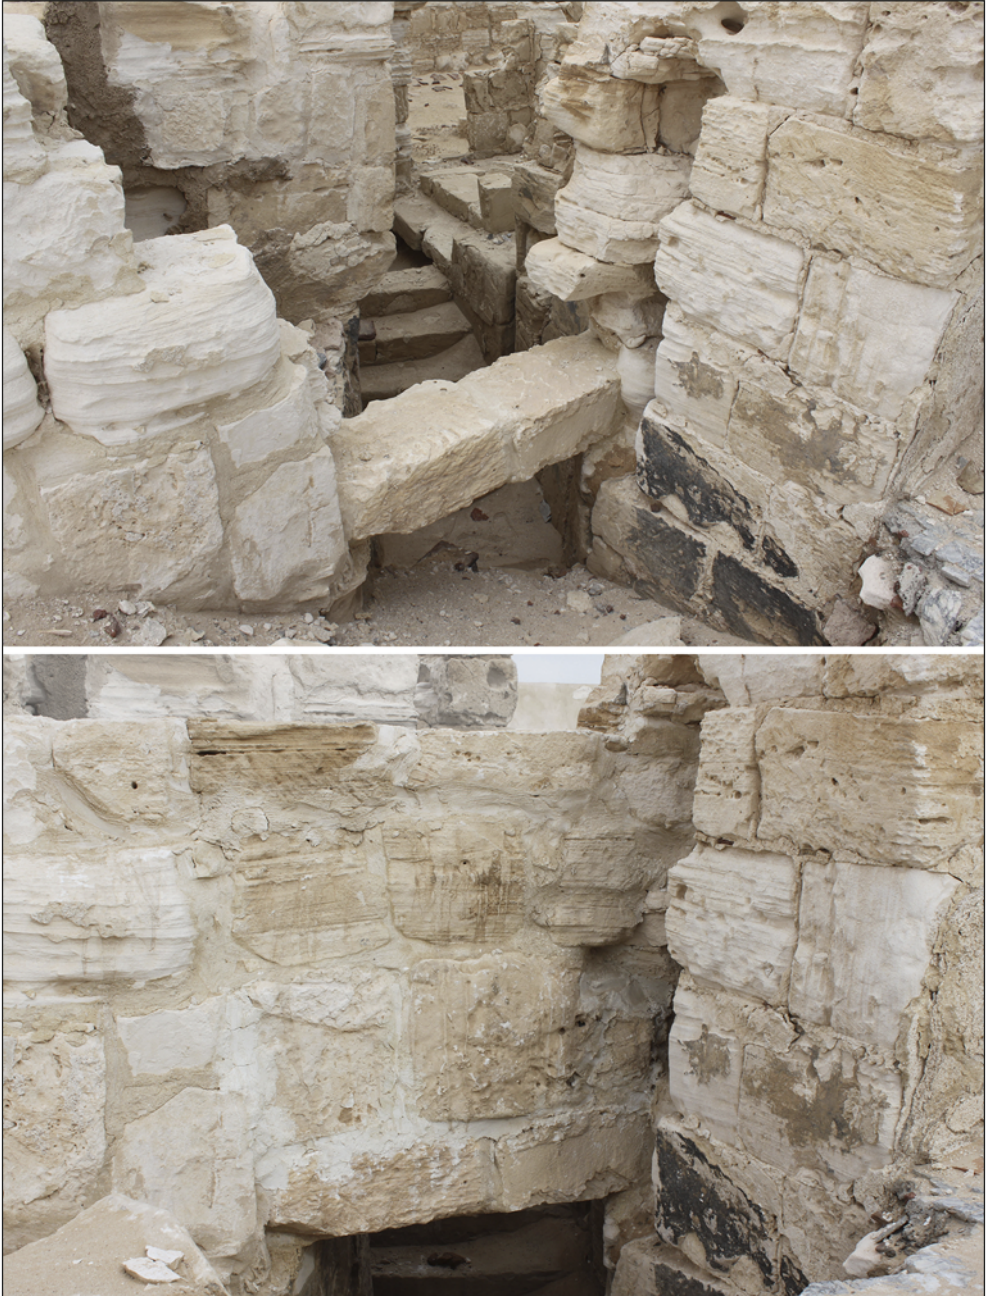
*Fig. 11. Southern Bath. Wall above the passage to the underground corridor (between rooms 18 and 8a), before and after continued restoration in 2014 (Photos R. Czerner)*

An exceptional conservation risk was posed by remains of a wall hanging over the passage to the underground corridor (18) [*Fig. 11*]. The wall separates the back of the caldarium from the northwestern part

of room 8a. After dismantling the upper parts of the wall, which had been in danger of collapse for some time, a supporting structure was constructed in 2013. It was composed of two reinforced concrete beams which formed a lintel above the passage and was hidden in hollows cut in the bottom of stone blocks laid on top of them. There was no lintel beam above the passage at the time that it was first pierced in the wall, hence the need to hide the new lintel securing the reconstructed part of the wall. In 2014, the next four layers of solid blocks were laid on top of the reconstructed wall.

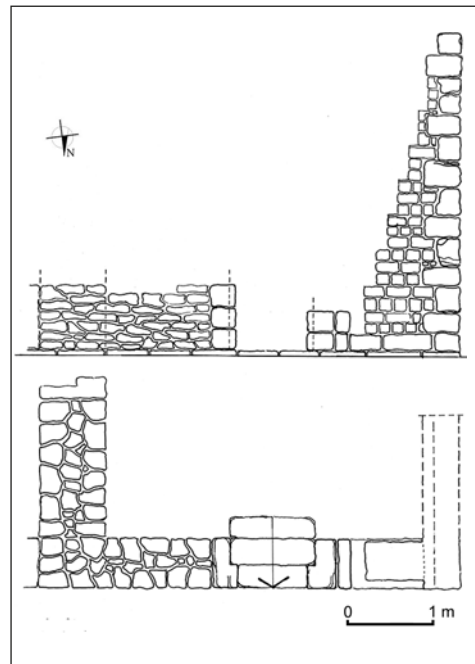
Fig. 12. Restoration of a house facade  
(Drawing W. Grzegorek)

the east, the eastern jambs of a door opening were reconstructed, using the original components. An adjoining wall, 0.73 m high, 0.60 m wide, and 1.97 m long, was built of crushed rock gravel. It runs, to the east, towards the

corner, and about 1.50 m further to the south [Fig. 12].
