# DONGOLA SEASONS IN 2012–2013

Włodzimierz Godlewski<sup>1</sup>

**Abstract:** The four seasons, two in 2012 and two in 2013, carried out in ancient Dongola by an expedition from the Polish Centre of Mediterranean Archaeology, University of Warsaw, were devoted to continuing excavations in a number of areas: the fortifications on the Citadel and houses from the Funj period (17th–18th century) outside of the fortifications; site SWN on the Citadel, including Building B.I (Palace of Ioannes) and Building B.V (church); and the monastery complex on Kom H, encompassing the monastic church, sanctuary of Anna, gates to the monastery for monks and laity, finally the commemorative building of the Dongolan bishops with three crypts where the third of the crypts was revisited to study the burials from an anthropological perspective. In late 2013, a new Qatar–Sudan Archaeological Project (No. 10) was launched with fieldwork concentrated on the Mosque Building and within the Citadel.

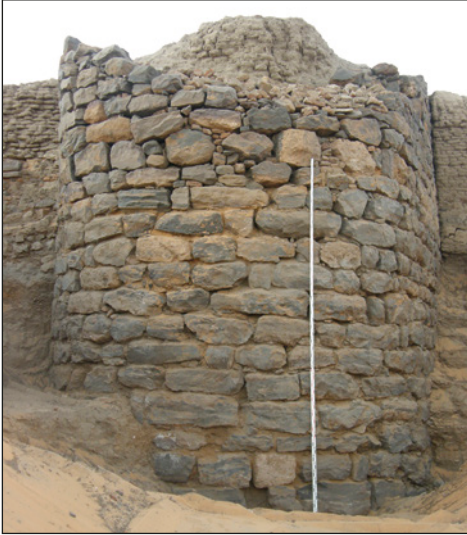
*Fig. 2. Northeastern tower, view from the north  
(Photo W. Godlewski, PCMA UW)*

The northeastern tower, which was explored during the first campaign of the season, was in a much better state of preservation than the northwestern tower excavated earlier [Fig. 2]. It was also founded on bedrock. The width was 6.10 m, length 9.00 m, and it rose to 8.35 m in height. The stone structure was reused for the outer walls of a 17th-century house, which was built on the top of the tower. Taking this into account, the original height of the tower (and the curtain on either side of it) can be estimated at about 10.50–11.00 m.

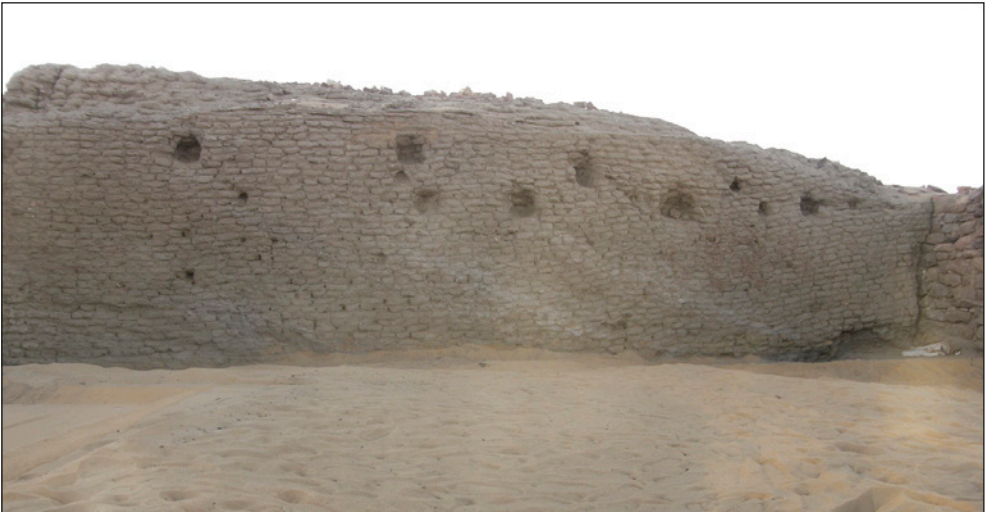
*Fig. 3. Facing of dried brick between the towers NE and N.2  
(Photo W. Godlewski, PCMA UW)*

At some point the fortifications underwent a program of development, building on top of the accumulated sand dunes and adding a new outer facing of dried bricks, approximately 1.00 m wide, on a level 4.70 m higher than the stone-wall foundation [Fig. 3]. This investment appears to have taken place sometime at the end of the 16th century, presumably in response to a growing Ottoman threat (the excavator

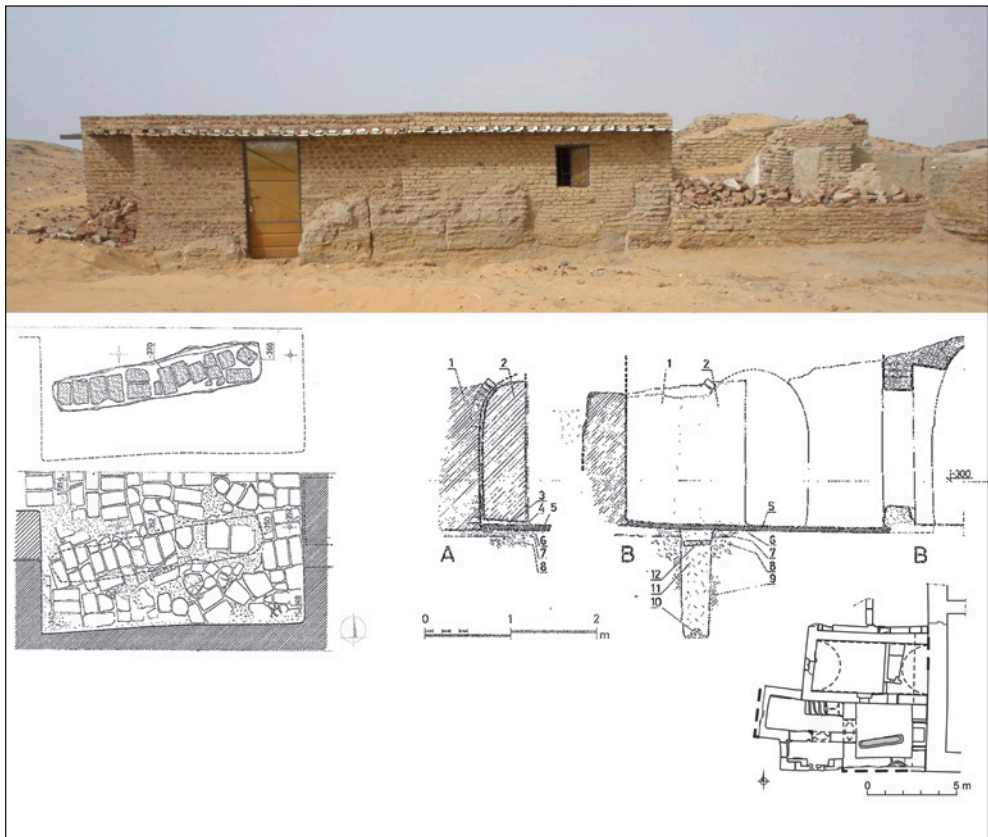
Fig. 11. Sanctuary of Anna: top, view from the south following general preservation work; bottom, plan and section views of the grave pit inside the sanctuary (Photo W. Godlewski; drawing J. Dobrowolski)

In the sanctuary of Anna, his tomb located in front of the altar was revisited for the purpose of anthropological study, the results of which are presented in the appendix below. The paintings and graffiti on the walls were studied thoroughly and documented. A roof was constructed over the reconstructed naos walls of the sanctuary, laying corrugated metal sheets on a grid of metal beams [*Fig. 11 top*]

1993: 106–108), to the west of the altar, close to the south wall [Fig. 11 bottom]. It had been opened in 1992, but anthropological examination was not carried out at

The floor of the sanctuary had been disturbed, but even so, traces of lime mortar observed on the pavement gave no suggestion for the shape of a marker. The biggest likelihood is that there was never any kind of marker for this grave in the restricted space of the sanctuary. The grave itself was a deep and narrow pit excavated in the soft limestone bedrock under the pavement; it was 2.40 m long, 0.39 m wide and 1.30–1.34 m deep (the dimensions may be slightly bigger than originally reported in view of the earlier exploration). Its southern edge was 0.63 to 0.80 m from the south wall of the shrine, the western end being closer to it.
