# Research and architectural conservation in Marina el-Alamein in 2017

## (Polish–Egyptian Conservation Mission)

In September 2017, the Polish–Egyptian Conservation Mission worked at the site of the Hellenistic and early Roman town of Marina el-Alamein for the twenty-second time.

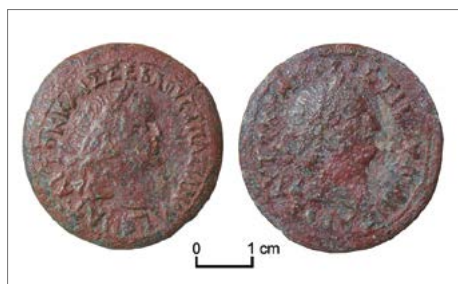
Fig. 4. Roman coin of Vespasian (AD 76/77) from east of the forum (Polish–Egyptian Conservation Mission Marina el-Alamein/ photo R. Czerner)

A large well-preserved Roman bronze coin turned out to be an interesting surface find from the area east of the street [Fig. 4]. It is an Alexandrian

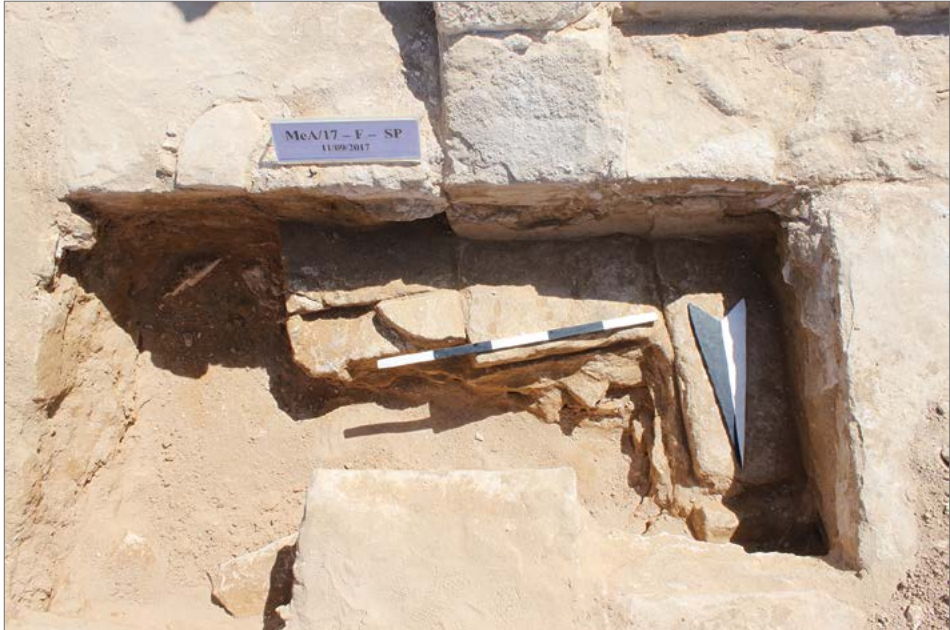
In 2016, conservation of the pavement next to the eastern side of the southern portico uncovered steps from an earlier phase, leading to the portico. A small test pit (about 1.20 m by 0.80 m) cut now next to the steps situated on the longer side of the southern portico [*Fig. 5*] revealed four slabs and then more slabs under a layer of soil, 0.13–0.15 m thick. The latter were placed at a slight angle compared to the slabbing in the forum and represent probably a fragment of pavement from an earlier phase. The test was dug to a depth of 0.40 m. Several animal bones (cattle, pig; U. Iwaszczuk, personal communica-

Fig. 5. Test trench next to steps leading to the southern portico of the main square (Polish–Egyptian Conservation Mission Marina el-Alamein/photo R. Czerner)

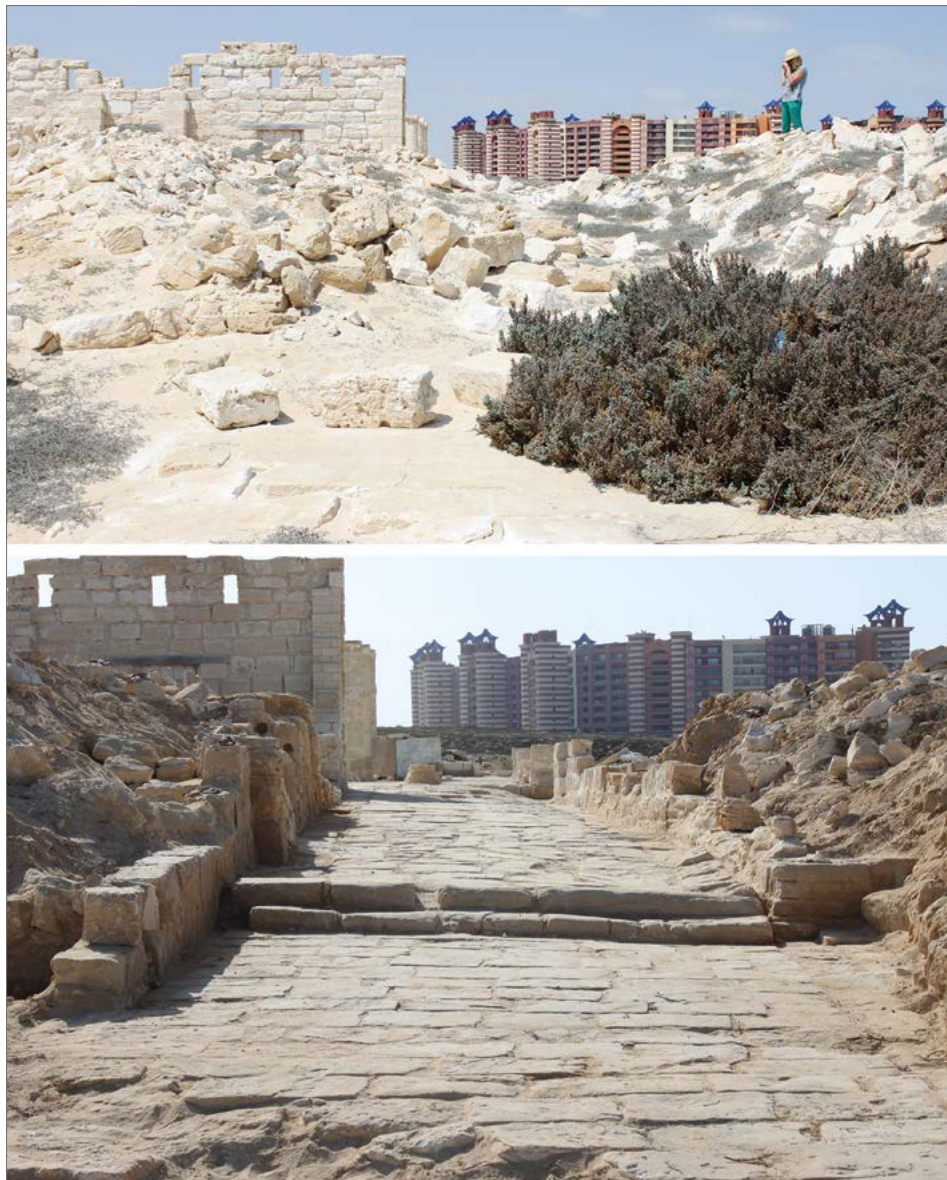
Fig. 6. Street east of the forum, view from the east: top, before cleaning and preservation; bottom, after cleaning and preservation in 2017 (Polish–Egyptian Conservation Mission Marina el-Alamein/ photos R. Czermer)

The presentation of this part of the site has been greatly enhanced by opening the entire length of the street [*Fig. 6*]. The wall on the northern side of the street and part of the wall on the southern side were protected: first to a limited extent on both sides in the western section in 2015 (Czerner et al. 2016: 162–163) and now along the entire length of the street [see *Fig. 2*]. One to three layers of original limestone blocks tumbled from the north wall were replaced in position. The

jambes of the entrance were made more distinct. Some parts of the wall on the southern side were protected in similar manner. At the eastern end, the rubble

masonry wall was pointed after having been cleaned. The wall between the easternmost entrance and the setoff, of which barely one course above the street

paving was preserved, was reconstructed with original blocks to a height of about 0.65 m, matching the height of the blocking of the doorway. The missing slabs in the street pavement were replaced as well. [RC, WG]

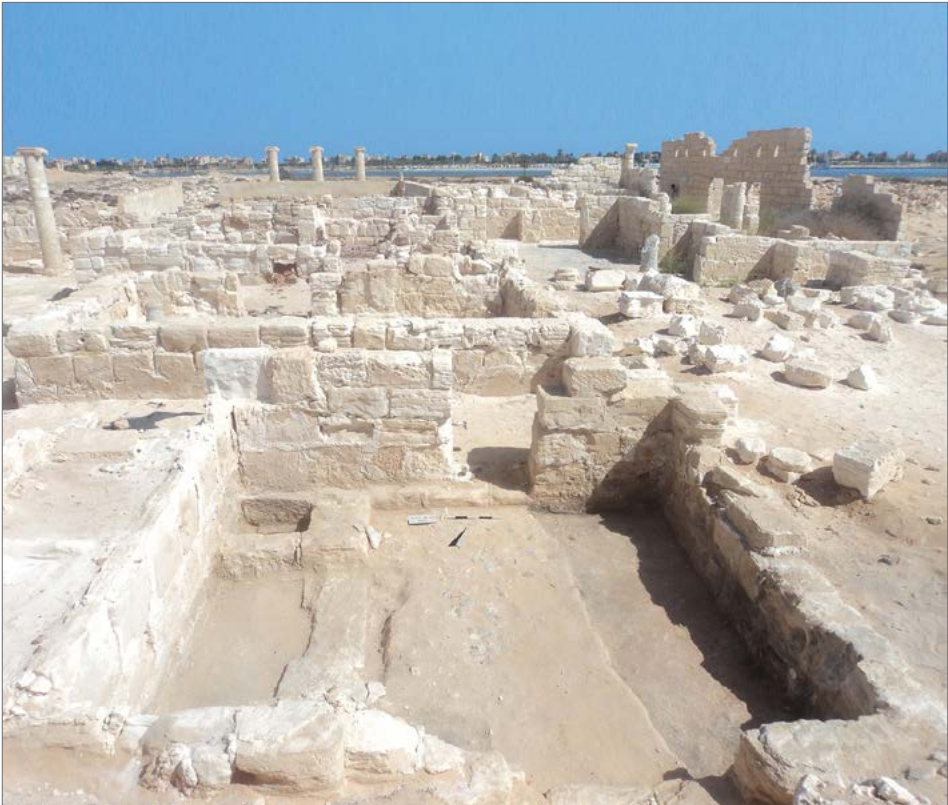
Fig. 7. Room 17 of the Roman baths south of the main square; view from the south after excavation in 2017 (Polish–Egyptian Conservation Mission Marina el-Alamein/photo W. Grzegorek)

A distinctive layer of packed, dark soil 0.12 m thick and about 1.00–0.90 m wide was observed in the eastern part of the room [see Figs 7, 8]. The lower sections of the east, north and south walls, up to 0.30 m, are blackened. The layer yielded fragments of pottery, identified as, among others, kitchenware, ampho-

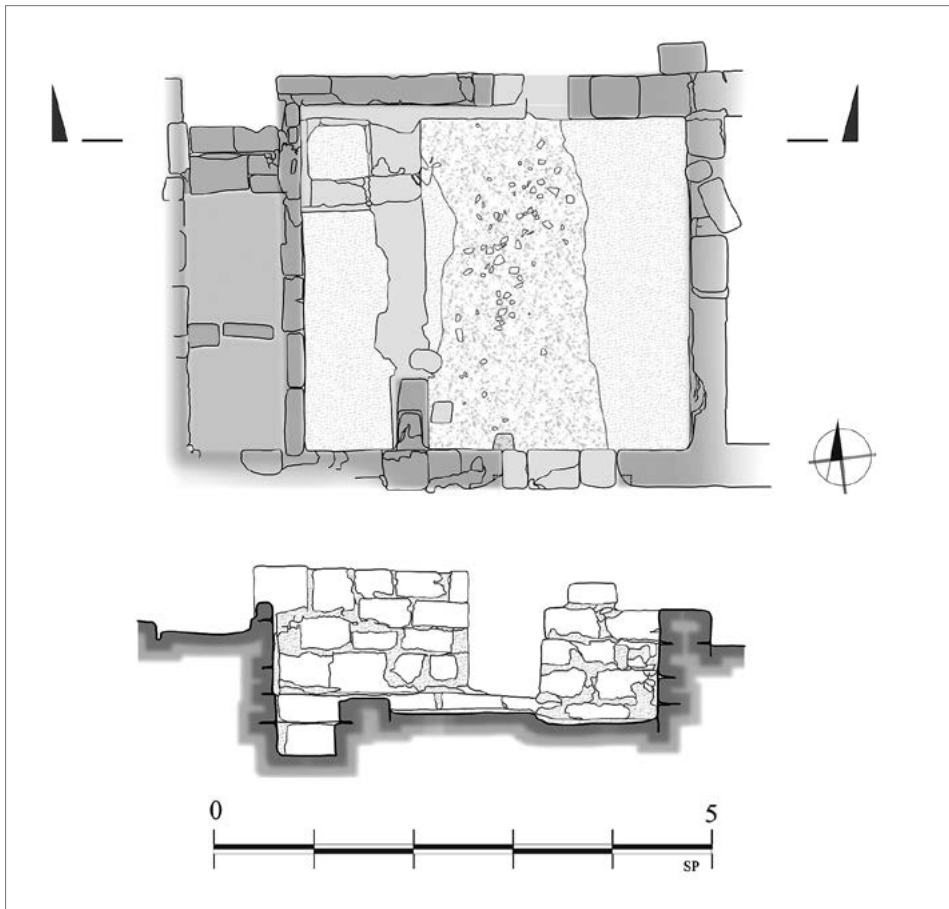
Fig. 8. Room 17 of the Roman baths south of the main square: plan and section (Polish–Egyptian Conservation Mission Marina el-Alamein/drawing S. Popławski)

Discovered in 2016, an inner wall, about 0.50 m wide, projecting north from the south wall, 0.91 m from the western corner, may have supported the landing of the stairs, the first flight of which was in the neighboring room. The foundation of this wall was examined in 2017 and was found to run as far as the north wall of the room. Another low wall, 0.27 m wide, built between the foundation and the west wall of the room, set off an almost square shaft in the northwestern corner. It measured 1.13 m by 0.99 m on the outside (inner dimensions 0.58–0.63 m) and was 0.63 m deep with a stone slab forming the bottom. [RC]

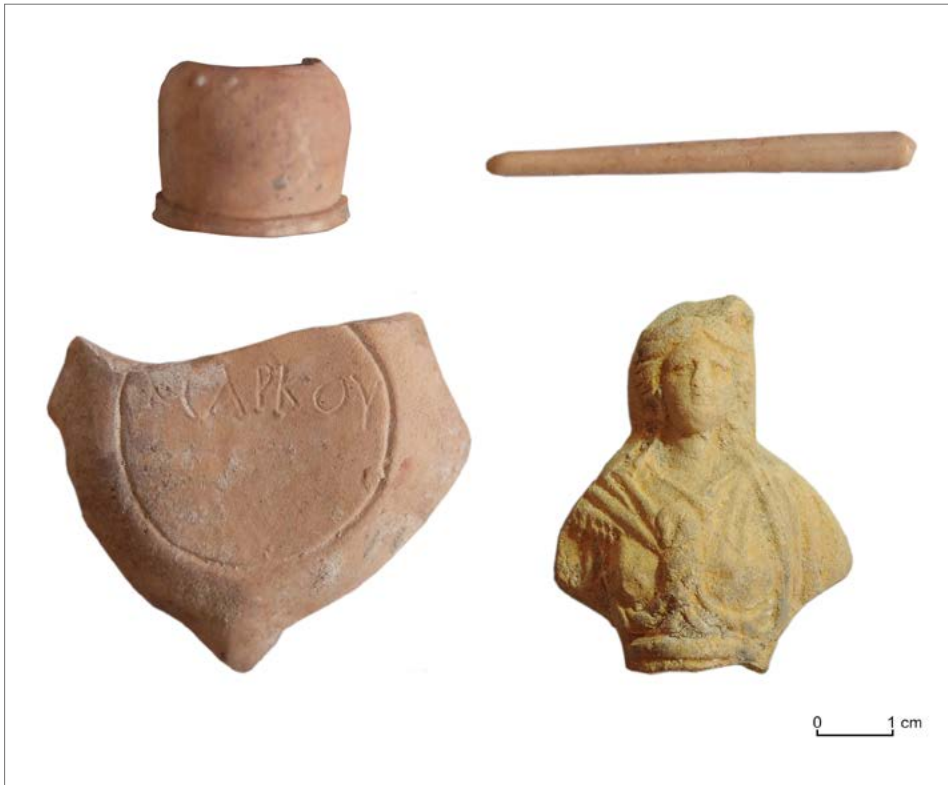
Fig. 9. Finds from Room 17 of the Roman baths: (counterclockwise from top right) bone hairpin; bone game pawn; fragment of an oil lamp base with a producer's inscription; terracotta bust of Isis (Polish–Egyptian Conservation Mission Marina el-Alamein/photos R. Czerner)

Greek: ΜΑΡΚΟΥ [Fig. 9 bottom left]. Lamps with this kind of signature were discovered primarily on islands of the eastern Mediterranean (Katsioti 2014: 157–158). Researchers point to a Cypriot workshop. Dating is not certain; it seems that they were produced no later than in the 3rd century. The context of the Marina find is dated mainly to the 2nd century or the beginning of the 3rd century. Pottery coming from the eastern Mediterranean, including Cyprus, was also discovered in this context. It is not known, however, whether the lamp from Marina could have come from the same Cypriot workshop. Further research should bring more data to bear on the issue.

Bone objects from the context included a damaged pin, another intact one with a conical wider end [Fig. 9 top right]. Hairpins like this complete one, relatively thick compared with other types, served to fasten knots and were commonly used in the Roman Empire (Bìrò 1994: 31, 78–79, Nos 134–151; Bartus 2003: 23–24, Fig. 1.1). Such pins could have been made of bronze as well (Riha 1990: 182, Nos 2632–2644). They are dated mostly from the 2nd to the 3rd century. Three pins of

the type were found in Marina in house Η10Ε in 2003; similar specimens were also discovered in Alexandria (Rodziewicz 2007: 200–201, Nos 417–419). Another bone object is a board game pawn [Fig. 9 top left]. Of cylindrical shape, it is hollow inside, at the foot decorated with two rings and a groove between them. A similar pawn was found in Alexandria (see Rodziewicz 2007: 237, No. 542).
