A new double foundation deposit in the Hathor Shrine of Tuthmosis III at Deir el-Bahari

Abstract: A double foundation deposit was found in the southeastern part of the Tuthmosis III Hathor shrine at Deir el-Bahari. The architectural features, a pit with a niche at the bottom, confirm the dating of both of these deposits to the times of Tuthmosis III. An original feature of the southeastern one is the initial circular cavity changed into a semicircular one by the building of a mud-brick wall in the east. Several courses of mud bricks built up the rim of the pit above the rock-carved cavity. The whole structure was plastered inside with mud plaster. The bricks were mostly reused from the Middle Kingdom structure of Mentuhotep II. The content, although disturbed, still consists of organic offerings as well as ceramics, but no inscribed material.

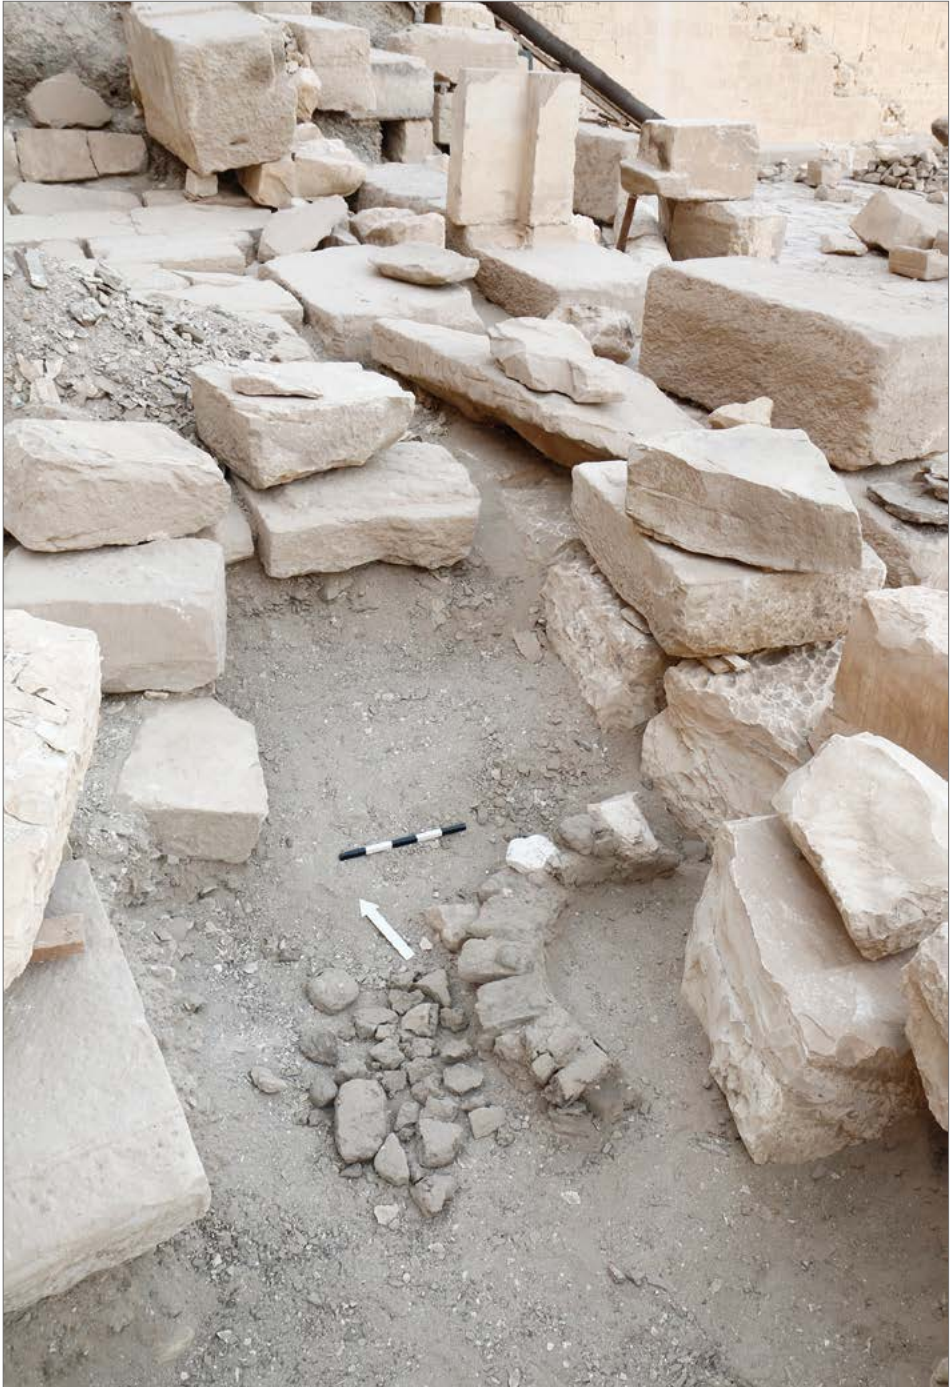
Fig. 1. Top of the southeastern pit at the time of discovery, viewed from the south (IFAO/PCMA UW/photo M. Caban)

A row of limestone foundation blocks oriented N–S ran against the eastern edge of the pit [Fig. 1]. The cavity is close to the last three preserved blocks, still *in situ*, to the south [Figs 2, 3].² The pit was also lying below what can be restored, on one hand, as the wall between the last two rooms of the Hathor shrine to the south, and on the other hand, as the floor of the last room to the south, in its eastern part. This location could refer to the southeastern corner of the Tutmosis III temple structure and more roughly to the southeastern edge

² The limestone block, which can be seen above the southeastern part of the pit in the original photo after discovery [Fig. 1] was moved to the south in order to clear the pit for study [see Fig. 3].

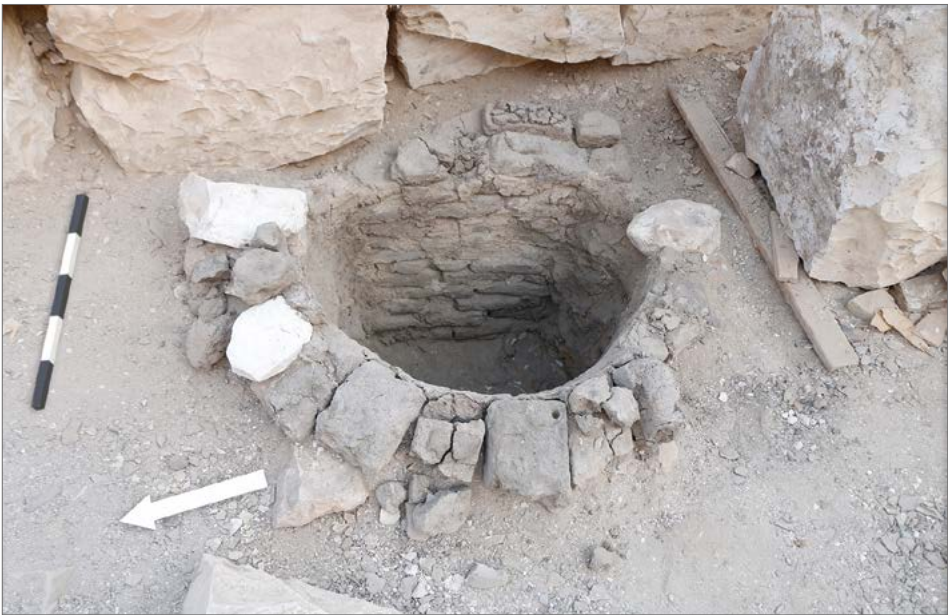
Fig. 3. Southeastern foundation pit after investigation, viewed from the west (IFAO/PCMA UW/photo M. Caban)

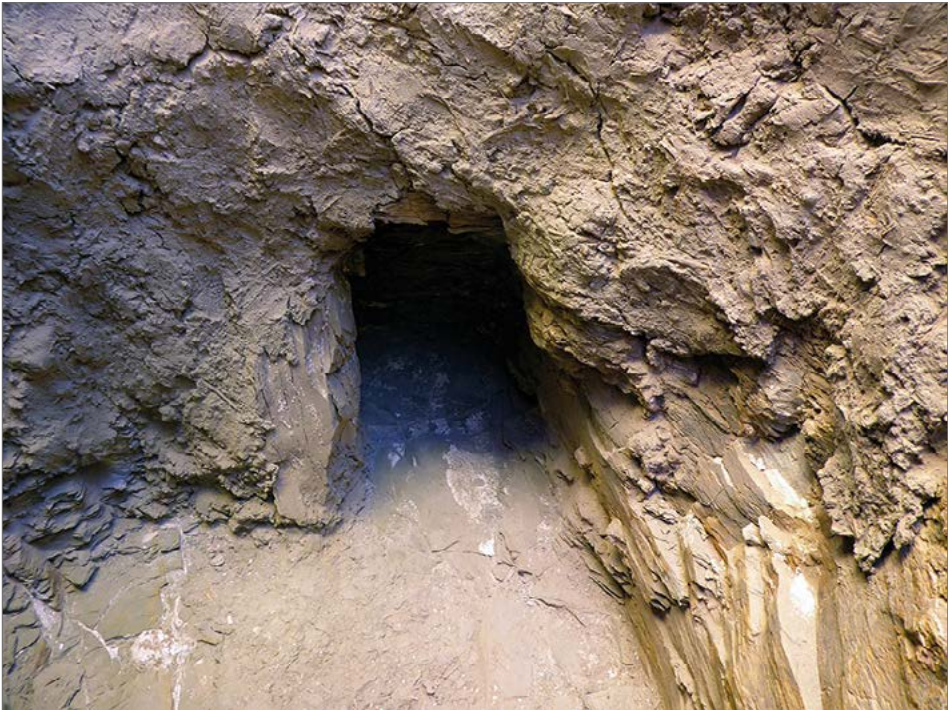
Fig. 5. The niche at the bottom of the southeastern pit (IFAO/PCMA UW/photo N. Beaux)

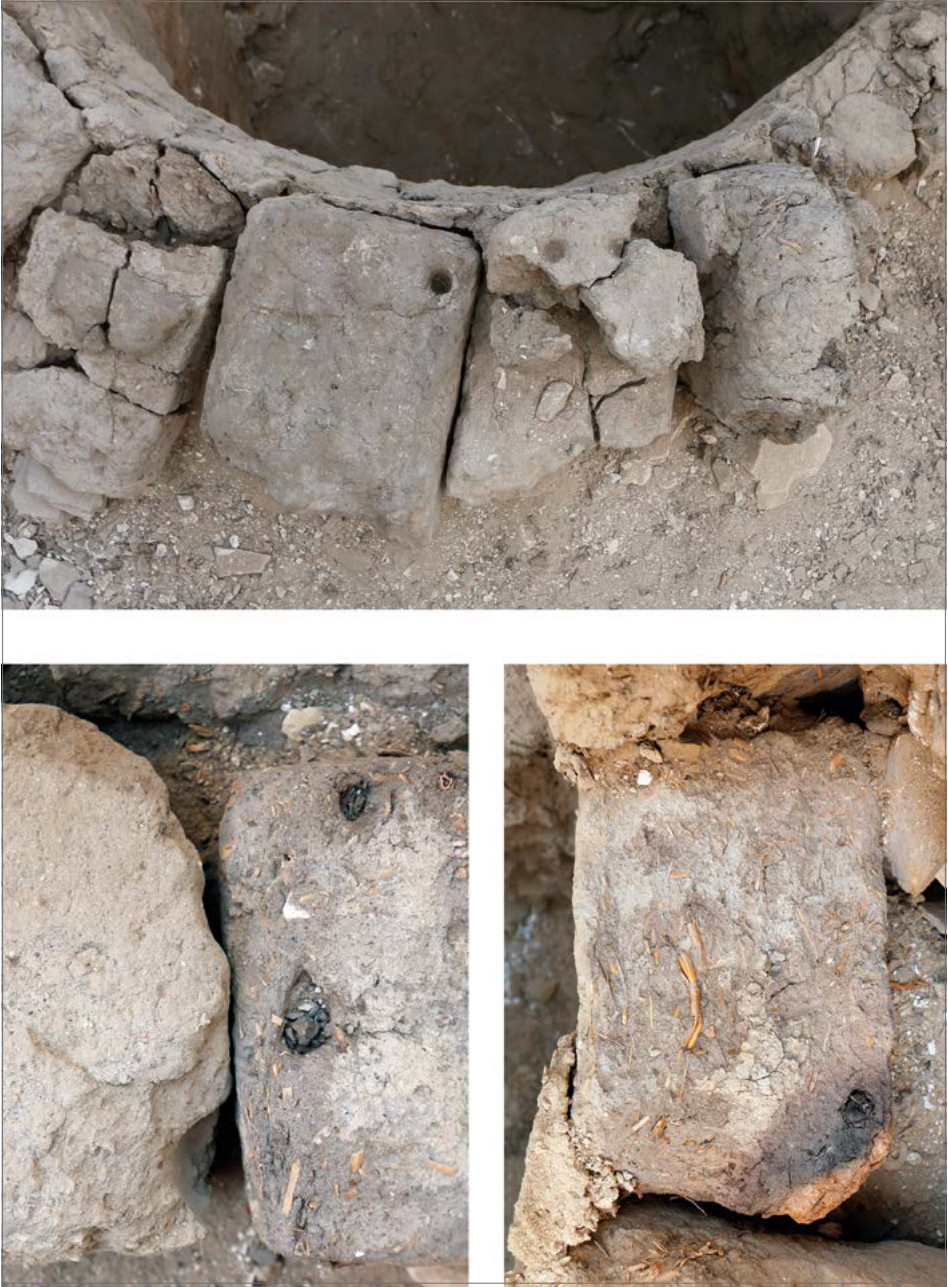
Fig. 6. Bricks used in the construction of the southeastern foundation pit: top, reused bricks of Mentuhotep II with marker points in the form of finger holes; bottom left, types of bricks used: yellow-grey mud brick with almost no straw content and bricks made of black mud mixed with large pieces of reddish straw; bottom right, fragmentary burned bricks (IFA0/PCMA UW/photos M. Caban)

The bricks are of two types, some are similar to the bricks used in the rest of the rim, that is, reused Middle Kingdom bricks made of rather black mud tempered with large pieces of reddish straw. In a few cases, the tops of these bricks present marker points in the form of finger holes, characteristic of Mentuhotep II's bricks in that temple (Arnold 1979: 7, 64, Pls 2–3) [*Fig. 6* top]. Another type of brick,

specific to that wall, is made of a yellow-grey mud and is much more compact. A very porous structure is visible in the breaks of these bricks, showing almost no straw content [Fig. 6 bottom left]. They are much smaller in size. Some of them have a very thin layer of whitewash on some sides, which indicates that they were re-used. As said above, fragmentary burned bricks were found in the wall structure [Fig. 6 bottom right].

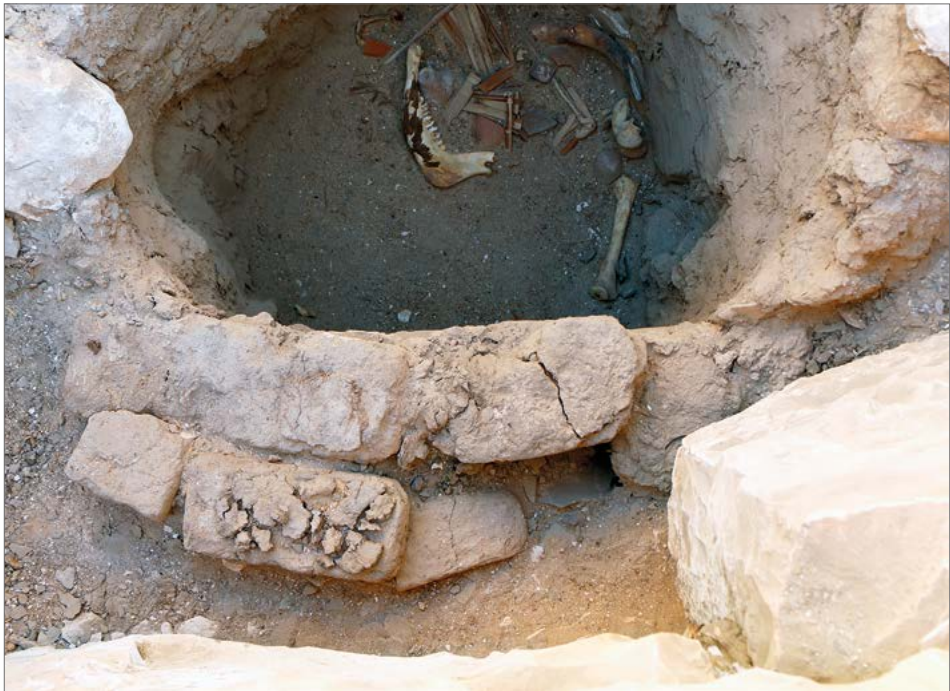
Fig. 7. Top of the east wall of the southeastern foundation pit, covered in its northeastern corner by part of a limestone foundation block (IFAO/PCMA UW/photo N. Beaux)

This “wall” is 0.37 m lower than the present attested upper brick of the semi-circular part. It has, at present, only one row of bricks higher than the rock top of the pit. It is clear that the limestone foundation blocks set to the east were put there after the pit had been built, as expected of constructions over a foundation deposit, since one of them extends over the northeastern corner of the pit, in the part lower than the rest of the structure [Fig. 7].

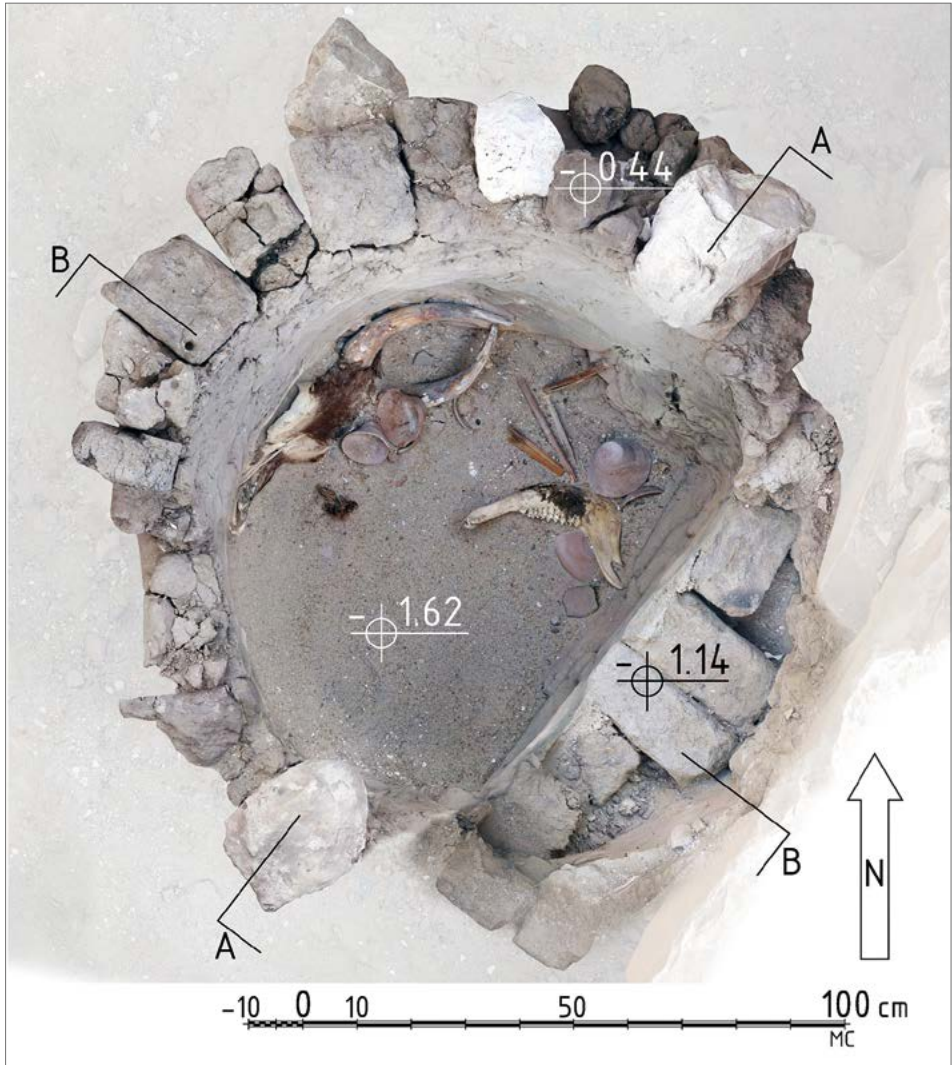
Fig. 8. Foundation deposit in the southeastern pit: disturbed content in arbitrary layer 12, level 1.62 m (IFA0/PCMA UW/orthophoto and processing M. Caban)

Considering the troubled stratigraphy, the content will be detailed by material and not layers, although it is worth noting that an ox skull [Fig. 9], jaws and legs were found towards the bottom of the pit, around 1.62 m from its top [Fig. 8]. Close to them were a few intact bowls and plates and at least two reed trays. Being bigger, they could have been moved around the bottom of the pit without being taken out, and thus remained more or less together.

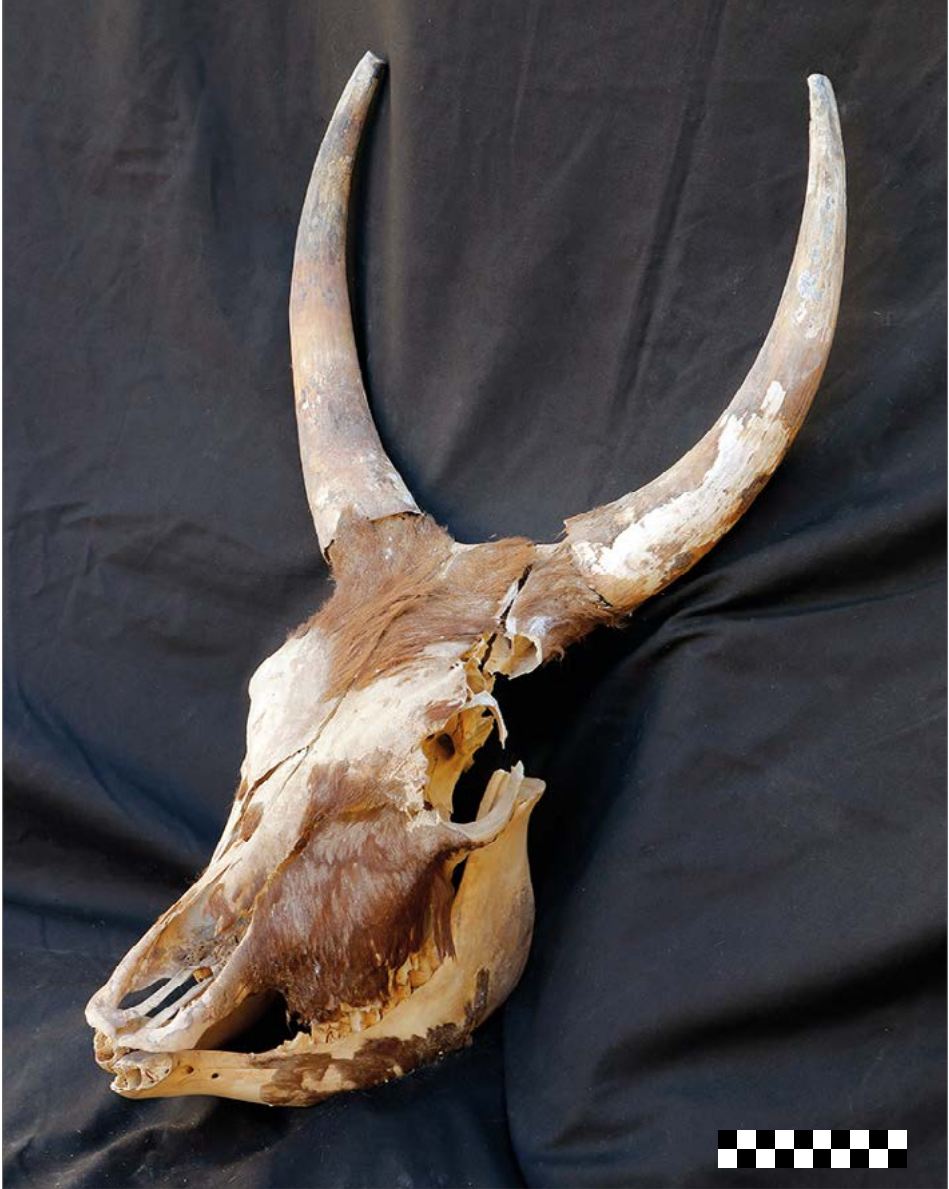
Fig. 9. Ox skull found in arbitrary layer 12, level 1.62 m (IFAO/PCMA UW/(IFAO/PCMA UW/photo M. Caban)

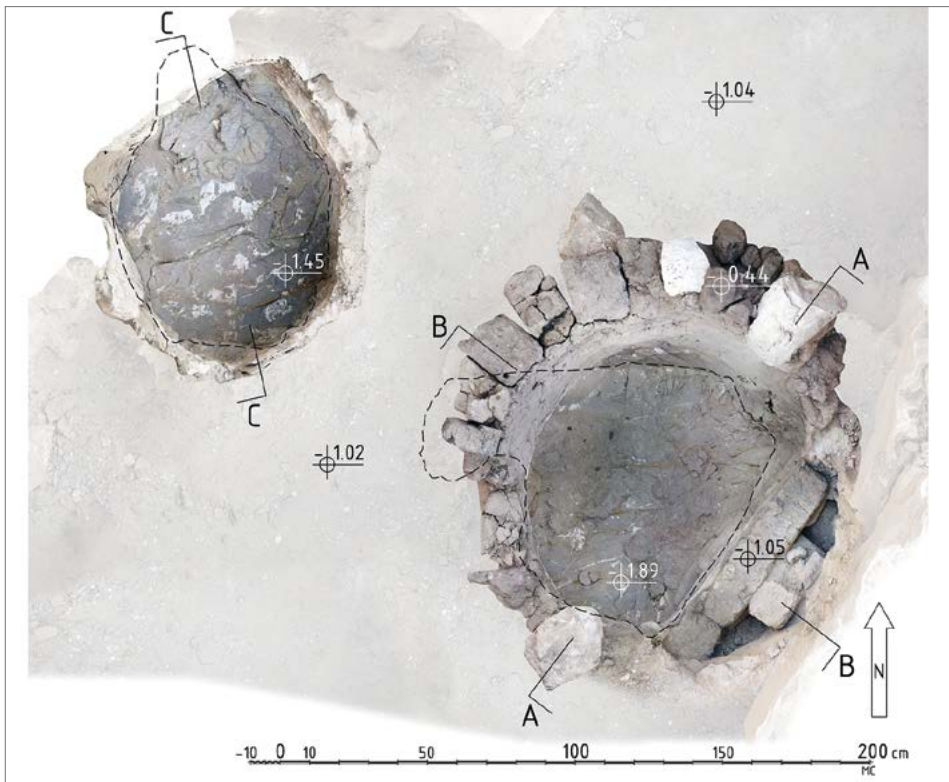
Fig. 10. Plan and location of the second pit discovered west of the southeastern foundation deposit (IFA0/PCMA UW/photogrammetry M. Caban)

The cavity lies 0.37 m to the west of the southeastern pit previously described, partly beneath a pavement block still *in situ* [Figs 2, 10]. It is more or less oval (1.05 m long, 0.76 m wide and 1.03 m deep) [Figs 11–12].

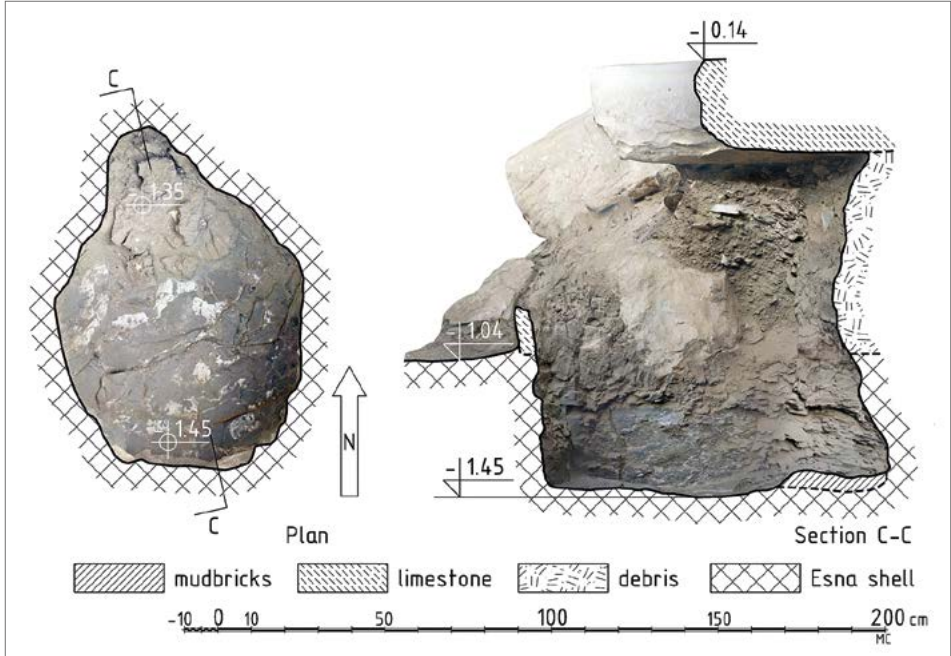
Fig. 11. Plan of the bottom and section of the southwestern foundation pit (IFA0/PCMA UW/photo-grammetry M. Caban)

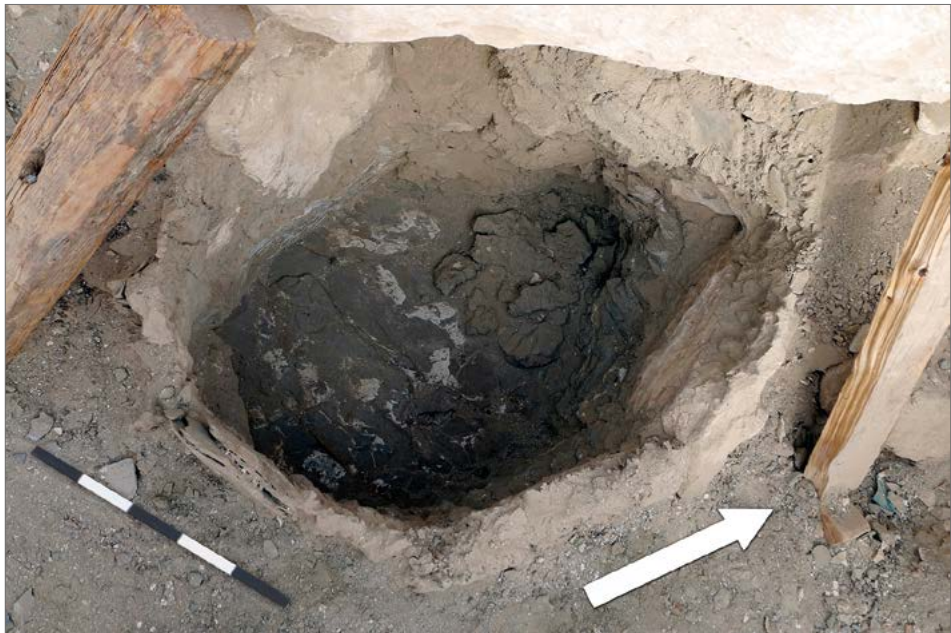
Fig. 12. The southwestern pit, view from the east (IFA0/PCMA UW/photo M. Caban)

A small niche is carved into the northwestern side of the pit [Figs 12–13]. Its orientation is more to the north than the niche in the other pit, although both niches are set roughly to the west of the pits. The bottom of the niche is covered with a thick layer of mud plaster preserving the builder's fingerprints. The niche is about 0.30 m wide and 0.20 m deep. Its ceiling is irregular: 0.30 m high at the entrance and only 0.10 m at the back.

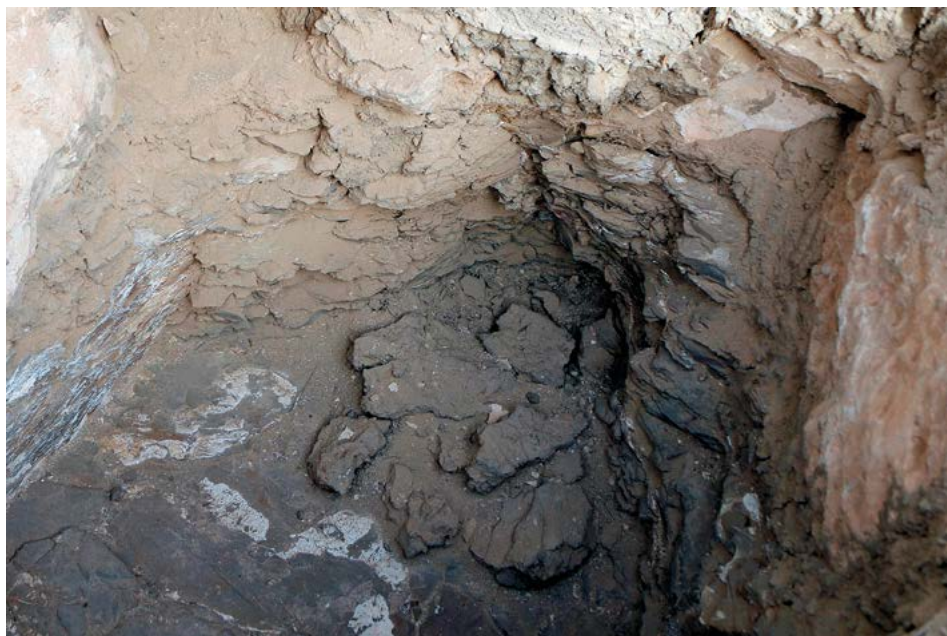
Fig. 13. View of the niche at the bottom of the southwestern pit, in its western side (IFAO/PCMA UW/ photo M. Caban)
