Naqlun 2016 Hermitage EE.50: preliminary report

Włodzimierz Godlewski

Polish Centre of Mediterranean Archaeology, University of Warsaw

Abstract: During the 2016 season in Naqlun, dedicated to an array of specialist studies of material in the storeroom, the team documented one of the hermitages located in the hills west of the monastic compound. The work was necessitated by evident illicit digging which had partly destroyed the compound. The hermitage, which occupied a small valley, appears to have comprised at least three living units, furnished with rock-cut storage pits in the floor and niches in the walls. The doorways and niches bore traces of architectural rendering. The complex may be interpreted tentatively as a residential and religious complex, and it is a good example of a mid-5th century hermitage, the dating confirmed by a study of the pottery assemblage coming from it.

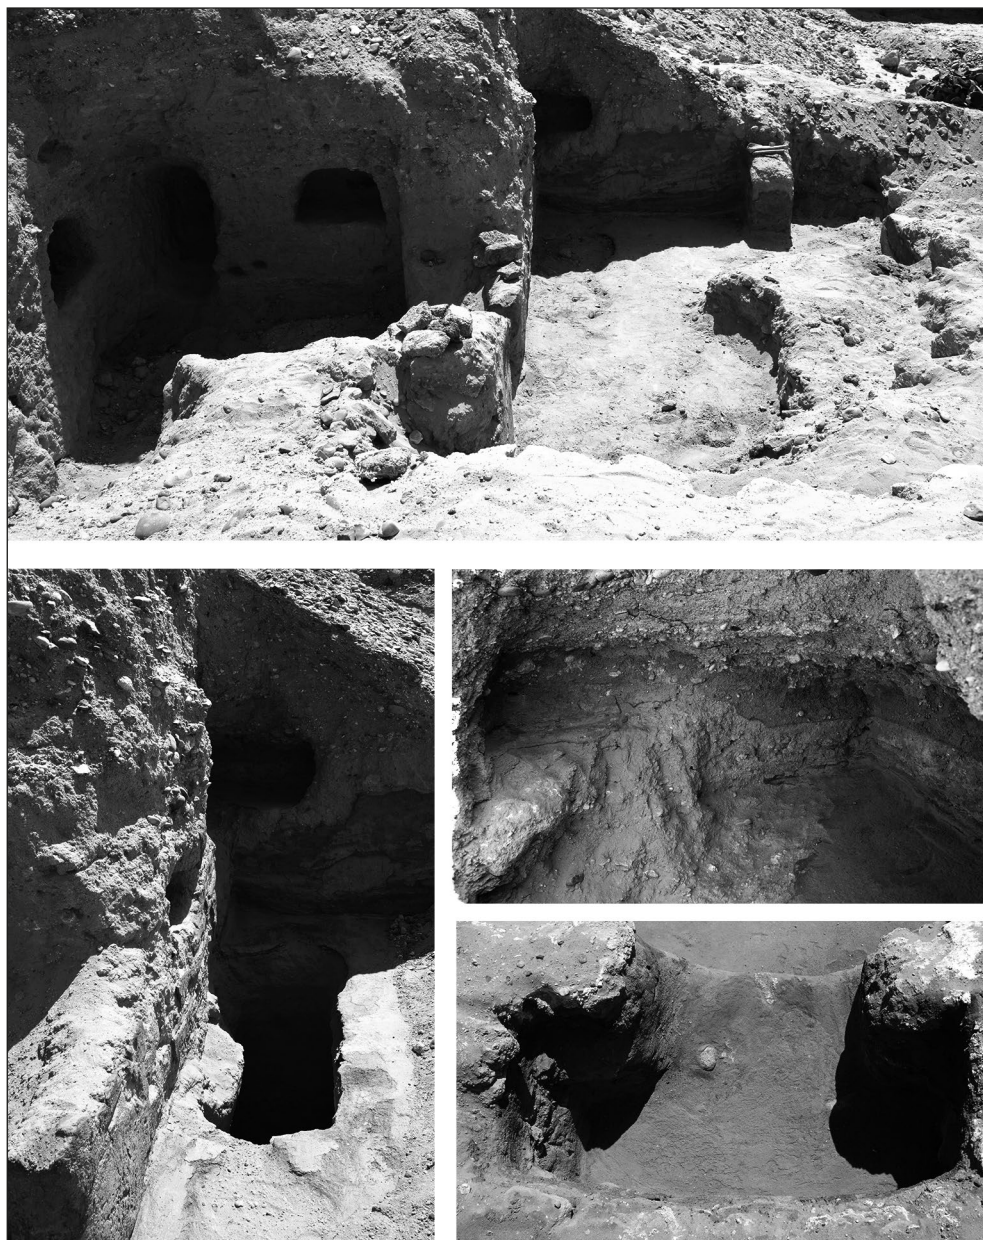
Fig. 3. Unit EE.50.1.1: above, view during the cleaning of the interior; seen from the north; left, detail with storage pit in the southeastern corner and large niche above it; right, two niches in the unit walls, above, niche in the south wall, below, niche in the north wall (PCMA Naqlun Project/photos W. Godlewski)

in the southwestern corner of the south wall [Fig. 3 above]. An engaged pillar, 0.45 m wide and 0.60 m long, formed the eastern side of this entrance. A niche was noted in the west wall by the doorway. It was 0.76 m wide and 0.18 m deep; a hollow in its floor, measuring 26 cm in diameter, had held a cooking pot, which was found broken. The niche apparently housed the door when it was open and the vessel may have been used as a door-block, but it may have served other purposes as well.

A long bench lined the west wall of the room. It was a mere 0.12 m high, but ran for 3.50 m and was 0.30 m wide. A storage pit cut into the floor occupied the southeastern corner of the unit [Fig. 3 left]. It was 0.62 m wide, 1.50 m long and no deeper than 1.70 m. A gravelly fill with rock debris contained fragments of the floor that had collapsed into the pit under the weight of the falling roof. The pit was not fully excavated, but the fill that was removed contained absolutely no finds, not even broken potsherds.

deep. The southern one was preserved fragmentarily; only its width could be determined and it measured 0.32 m. A third and much larger niche appeared on the south wall, in the southeastern corner and above the pit [Fig. 3 right above]. It was 0.80 m wide and 0.45 m high; its

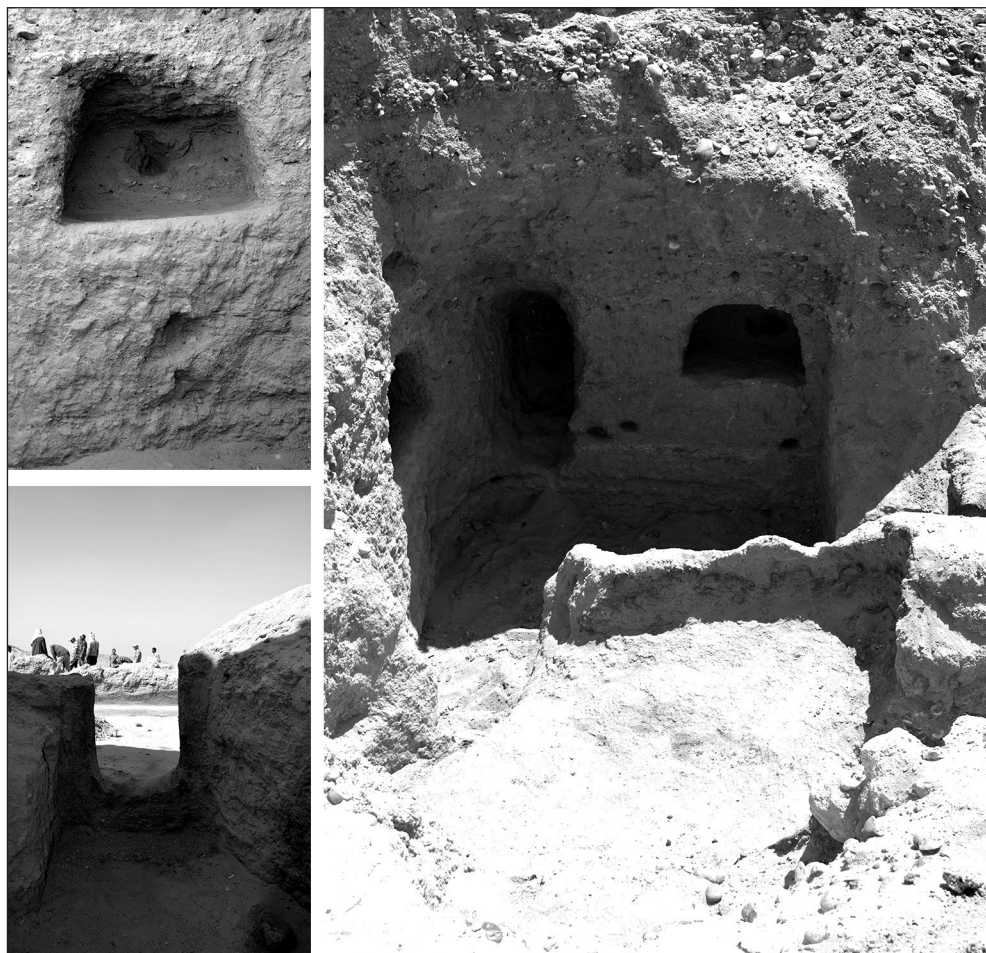
Fig. 4. Unit EE.50.1: right, sleeping cubicle EE.50.1.3 in the foreground, seen from the north, on the left doorway to room 50.1.2 which is in the background with the niche in the south wall and, to the left, of it in the photo, a cut made by recent pillagers; top left, niches cut in the east wall; bottom left, doorway between rooms 50.1.2 and 50.1.1, seen from inside (PCMA Naqlun Project/photos W. Godlewski)

An entrance in the central part of the east wall led to the second room. It was just 0.44 m wide and it was placed 2.80 m from the southeastern corner. It broadened on the inside, forming jambs 0.15 m wide and 0.12–0.14 m thick. These were rendered with a mud plaster [Fig. 4 bottom left], unlike the rest of the walls of the room.

Room EE.50.1.2 was small: 1.90 m by 2.60 m, actually 2.20 m with two niches, one by the entrance, measuring 0.75–0.95 m, and the other in the northeastern corner, measuring 0.84 m by 0.84 m. The entrance to the latter was framed with vertical bands of white lime plaster, of which very meager evidence remained [see Fig. 4 top left]. The niche in the east wall had the bottom 0.76 m wide, cut 0.60 m deep into the rock and was 0.50 m high, starting at a level 0.90 m above the floor. The one in the south wall started at 0.95 m above the floor and had similar dimensions (just 2 cm less on the height). The walking level inside the room was lower than in 50.1.1 and there was no preserved mud floor here.

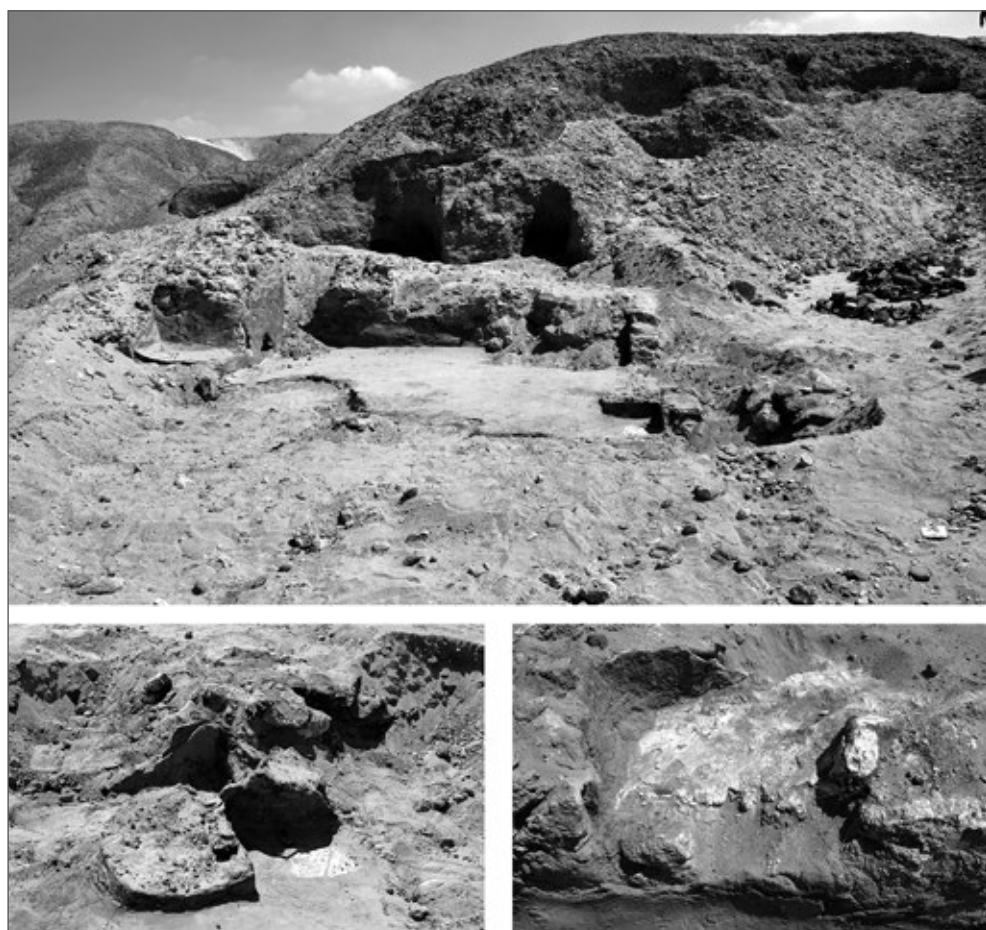
Fig. 5. Unit EE.50.2: top, view from the west; bottom left, jamb and entrance to EE.50.2.1; bottom right, remains of a niche in the east wall (PCMA Naqlun Project/photos W. Godlewski)

Room EE.50.2.1 was a large hall, 4.35 m by 3.60 m, measuring by the remains of the floor and a fragment of a bench by the east wall. Otherwise, the east wall and the northeastern corner of the room have been destroyed. The evidence for the entrance is also poor, merely a jamb in the south wall measuring 0.47 m by 0.46 m. The niche in which the entrance was situated was 0.60 m wide. The bench by the east wall presumably extended the whole length of this wall; the surviving fragment is 0.30 m wide and 0.15 m high. The walls were preserved quite low, but enough to show the remains of a niche in the northwestern corner, 0.87 m deep and at least 0.60 m wide. The bottom of another niche could be observed in the east wall, some 1.40 m from the northeastern corner. It had a lateral hollow that made the interior of the niche at least 1 m wide (with the opening being 0.63 m); the niche was 0.70 m deep [Fig. 5].

The unit consisted of three or four rooms in a row, opening one from the other, tentatively connected with room EE.50.2.1 described above [Fig. 5]. It is now entered

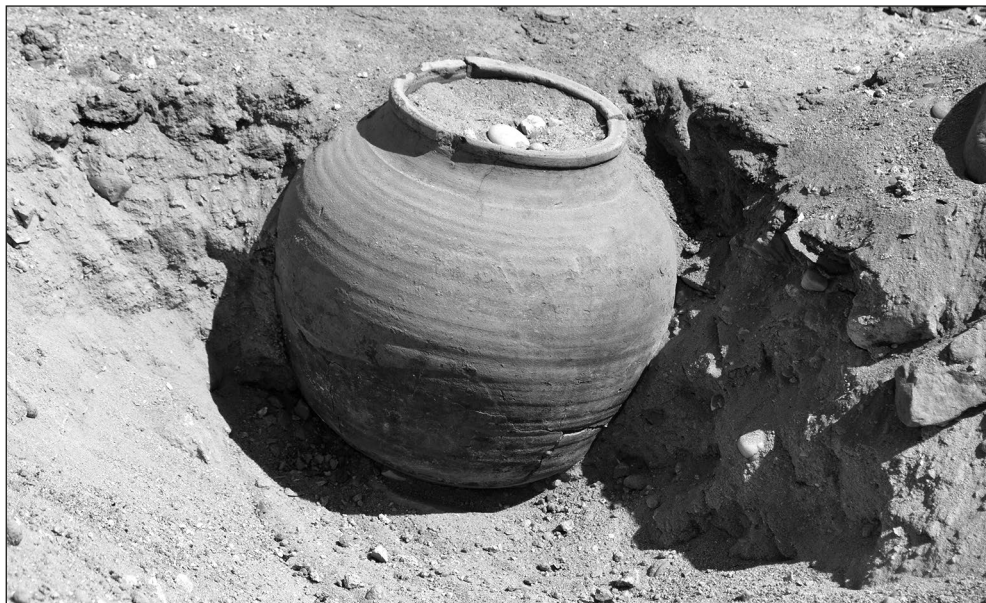
*Fig. 6. Cooking pot sunk into the floor of room EE.50.3.4
(PCMA Naqlun Project/photo W. Godlewski)*

next to room EE.50.2.1. A mud floor survives with a large thick-walled cooking pot sunk into it in its reserved western end [*Fig. 6*]. The raised edges of this floor on the eastern and southern edge are the sole survivors of the lost walls of this room.

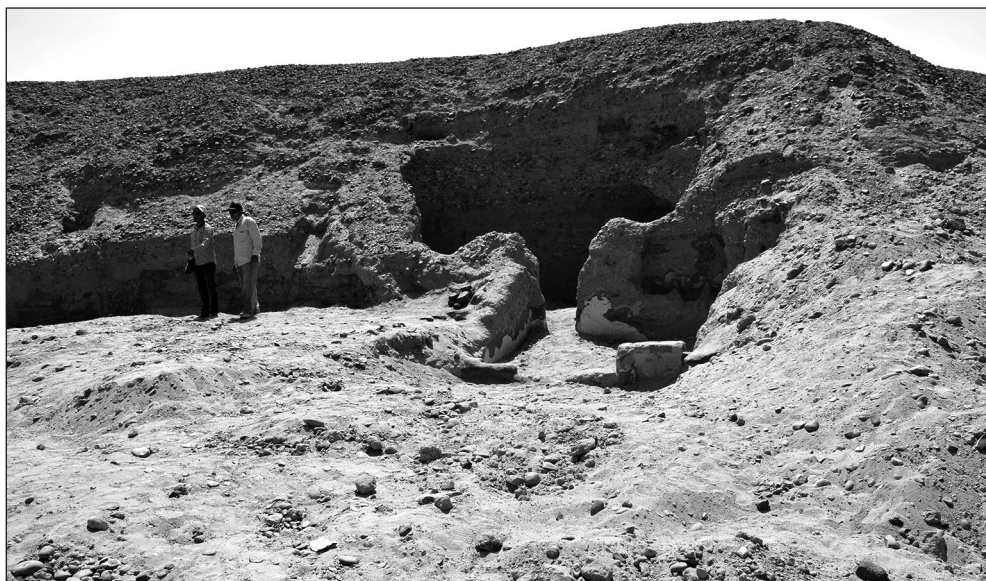
*Fig. 7. Unit EE.50.3: Rooms 50.3.1–2, view from the north
(PCMA Naqlun Project/photo W. Godlewski)*

through a small trapezoidal room measuring 3.50 m by 5.05–4.45 m, preserving stubs of walls up to the ceiling only in the southern part [Fig. 7]. The walls were not rendered with plaster and there were no niches (the robbers had attempted to cut a hole in the west wall). The walking level here was not reached at this time.

3.00 m by 3.10 m. The walls were also badly destroyed, the highest point being in the southwestern corner [see *Fig. 7*]. Two niches were cut in the walls, close together in the southwestern corner; the tops of these niches have not survived. The niche in the south wall had the bottom 1.20 m wide by 0.40 m deep; three circular hollows were cut in a row inside these two niches (although whether they were part of the original design is not clear). The niche in the west wall measured 0.86 m by 0.66 m on the level of the bottom. It was at least 0.98 m high and may have been topped with a conch.

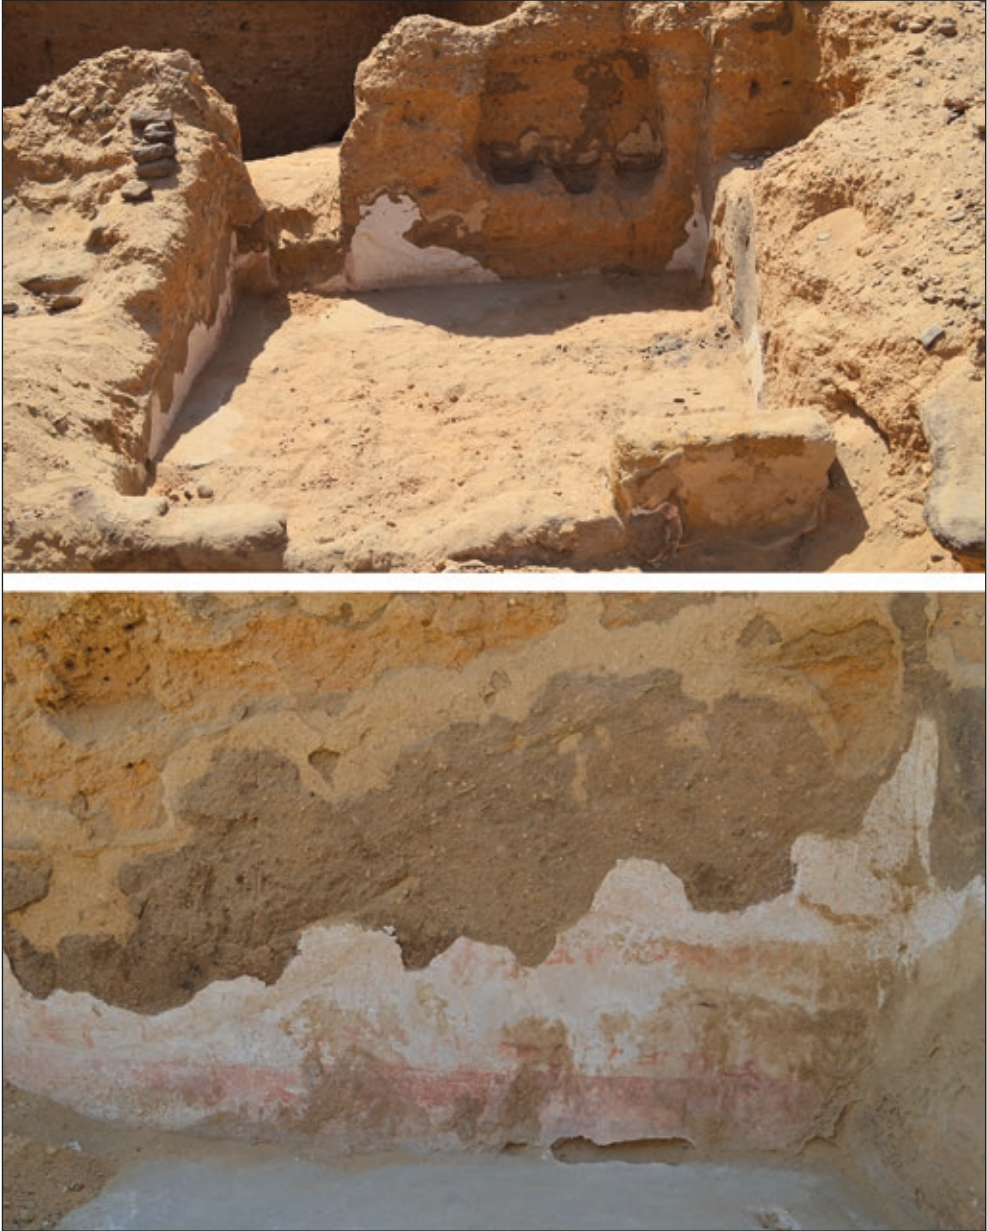
Fig. 8. EE.50.3.2: top, view of the room toward the entrance in the south wall, note patch of lime plaster preserved just above the floor next to the entrance and niche with three circular hollows in its floor; bottom, remains of lime plaster with a painted inscription on the east wall (PCMA Naqlun Project/photos W. Godlewski)

A wide entrance gave from the north; it was 1.15 m wide and had rounded pillars finishing off the sides. The western one was 0.20 m wide and 0.15 m long. The entrance wall was 0.20–0.25 m thick, the one on the west 0.47 m to the pilaster, the one on the east 0.55 m. Mud bricks were used in the construction. The floor had a much worn surface of white lime mortar. A coat of white lime plaster covered the mud-and-sand rendering of the walls of the room and the inside of the niches. There were red bands painted just above the floor, presumably on all the walls and framing the door in the south wall, which led to the next room. An inscription painted in red, in large letters and with much interlinear space, can be seen on the east wall; its state of preservation and salt efflorescence on the surface make it difficult to decipher.
