DEIR EL-BAHARI TEMPLE OF TUTHMOSIS III, CAMPAIGNS 2012–2013

Monika Dolińska

Abstract: In 2012 and 2013 the mission continued research and documentation work, concentrating on scenes located in the Hypostyle Hall, the Bark Room, and rooms D, G and H. Dozens of painted stone fragments were cleaned and protected. Photoscanning techniques were used to improve detailed rendering of the temple. New photomontages were produced and subsequent walls were drawn, joining previously separate scenes.

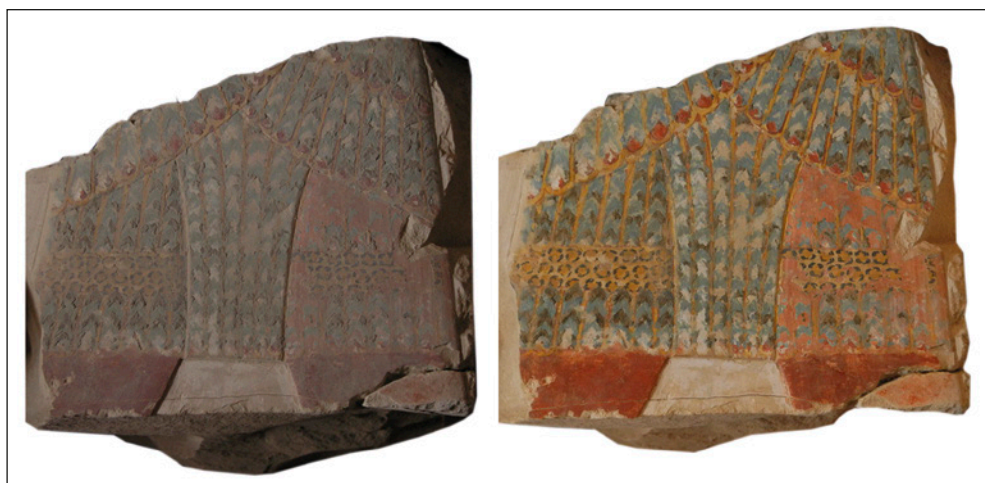
Fig. 1. Fragment of a royal feather dress, before (left) and after cleaning (Photos M. Szewczyk, M. Dolińska)

Lacking two conservators to handle blocks, the one restorer present, a specialist in painting restoration, concentrated on securing the polychrome layer on endangered and/or especially valuable fragments [*Fig. 1*]. The painted surface of blocks is constantly abraded by sand particles present in the current, less than perfect storage conditions, causing a fa-

ding of the original intensity of colors. Fragments that had suffered in the catastrophic rainstorm of 1994 were also in need of attention, having salt efflorescence come heavily to the surface. Although restoring the original condition is usually not possible, consolidation of the stone and paint layer is of utmost necessity. In 2013 the most endangered stone surfaces were protected, many more were cleaned and hardened, and storage conditions were improved (special shelves and linen covers) to prevent further deterioration.

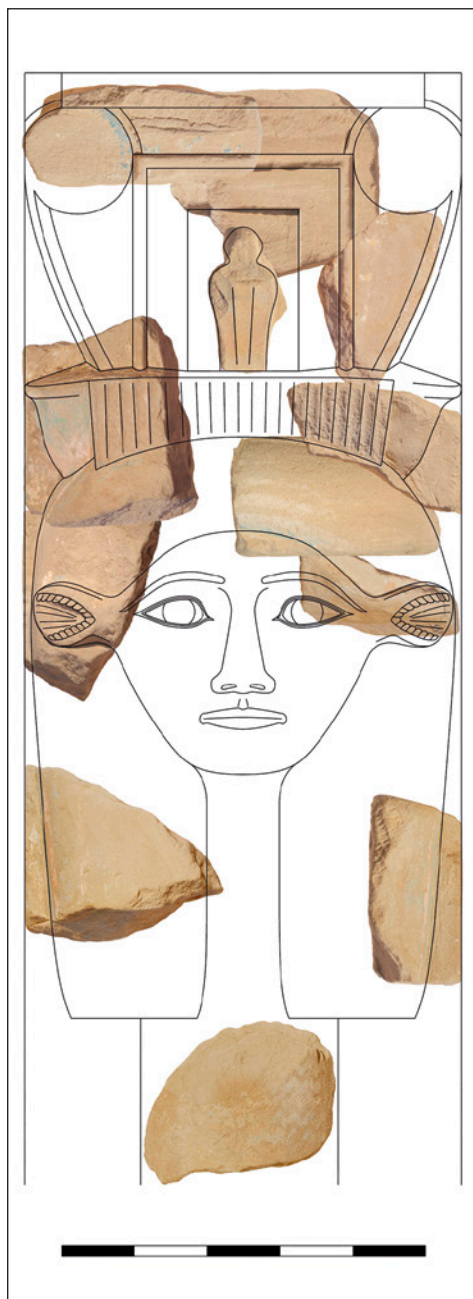
Fig. 4. Reconstruction of a Hathor capital
(Photoscanning and drawing M. Caban)

Photoscanning techniques were applied to restore the Hathor capital based on just a few preserved fragments [Fig. 4]. The naos of the capital turned out to have only one uraeus, instead of the two seen in the neighboring Hatshepsut temple. It is likely that only two pilasters with Hathor capitals existed, completed perhaps by two columns.

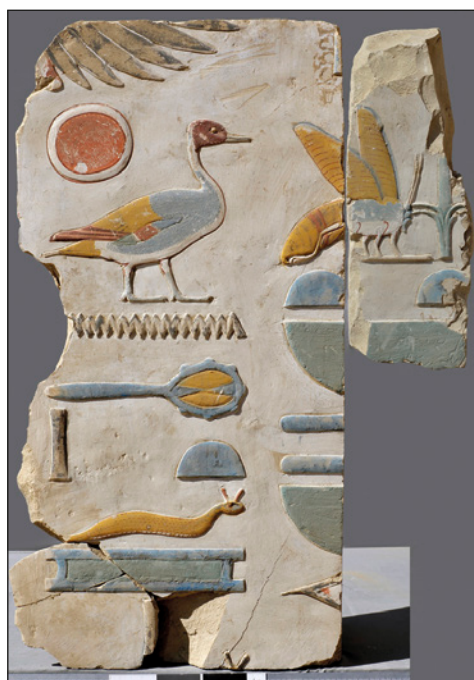
Fig. 5. Joining fragments with royal titles from room G, South Wall (Photo and photomontage Z. Doliński)

The preparation of a corpus of photographic documentation has also progressed methodically, especially with regard to fragments of scenes to be used in photomontages as well as joining pieces not photographed previously [Fig. 5]. Some complete blocks stored in the rear chamber of the storeroom will have to be rephotographed in the future once proper access has been ensured.

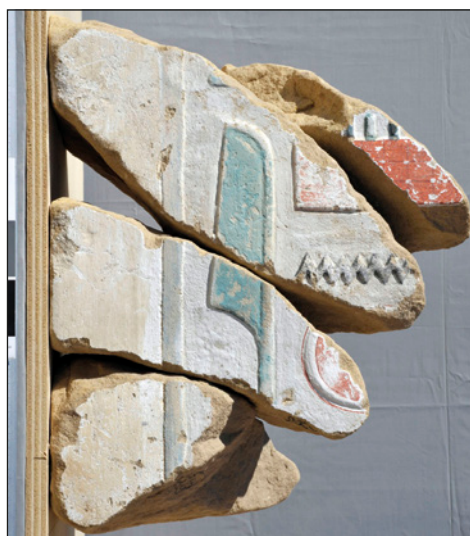
Fig. 6. Fragment cut-away from the entrance to the Bark Room, with the unerased name of Amun (Photo Z. Doliński)

and the remaining fragmentarily preserved rooms. Wiercińska recently identified new evidence concerning the widening of the door between the Hypostyle Hall and the Bark Room — fragments of cut away doorjambs with royal titles [Fig. 6]. Some very fragmentary scenes in the Offering Table Room were also newly located.

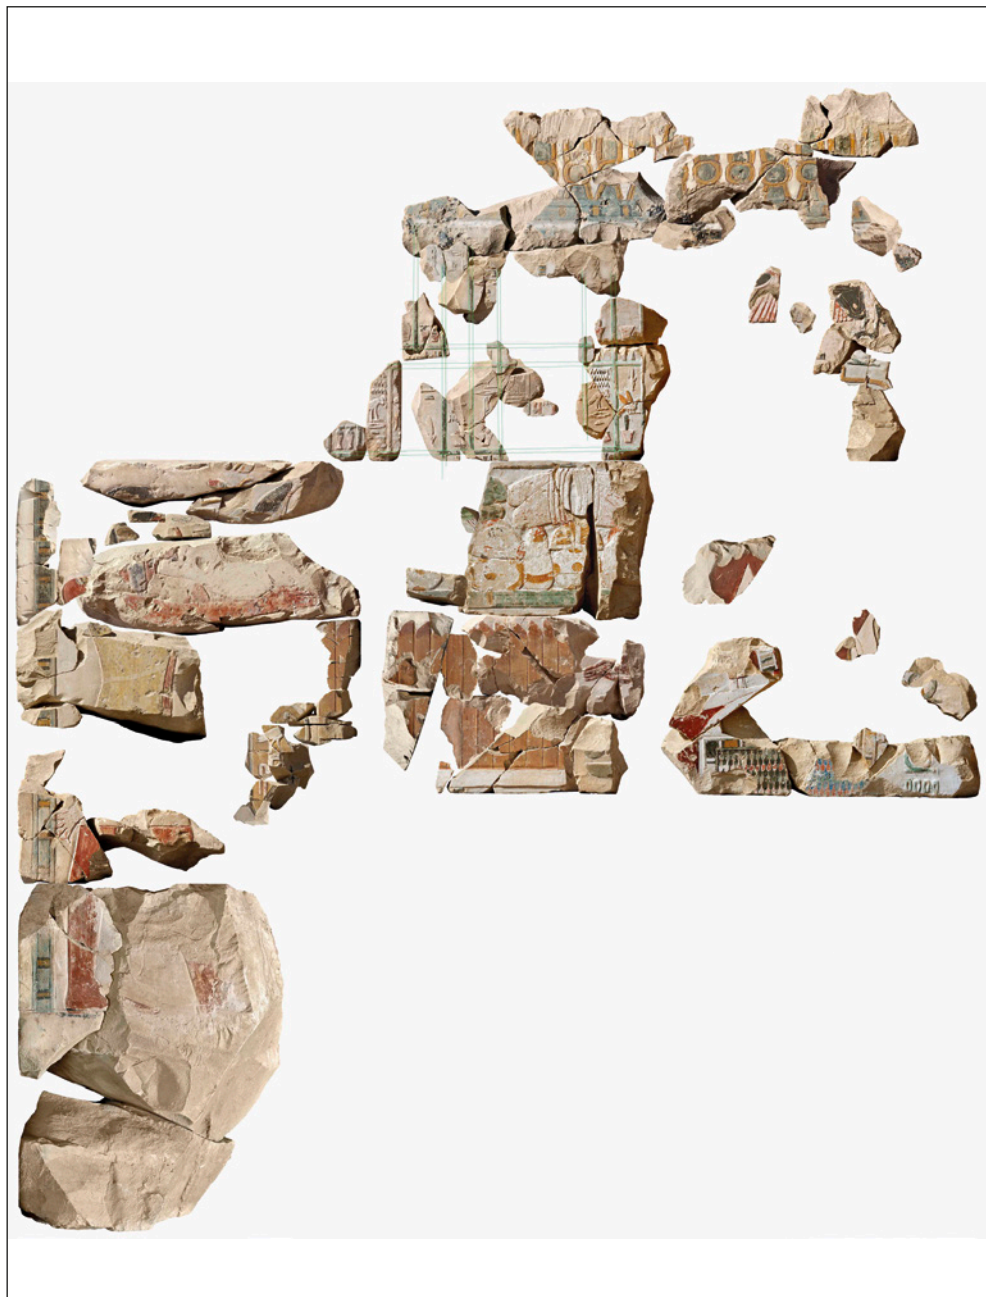
*Fig. 7. Reconstruction of the left wall of the niche
(Photo and photomontage Z. Doliński)*

Several new photomontages were assembled, including the left wall of the niche in room D [Fig. 7], a figure of the king seated on a throne in a royal bark from the East Wall of the Hypostyle Hall and a part of the South Wall in room D with

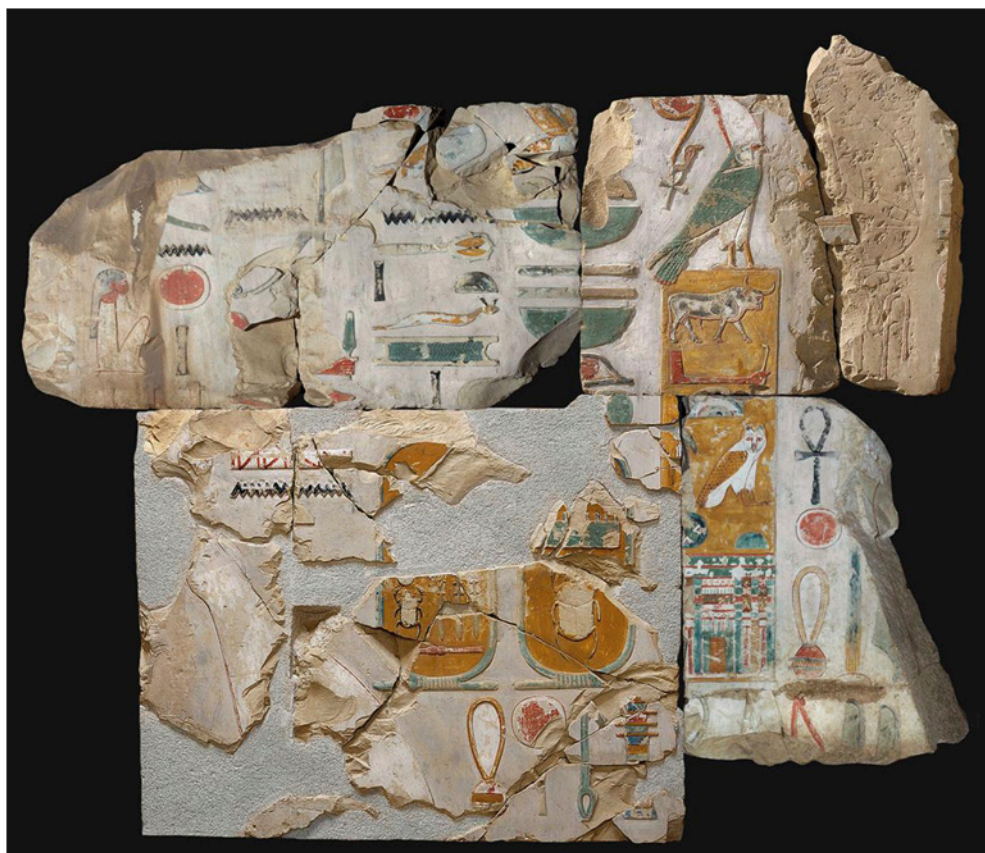
*Fig. 8. Royal titles in room D, South Wall
(Photo and photomontage Z. Doliński)*

the royal titles [Fig. 8]. The photomontage of a figure of the king with royal *ka* from the same scene is in preparation.
