Wessel de Jonge*

Concrete heritage in the Netherlands. Valuation and conservation of concrete and reinforced concrete structures

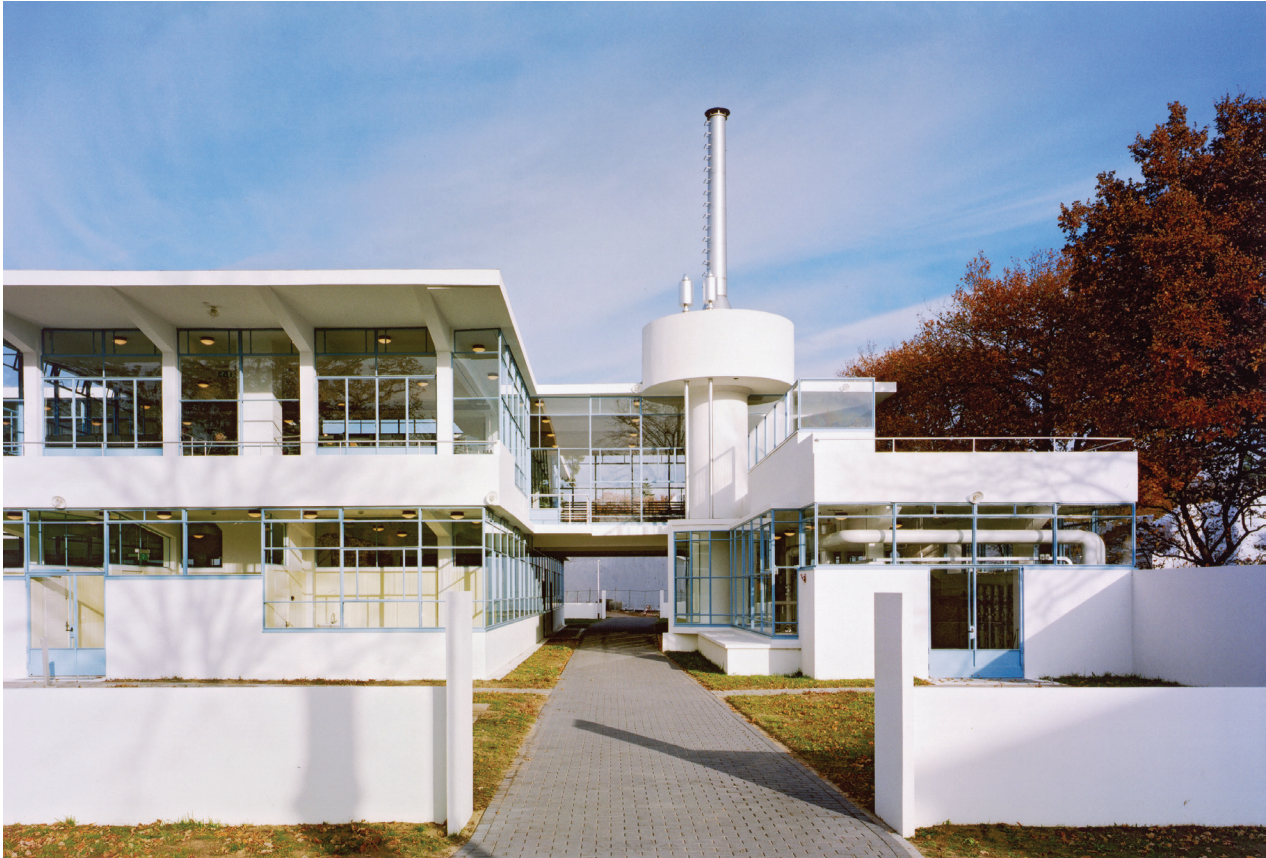
Fig. 1. “Zonnestraal” sanatorium, main building (1928) after restoration in 2003. View through one of the driveways that were restored (photo: © M. Kievits/S. Voeten, 2003, WDJArchitecten Archives)

In his publication *Hoogbouw*, or *High rise construction*, the Dutch Modern Movement architect Jan Duiker (1890–1935) argued in 1930: *It is required, through clear calculation of loads on to beams, on to supporting columns, and on to the fully loaded foundation piles, to try the most economical solution, which, at the same time, will be the lightest. Cantilevered constructions will reduce the static moments considerably, and reduce the intervals of supports* [4, p. 33]. This way, the load bearing structure is reduced to floor slabs with beams on minimal bearings, which is convincingly demonstrated by the slender concrete structural frame of Duiker’s “Zonnestraal” sanatorium of 1928 (Fig. 1).

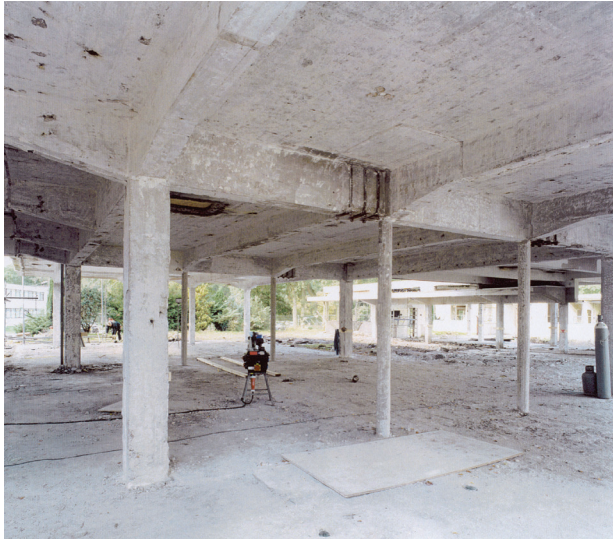
Fig. 2. "Zonnestraal" sanatorium, main building (1928), ground floor during the restoration works.

The render and plaster finishes have been blasted off revealing the slenderness of the actual reinforced concrete structure. The metal brackets involve a repair that dates to the time of construction (photo: © WDJArchitecten, around 2002)

Similar to the ancient Greek masters who modelled their natural stone structures according to traditional timber buildings, the design of early reinforced concrete constructions was borrowed from common building technologies in timber and cast iron. Also, the famed Hennebique system⁴ was based on the use of columns and a structural grid of primary and secondary beams to support the floor slabs. In contrast to timber and iron structures however, Hennebique’s system involved a monolithic structure. Next to the Monnier system, Hennebique’s was one of the most widespread structural systems in reinforced concrete, and it has often been used in the Netherlands. The reinforced concrete frame of the former sanatorium “Zonnestraal” for instance, has a similar structure of main beams and lighter secondary beams (Fig. 2).

For the restoration contract we decided to have all concrete surfaces blasted as very little of the original plaster remained (Fig. 2). The concrete was then repaired in the classic way with epoxy-based repair products. The presence of a layer of plaster in the original state appeared to be an advantage as it could be replaced by shotcrete to obtain sufficient strength and as an additional alkaline cover on the reinforcement of the concrete itself. By applying a thin film of plaster of a composition similar to the original, the appearance and the dimensions of the concrete work are virtually identical to the original. In practice, the shotcrete application appeared to be technically required only locally.

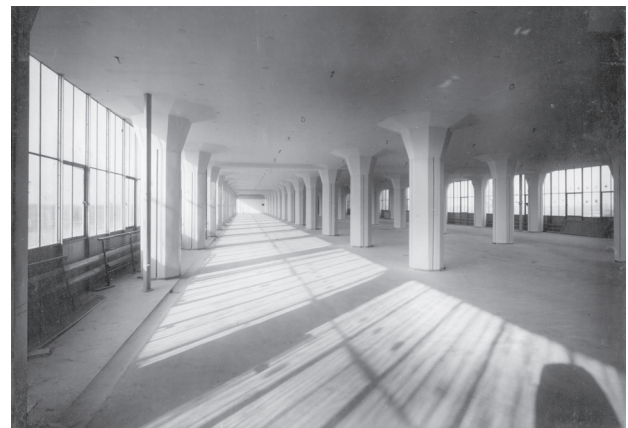
Fig. 4. The Van Nelle Factory interior shortly before completion in 1928. The octagonal mushroom-head columns allowed for the use of floorslabs without beams. The flush ceilings benefit daylight conditions.

The columns feature metal rails on four sides for the fixing of production equipment (photo: J. Kamman, Historisch Archief de Wed. J. van Nelle, Stadsarchief Rotterdam)

simultaneously with his structural design for the sanatorium buildings (Figs. 3, 4). Thanks to the absence of floor beams, half a meter of construction height was saved from each floor, thereby reducing the height of the building by 3.50 m. The reduction of the façade surface, and also of the

Instead, at the factory, where changes in production lines were expected to be particularly frequent, all columns feature metal rails at four sides, allowing the easy fixing and later repositioning of machinery and conveyor belts with track bolts (Fig. 4). To the same end, a grid of metal dowels was embedded in the floor slabs at regular intervals. With the introduction of the electric power tools like drill hammers – around 1923 in the US and five years later in Europe – this became much easier, but the Van Nelle buildings were largely completed by then¹³.

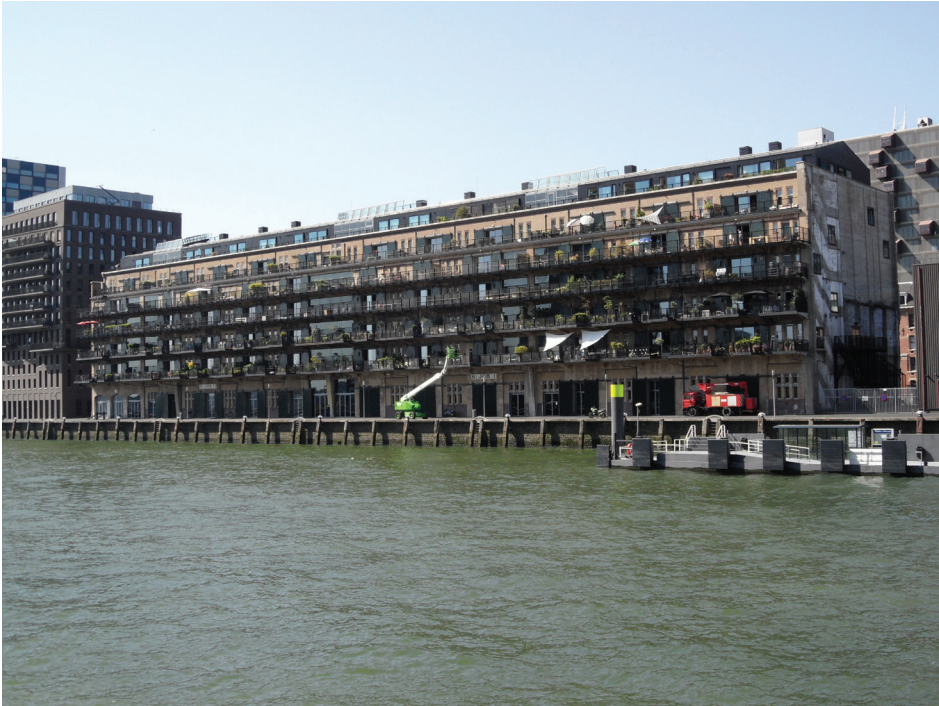
Fig. 6. The St. Jobsveem warehouse (1914) in the Rotterdam docklands after conversion into a condominium with 109 apartments in 2007. Due to the ample loadbearing capacity of the huge reinforced concrete loading platforms these could be transformed into hanging gardens.

The same may be true when concrete is covered with other materials like render and plaster. In eclectic buildings we often find plastered surfaces that are dressed so as to remind natural stone – which was rare and therefore expensive in the Netherlands. A case in point may be the Sint Jobsveem, a 1914 warehouse in the Rotterdam docklands, which was converted into apartments in 2007¹⁴ (Figs. 6, 7).

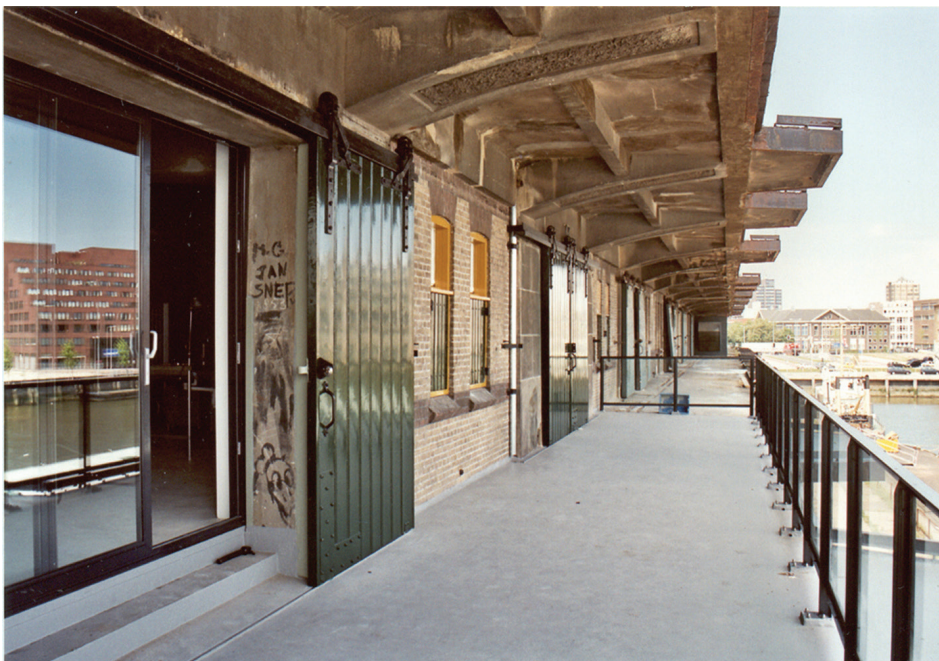
Fig. 7. Former St. Jobsveem warehouse. The installment of a model apartment included trial repairs of the concrete decks that were to serve as terraces. The underside of the platform above still shows the damage to the plaster finish that was originally dressed to mimic natural stone

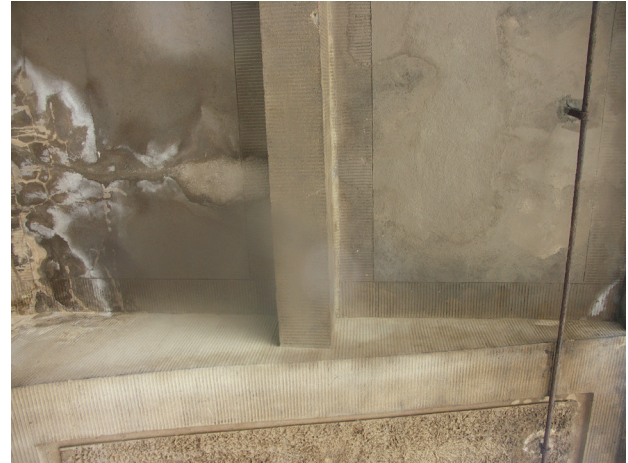
Fig. 9. Former St. Jobsveem warehouse.

A similar area after concrete repair and partial restoration of the dressed plaster finishes, including the combed finish of the secondary beams and around the smoothly finished ceiling. The colour is touched up with a stain (photo: © M. van Hunen, 2006, WDJArchitecten Archives)

For the plaster finish special mortars have been composed by Remmers Building Chemicals, toned with various pigments into a palette for repair on the spot. Finding the right colour for the mortar was a minor challenge as compared to the choice of the proper aggregates and the proportion between them, which required several series of trials. On the basis of the results, a small palette of repair mortars has been selected, in slightly different shades, allowing the craftsmen on the scaffolding to select a tone from spot to spot, depending on the adjacent material. The 1914 combs have been remade in order to give the renewed patches the same surface texture (Fig. 9).

Eventually, we could convince the client that a more restorative approach would be a better choice. The major part of the plaster finishes has been retained and repaired with the same type of repair mortars as elsewhere. The differences in colour and brilliance between old and new have been touched up with a stain, Keim Restaura Lazur, that has been toned with a dash of pigment (Fig. 9).

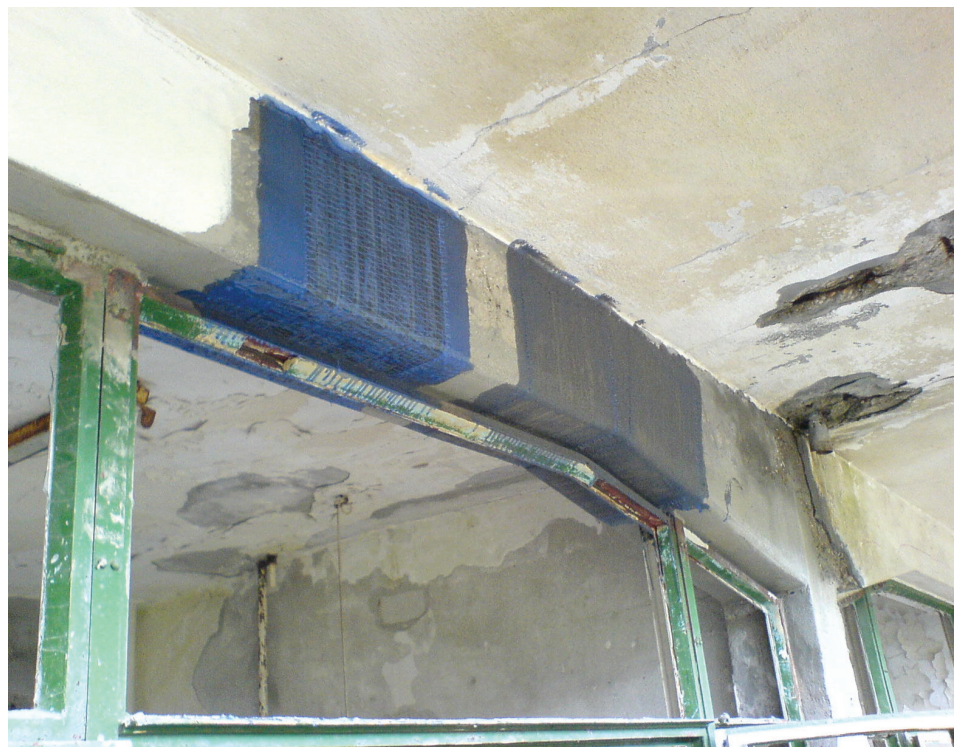
Fig. 10. Sample tests of strengthening the bearings of the longitudinal beams with carbon fabric, after removal of the render and plaster finishes. The method proved effective but could not resolve the lack of load-bearing capacity of the columns themselves (photo: © WDJArchitecten, 2006)

In order to master the static problems with the beams, we have tested the use of “Carbon Shear”, a thin carbon-fibre fabric, that was attached to the sides of the beams after removal of the plaster. It worked well, although it appeared rather expensive. Again, the original layers of render and plaster were helpful, as it allowed to conceal the carbon fabric later within the replacement finish (Fig. 10).

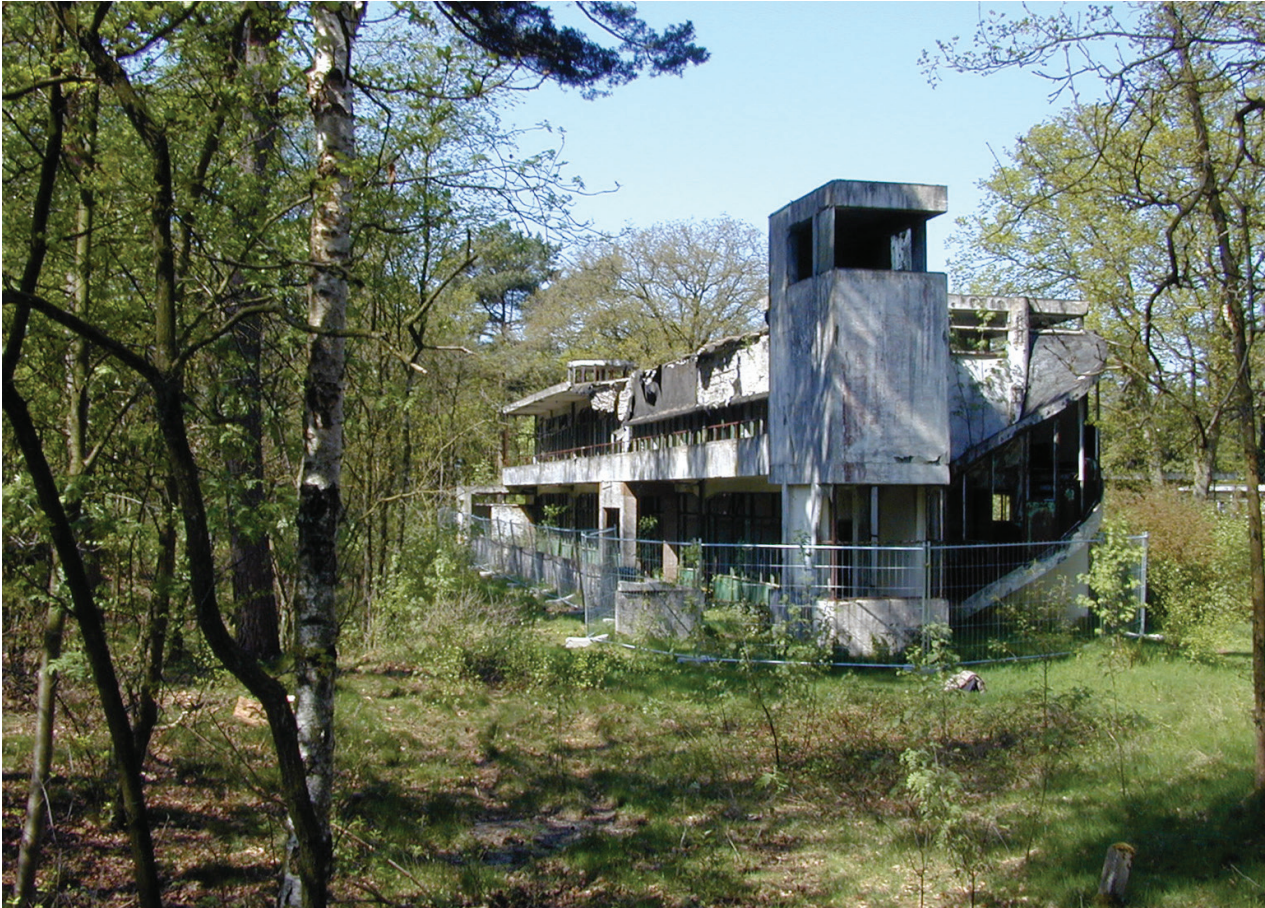
Fig. 11. „Zonnestraal”, Dresselhuys Pavilion (1931) after the collapse of the chloride-infused reinforced concrete roof slab. The exterior restoration of this structure was completed in 2013 (photo: © R. Wielinga, 2001, WDJArchitecten Archives)

Still, in addition, the worst columns had to be completely replaced, as were all the balconies and the roof slab, which showed persistent damage of pit corrosion as a result
