Małgorzata Rozbicka, Robert Kunkel, Wojciech Wólkowski

Dzieje budowlane warszawskiego pałacu Adama Kazanowskiego w świetle badań architektonicznych¹

Construction history of the Adam Kazanowski palace in Warsaw in the light of architectural research¹

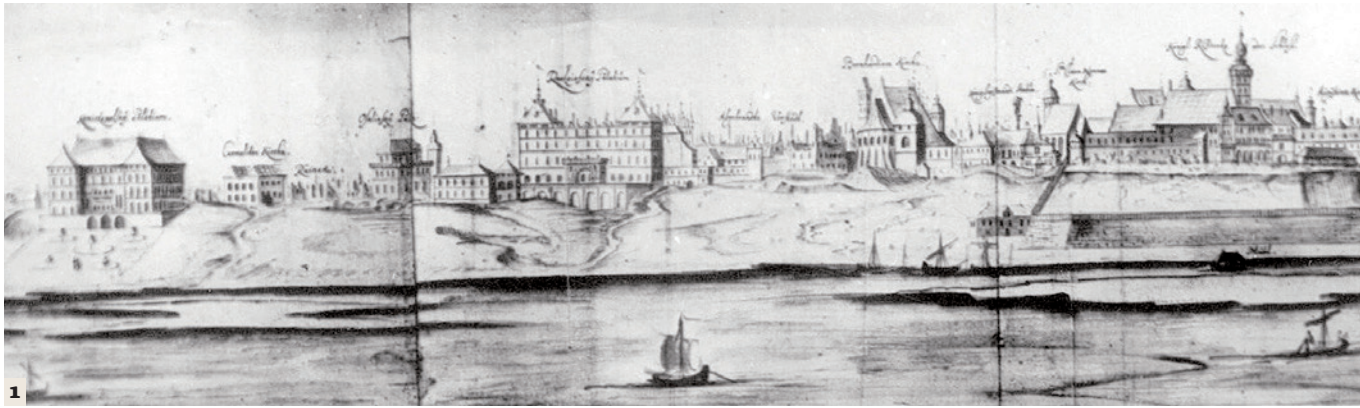
1. Fragment panoramy Warszawy z dawnym pałacem Adama Kazanowskiego wykonanej przez Erika Dahlberga w roku 1656

1. Fragment of the panorama of the city of Warsaw with the former palace of Adam Kazanowski, drawn by Erik Dahlberg in 1656

elewację pałacu od strony Wisły, wykonana na podstawie panoramy Warszawy narysowanej przez Erika Dahlberga w roku 1656, a wyrytowanej (i nie ukrywajmy – upiększonej) przez Nikolasa Perelle’a do księgi Puffendorffa (il. 1).

The aforementioned two literary descriptions have been – and still are – the only starting point for all authors who wrote about the palace in subsequent years, with the first among the works dedicated to this subject having been written by Aleksander Wejnert, published in 1848 in *The Antiquities of Warsaw*, volume 2. This article was accompanied by a rather fantastic drawing showing an imaginary façade of the palace facing the Vistula river, made on the basis of the panorama of Warsaw drawn by Erik Dahlberg back in 1656 and then engraved by Nicolas Perelle, who also did not shy away from enhancing the overall aesthetic appearance of the city, with the final result being published in Puffendorff’s book (fig. 1).

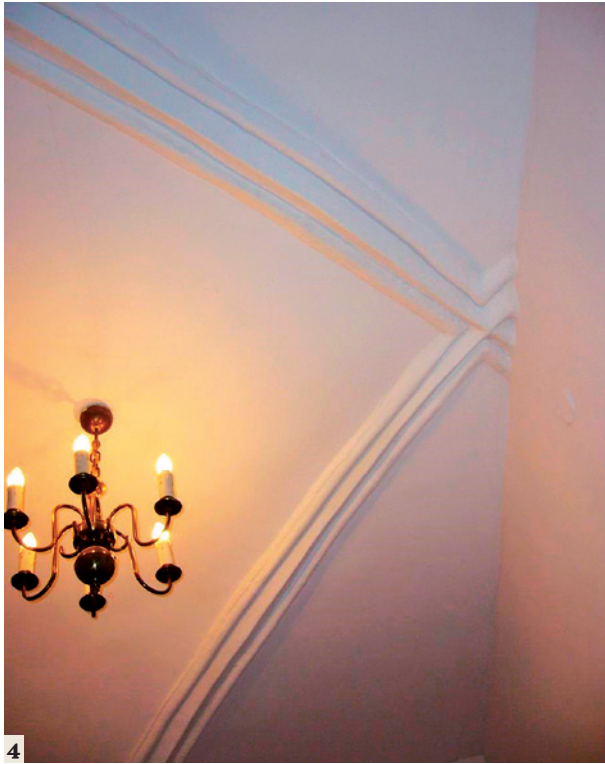
4. Zachowany fragment sklepienia z dawnego dworu Bobolich. Fot. M. Rozbicka

4. Preserved fragment of the vaulted ceiling inside the former Bobola manor house. Photo by M. Rozbicka

cztery przęsła krzyżowych sklepień podzielone potężnymi gurtami (il. 3). Sala ta, mimo pocięcia jej na mniejsze pomieszczenia ściankami działowymi, zachowała się w całości do dziś. Kolejna kondygnacja – dzisiejszy parter, również przekryta pierwotnie czterema kwadratowymi sklepieniami krzyżowymi, podzielona była jednak ścianami, prawdopodobnie na trzy pomieszczenia – sień i dwie izby. Zachowały się jedynie dwa z czterech przęseł, północno-wschodnie i południowo-wschodnie, z czego tylko w tym drugim uchowały się partie profilowanych żeber (il. 4).

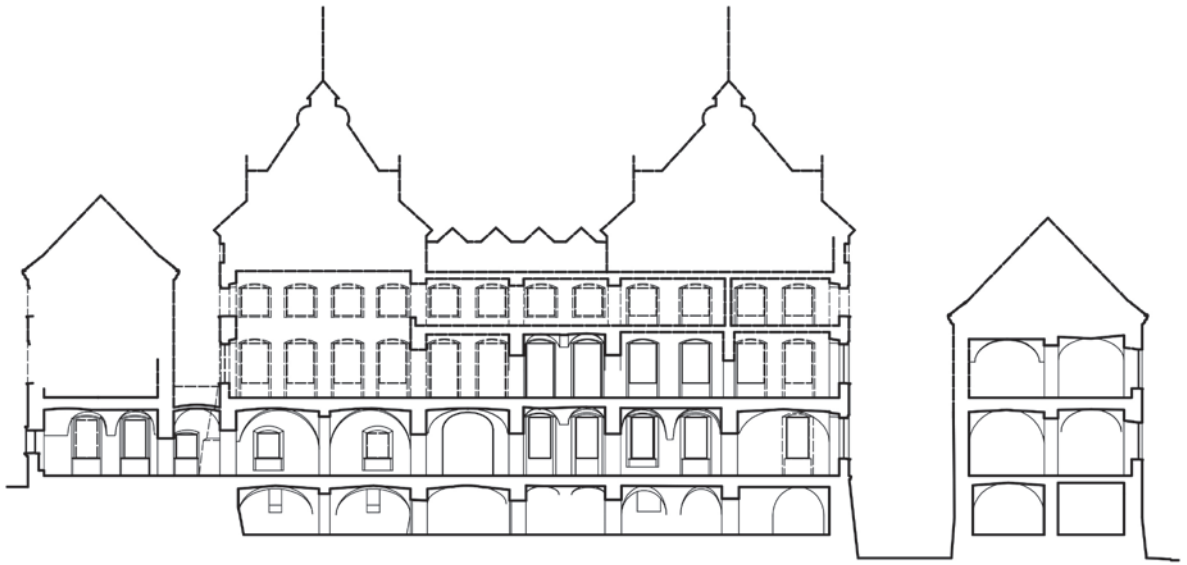
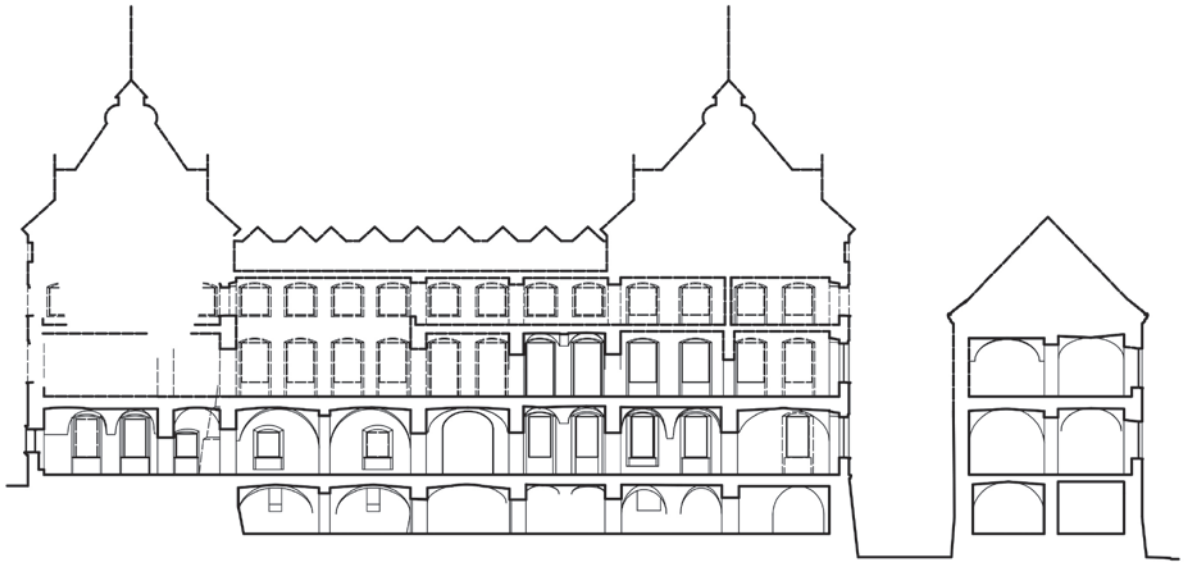
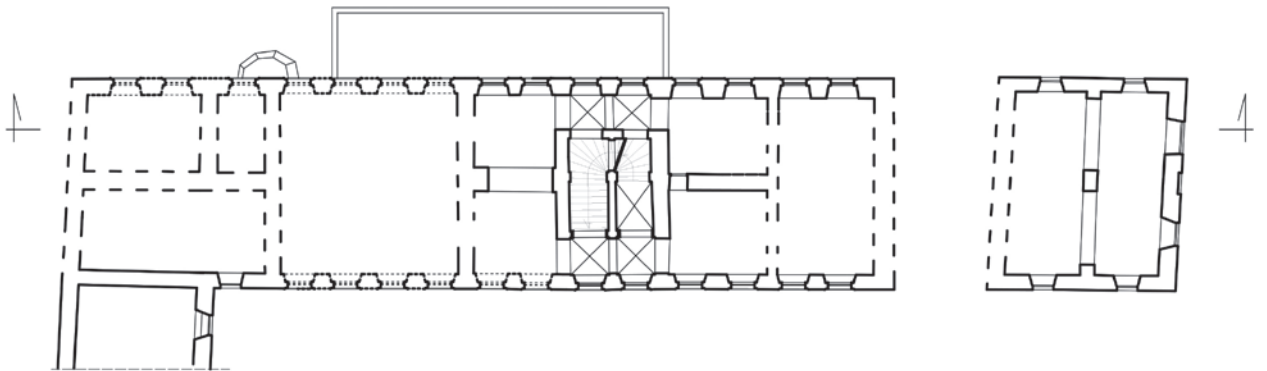
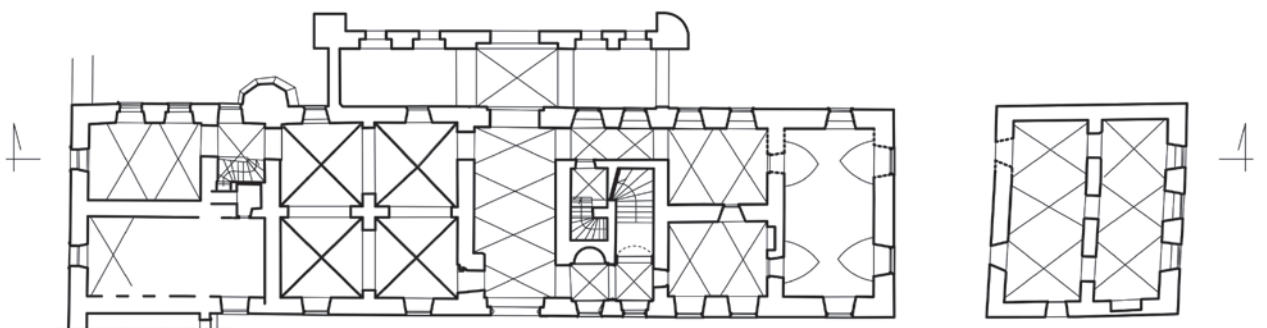
5

5. Hypothetical projections and cross-sections of the former Adam Kazanowski palace with the main wing reaching towards the northern boundary of the site (above) and with the main wing reaching towards the northern wall of the former Bobola manor house (below). Worked out by M. Rozbicka, R. Kunkel, W. Wólkowski

Nie do końca jasna pozostaje kwestia zasięgu głównego skrzydła pałacu od strony północnej. Układ przestrzenny północno-wschodniego narożnika zespołu z 1. połowy XVII wieku został bowiem skutecznie zartarty późniejszymi przebudowami dokonanymi przez siostry karmelitanki i Towarzystwo Dobroczynności. Mogło ono bowiem kończyć się na północnej ścianie dawnego dworu Bobolich, na co wskazywałby zasięg piwnic obiektu, lub dochodzić do narożnika posesji, co sugerowałaby historyczna ikonografia. Na panoramie Powiśla widzianego z Zamku Królewskiego namalowanej przez Canaletta w roku 1773 na północnej ścianie klasztoru karmelitańskiego wyraźnie widoczne są relikty starszej fasady zapewne głównego korpusu lub, co jest mniej prawdopodobne, jego północnej oficyny (relikty te usunięto niestety po 1945 roku wraz z likwidacją oficyny Resursy Obywatelskiej i przebudową dachu skrzydła północnego i wschodniego) (il. 5).

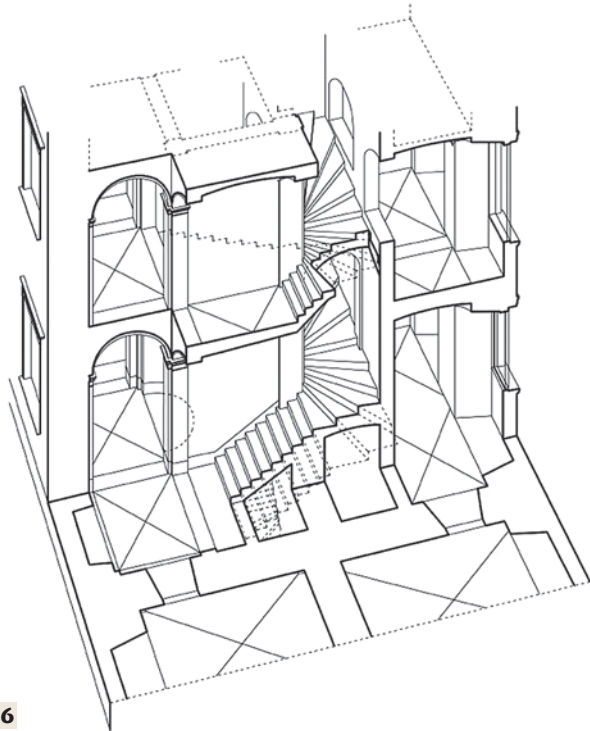
6. Hipotetyczna rekonstrukcja głównej klatki schodowej pałacu – perspektywa przekrojowa. Oprac. M. Rozbicka, R. Kunkel, W. Wólkowski

6. Hypothetical reconstruction of the main staircase of the palace – cross-section view. Worked out by M. Rozbicka, R. Kunkel, W. Wólkowski

te schody, wiodące z piwnic aż po *mezzanino*, zostały przez Jarzemskiego opisane jako „ślimak”. Klatka schodowa dekorowana była tokańskimi pilastrami. Pod biegiem schodów wiodących na piętro wykonano od strony sieni okazałą niszę, zapewne na posąg.

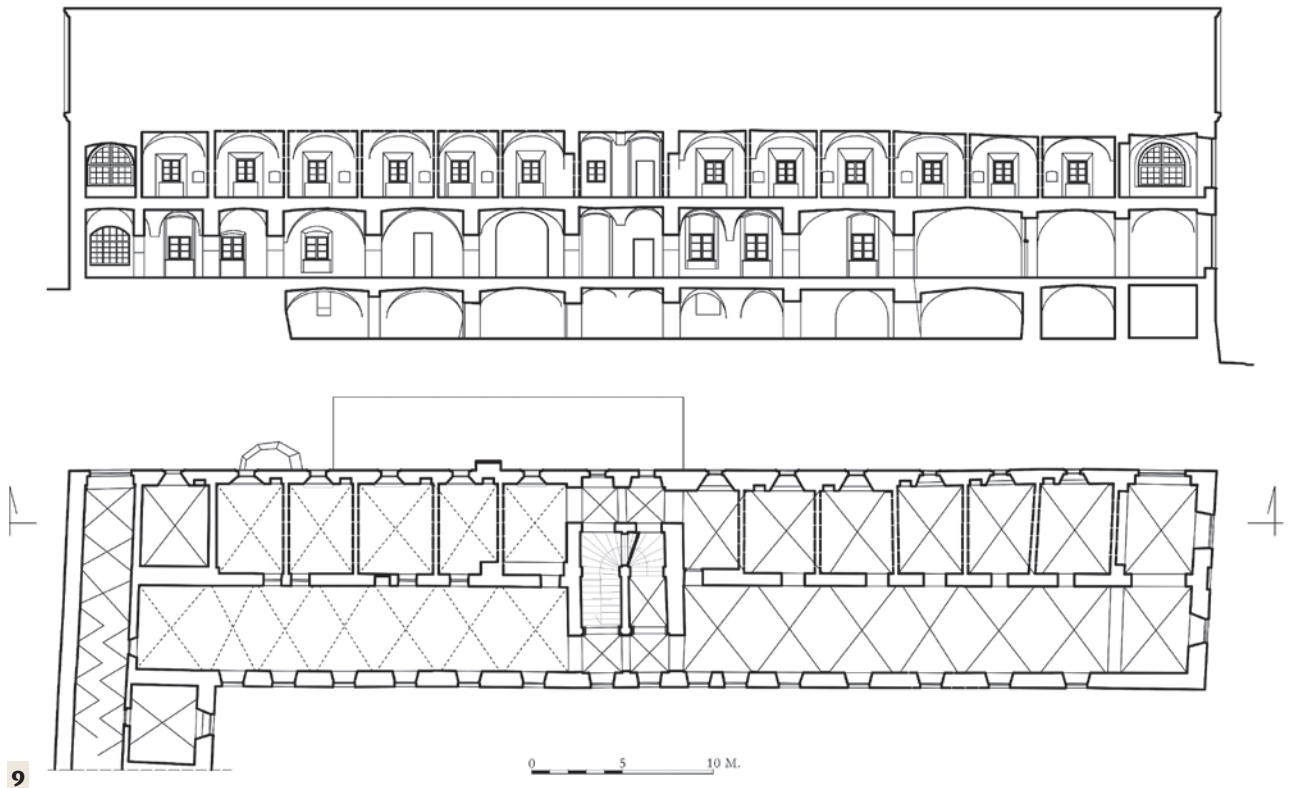
9

9. Hipotetyczny przekrój przez trakt wschodni oraz rzut wschodniego skrzydła klasztoru Karmelitanek Bosych po przebudowie w roku 1664. Oprac. M. Rozbicka, R. Kunkel, W. Wólkowski

9. Hypothetical cross-section of the eastern suite of rooms and projection of the eastern wing of the Discalced Carmelite convent following the completion of alteration works in 1664. Worked out by M. Rozbicka, R. Kunkel, W. Wólkowski
