Wall Painting Decoration from the North-West Church in Hippos-Sussita of the Decapolis

JULIA BURDAJEWICZ

Abstract: Excavations in the North-West Church yielded numerous fragments of plain and painted wall plaster, which suggest that the entire interior of the church was plastered, and in large part, decorated with wall paintings. The majority of painted remains were discovered in the *martyrion* chapel and in the *diakonikon*. This paper describes the findings and addresses the following questions: to what extent was the church painted; what did the paintings represent; were these paintings aniconic; what are the characteristic features of the technique of execution of these paintings; do these paintings belong to a single phase of decoration of the church?

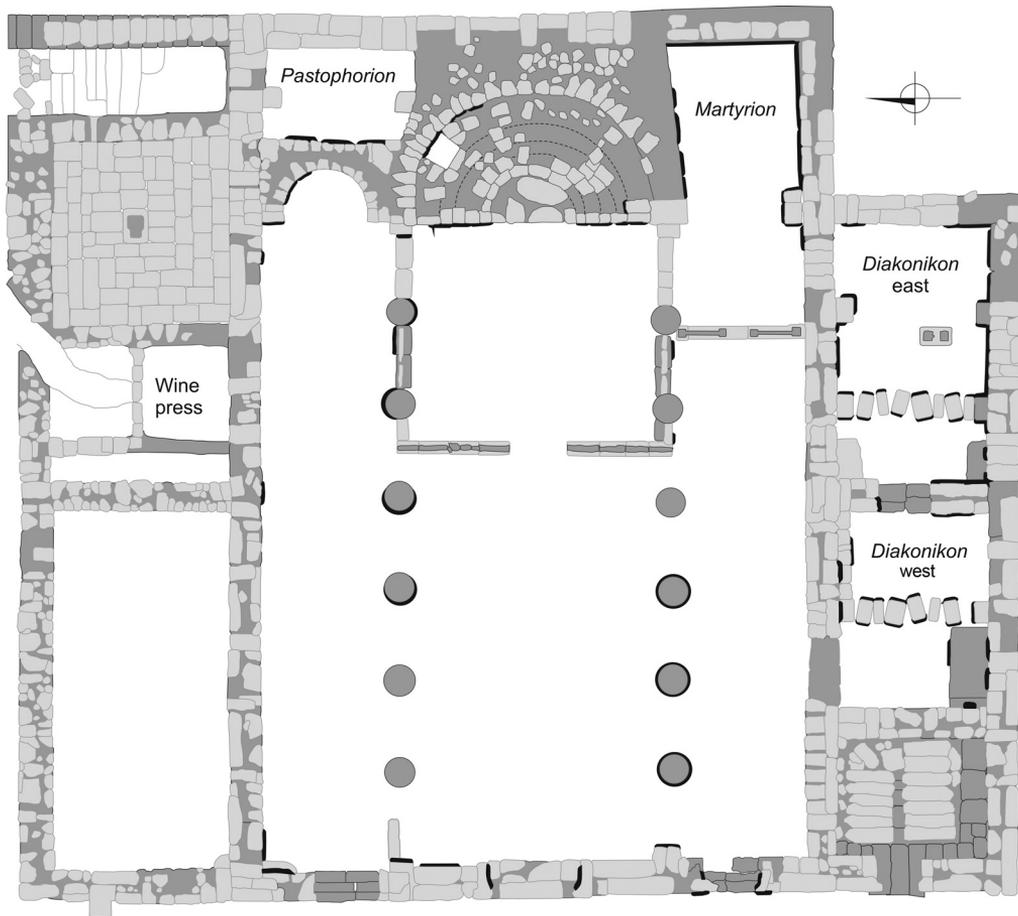
1. The plan of the North-West Church with locations of plaster found *in situ* marked with black color (Drawing: M. Burdajewicz).

Numerous fragments of wall plaster were found *in situ* on all walls, benches and elements of the arches dividing both rooms of the *diakonikon*, which is located in the southern wing of the church (**Fig. 1**).⁹ While no painted fragments were recorded by the excavators in the western room, the eastern room appears to have been adorned with painted decoration, at least on its eastern wall. Numerous colorful painted fragments were found in the eastern bay of the room, between the stone 'reliquary' and the eastern wall.

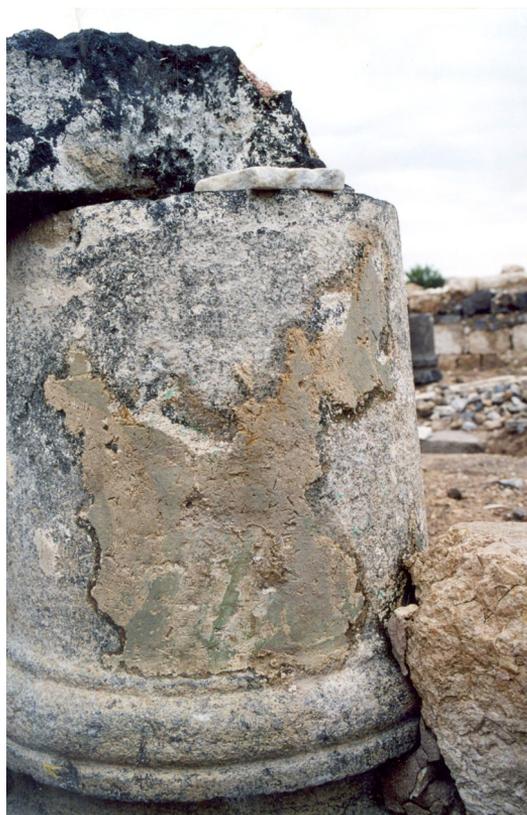
2. Remains of painted plaster on one of the columns in the North-West Church with traces of green winding strands (Phot. J. Burdajewicz).

Excavations in the nave of the church yielded a few fragments of plain white plaster surviving on the steps of the *synthronon*, in the apse, as well as on the limestone chancel screen. A handful of small red and black colored pieces were recovered from the debris. However, it was only after the first rainfall following the excavations that any significant discovery could be made. Plaster surviving on several columns turned out to be painted. It appears that the shafts were plain white with 2–3cm wide green winding strands arranged in a vertical direction (**Fig. 2**). A couple of basalt capitals retain red plaster on the *echinus*

in between the volutes and green plaster on the uppermost part of the column's shaft. These green traces were initially interpreted as a wreath of laurel-like leaves,² but surviving remains are in fact too fragmentary to confirm such an interpretation. The bases of the columns were made of white marble (reused from earlier buildings) and hence it is unlikely that they were plastered, especially because the smooth character of marble surface would render plastering very difficult.

Another type of decoration which allows for some interpretation are green strands painted on the columns of the North-West Church. The first possibility is that they were intended to imitate veins of white and green marble, concealing at the same time crude basalt of the shafts. Painted imitations of marbles were an inexpensive substitute for the real stone material, commonly executed in the Hellenistic-Roman period and after. Another possibility, however, is that the columns were decorated with vines entangling the shafts. Parallels of such decoration could be found on Constantine-era columns which used to support the *ciborium* over saint Peter’s *memoria* in the Roman basilica of St. Peter.³⁶ Portions of the flute-twisted shafts were intermitted with portions decorated with vines and *putti*. The motif of vines entangling a column appears also on a Coptic textile from the sixth century.³⁷

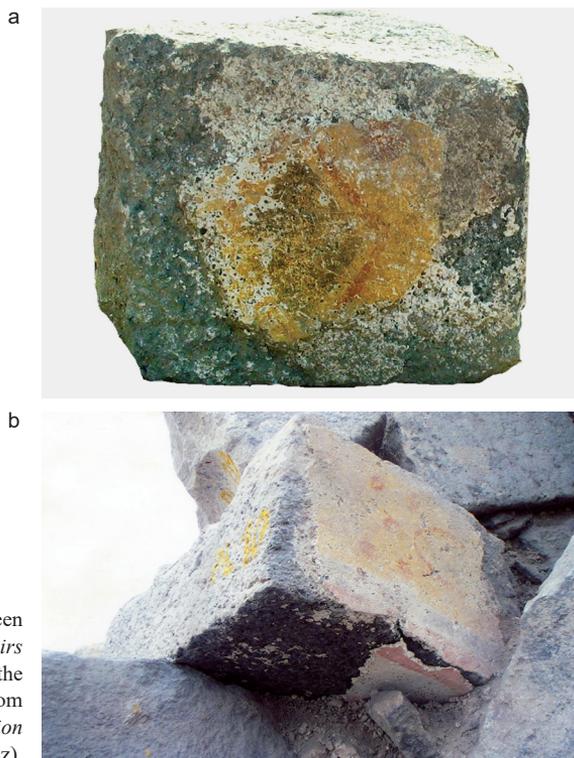
3a. One of the decorated (green rhombus in a red contour) *voussoirs* from the archway leading to the *martyrion*; b. a *voussoir* from the archway leading to the *martyrion* upon discovery (Phot. J. Burdajewicz).

of the recovered *voussoirs* retained plaster on their *intrados* and on the dressed faces. The plaster on the *intrados* surface is generally plain white with only one of the blocks featuring a trace of a top of a round yellow shape in the center of a white field. The ridges are decorated with a red vertical band (folded over the ridge) and a faded black stripe next to it. The faces of the blocks are decorated with simple geometric shapes: green ovals and rhombi with red contours placed against a yellow background. The ovals and rhombi were arranged alternately, separated from each other with sets of five red dots (**Fig. 3a**).

One of the *voussoirs* was found virtually *in situ*, only slid down from the springer of the arch (**Fig. 3b**). Its position indicates that the neatly dressed face of the block with ‘rhombi and ovals’ decoration faced the aisle. This decorative pattern appears on the ‘even’ faces of other blocks, while very little painted plaster survives on their rear sides. It seems logical that when constructing the arch, the *voussoirs* were arranged with their neatly dressed faces (that is, well-fitted to plastering and painting) facing the aisle, while the rough ends were directed towards the interior of the chapel. This would indicate that the western face of the arch was decorated with an ornament of alternating rhombi and ovals separated with sets of five red dots (**Fig. 4a**). Both ridges of the arch were decorated with vertical black and red bands. However, the remains of plaster on the surviving pier are too scanty to determine whether the same decorative motif continued also below the imposts (**Fig. 4b**).

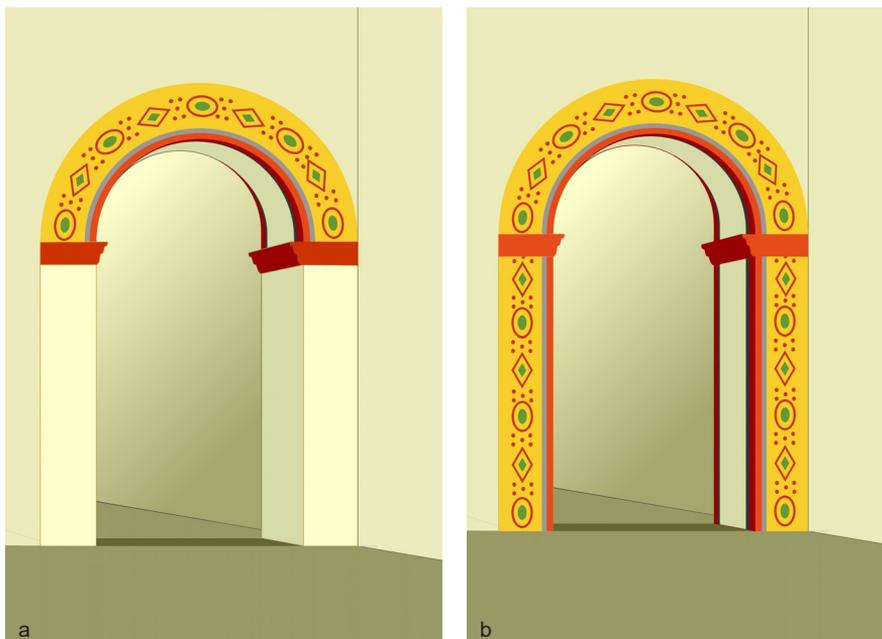
4a. Graphic reconstruction of the 'rhombi and ovals' decorating the archway to the *martyrion*; b. the same motif decorating also the piers of the arch (Drawing: J. Burdajewicz).

One decorative motif which could be interpreted with some certainty is the ‘rhombi and ovals’ pattern adorning the archway into the *martyrion*. It is not clear whether it also ran on the faces of the piers, yet it appears more plausible that it decorated only the vault of the arch (**Fig. 4a-b**). A very similar motif, representing oval and rectangle ‘jewels’, can be found on wall mosaics decorating the churches from the pre-iconoclastic period both in the East and in the West. The church of Hosios David in Thessaloniki has such a motif decorating the conch of an apse with the representation of Christ (c. AD 540);²⁷ wall mosaics running above the arches of the nave of the St. Demetrios church in Thessaloniki had a very similar decoration (the mosaics are now lost, known only from reproductions).²⁸ On the Italian peninsula, the ‘jewels’ motif can be found on the framing of imperial representation of Justinian in San Vitale in Ravenna (c. AD 540)²⁹ as well as on the archway of the St. Venanzio chapel in the church of San Giovanni in Fonte on the Lateran in Rome (AD 640–642)³⁰ and on the triumphal arch of Santa Maria Maggiore (AD 432–440).³¹

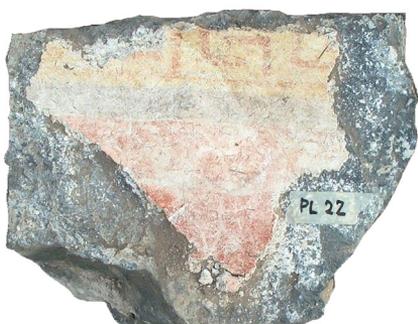
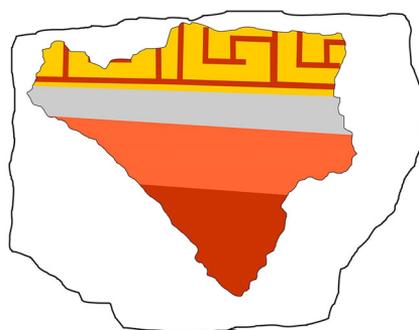
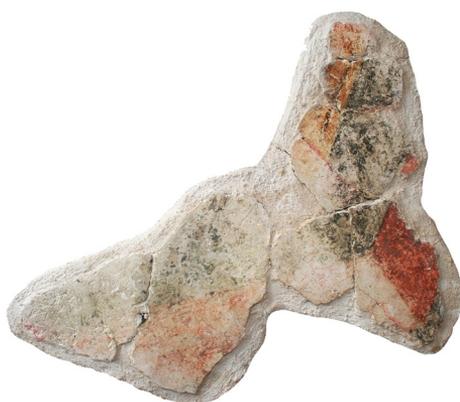
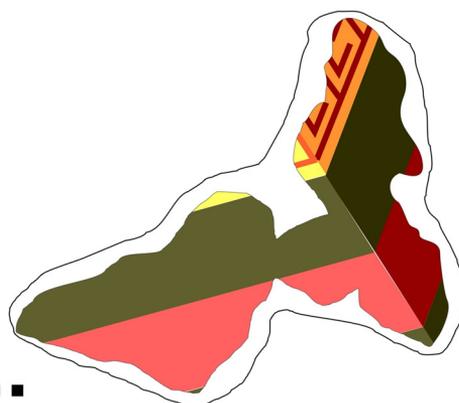
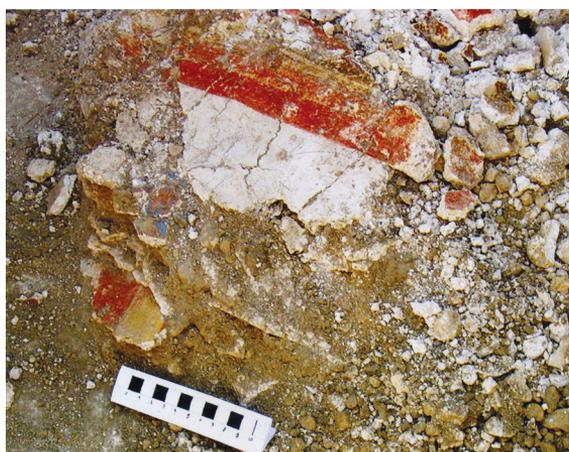
5a. One of the blocks from the *martyrion* retaining plaster decorated with the meander motif; b. reassembled fragments of plaster from the *martyrion* decorated with the meander motif; c. bright sheet of painted plaster (several hues of red, green, yellow, orange and blue colors) found at the foot of the eastern wall in the *diakonikon* (a-b. Phot. and drawing: J. Burdajewicz; c. Phot. J. Młynarczyk).

Out of the numerous fragments of painted plaster which were found in the debris in the *martyrion* chapel⁷ the most significant group comprises pieces representing red, pink and black color fields and yellow bands decorated with a red meander. The same decorative motif is also preserved on several basalt ashlar (**Fig. 5a**). A characteristic feature visible on some of the larger surviving pieces is that the yellow, black and red color fields form acute and obtuse angles, as in hexagons or octagons (**Fig. 5b**). Each of these base colors has two tones – pink and dark red, light and dark yellow, black and gray. The sequence of these color fields varies: one example is decorated (from left to right) with a red and pink band, followed by a yellow field with meanders, a faded black band and a yellow field again. Another piece represents dark red and pink fields next to each other, a black stripe running along them followed by a yellow band with a red meander.

- it consists of three basic colors – yellow with red meander, red and black;
- each of these three basic colors appears in two tonalities – lighter and darker, which may suggest some kind of light and shadow effect;
- these colors run along each other in bands, but they do not always have the same width and sequence;
- these color bands appear to turn in acute and obtuse angles.

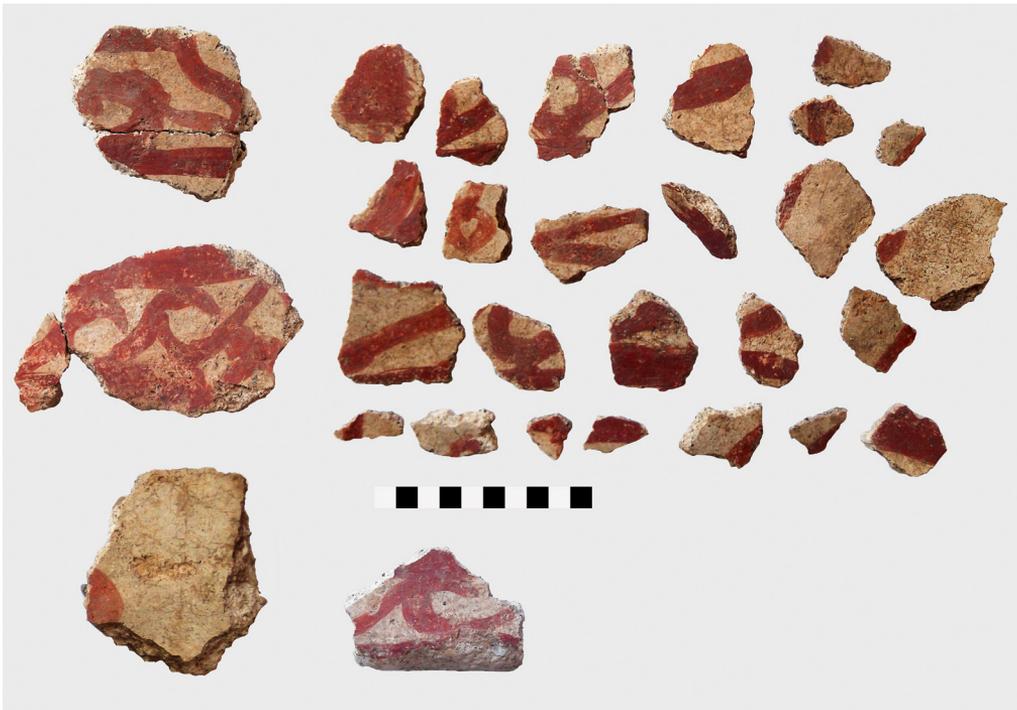
6. Fragments of the simple red geometric decoration found in the so-called wine cellar in the northern portico of the atrium (Phot. J. Burdajewicz).

Fragments of ornamental paintings found in the so-called wine cellar in the northern portico of the *atrium* were not subject to microscopic analysis, but based solely on macroscopic observations one can note that their technique of execution significantly differs from murals found in the basilica. The substrate consists of three layers. The lowermost contains relatively large, multicolor pebbles, which appear to have come from the Sea of Galilee. This layer has an irregular thickness. On top of it is a layer of a uniform, hard and compact mortar, about 8mm thick, which also contains a significant amount of aggregate, although of much smaller fraction. The grains are easily distinguishable by the naked eye, but the majority of them do not exceed 1mm in length. There is also an insignificant admixture of small pebbles, *c.* 3mm in length. There are no pores nor traces of organic admixture visible by the naked eye. The uppermost layer appears to be no more than 1mm thick, containing very fine filler. The presence of a smooth and very thin uppermost layer of plaster as well as the very good condition of the paint layer may indicate that the painting was executed in a *buon fresco* technique on top of at least three, well-executed, layers of mortar. This technique and manner of execution appears Roman in character. It is plausible that these pieces may have survived on ashlar from a Roman-era building used for construction of the cellar.
