**Teresa Dziedzic\***

## *Details' wandering – transformations of architectural details and sgraffito of Grodno Castle in Zagórze Śląskie*

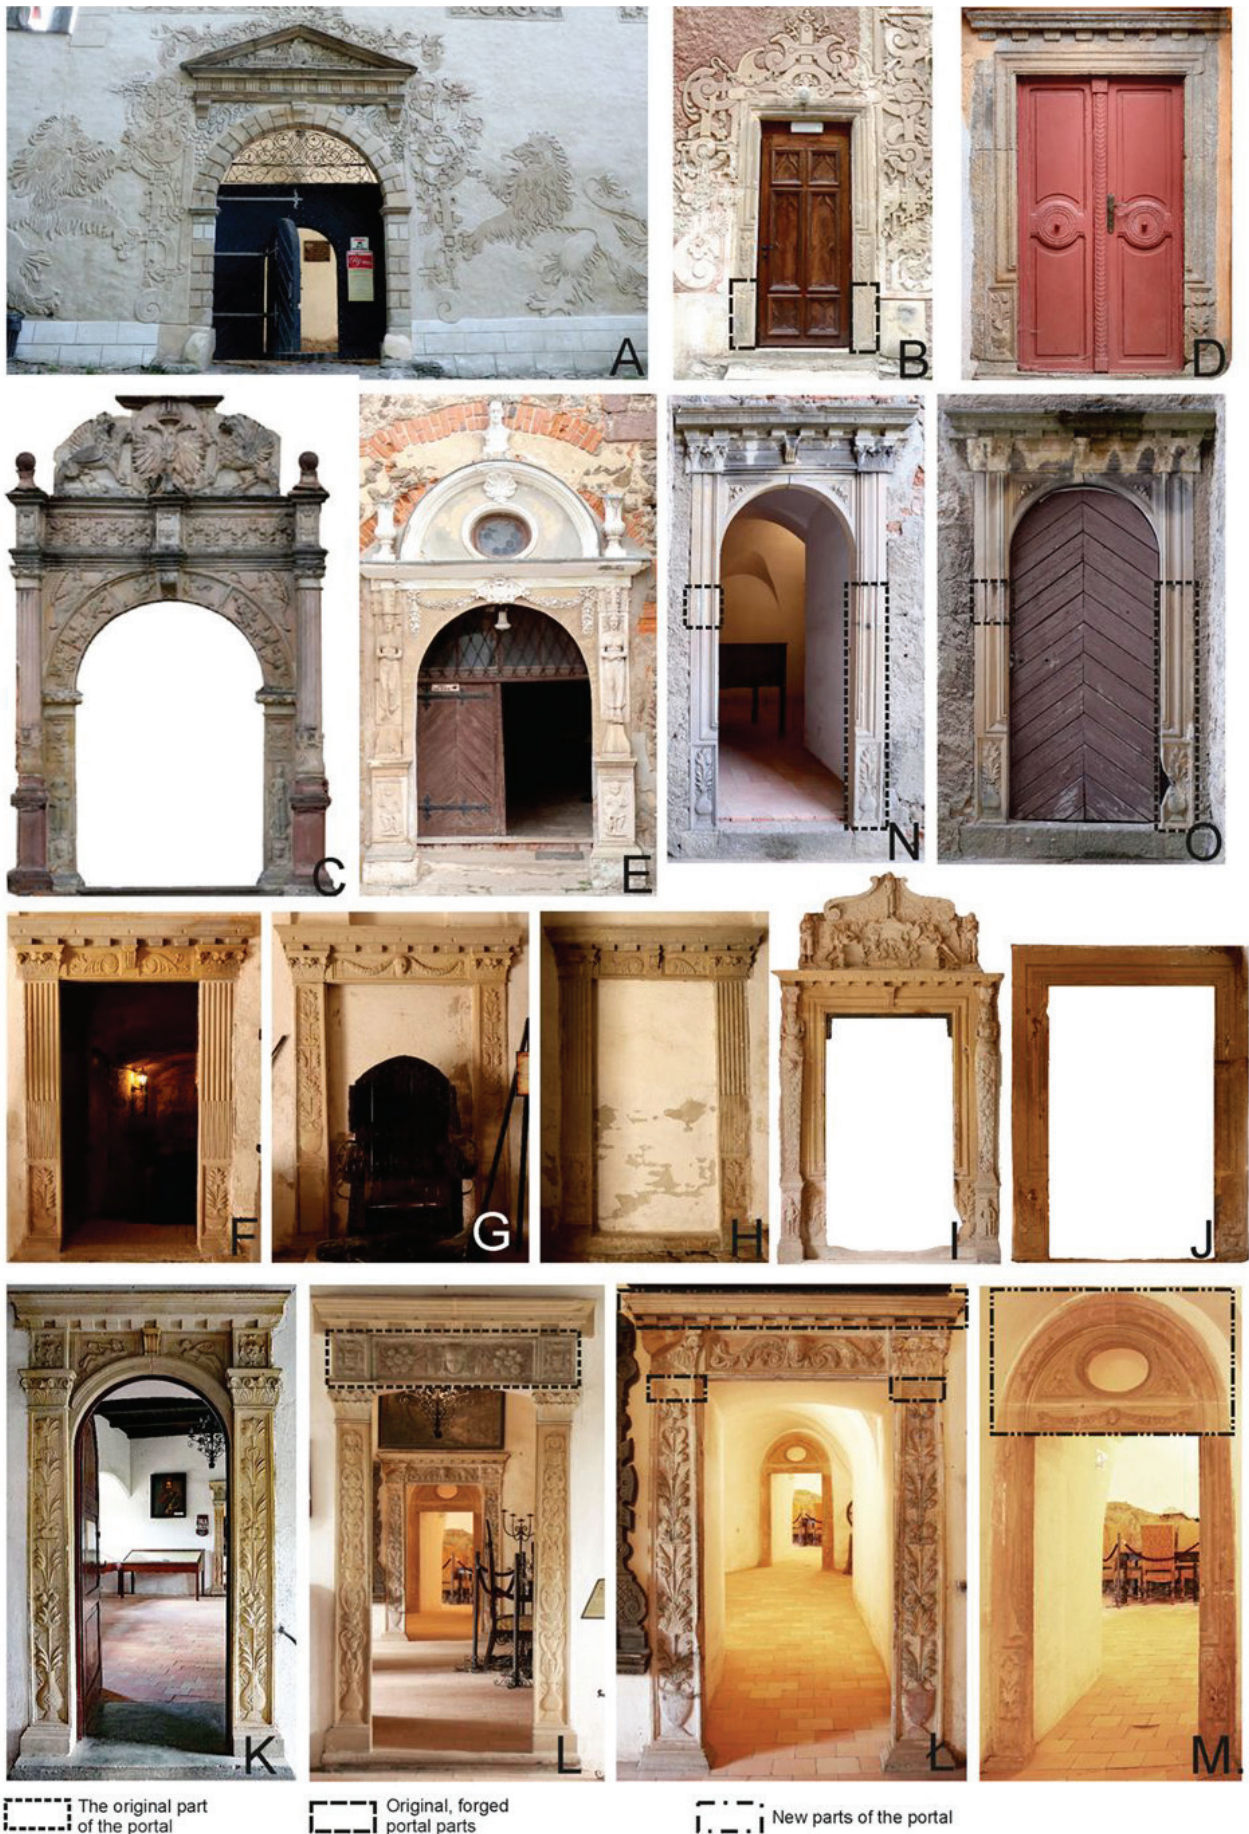
Fig. 1. List of the analysed portals (photo by A. Gryglewska, A. Chodkowska, 2019, elaborated by T. Dziezic)

The material analysed in the article consists of sixteen modern portals, which changed their location over the course of 200 years, underwent modifications and more or less professional restoration procedures (Fig. 1).

The entrance gate is closed with a full arch in the portal frame (Fig. 1A). Above it, there is a pediment resting on entablature with a triglyph frieze with a tympanum and a rococo Zeidlitz cartouche with the inscription *Fortiter et fideliter*. The portal’s composition is complemented by a sgraffito decoration – a ferrule ornament around it with “roaring” heraldic lions as holders. It was built together with the gatehouse during the expansion of the castle in 1570 and was restored by Noellner between 1903 and 1904 [6, p. 19]. August Zemplin wrote in 1826 that the gatehouse was covered with a gable roof similar to the city gates. The renovated building housed Büsching’s summer apartment [2, pp. 13, 14]. One hundred years later, in 1927, Viktor Schaetzke described the exact appearance of the gate and portal, mentioning that the upper part of the full arch of the gate is closed by a beautiful, forged grate from 1565. He mentioned that in the superstructure there is the Zedlitz family’s coat of arms, borrowed from an old tombstone and the maxim *Fortiter et fideliter*. He also noted that the sgraffito decoration dating back to the best Silesian Renaissance around 1570 and differing from the popular ones with the extraordinary richness of motifs, delicate lines and vivid multi-coloured polychrome catches the eye most. A very important piece of information given in the description is that during the analyses it turned out that, contrary to previous assumptions, the plaster does not consist of two differently coloured layers. Rather, there was one layer of lime plaster, with an undercoat 1 cm deep. As Robert Weber pointed out, the relief with its very delicate lines delighted visitors even before 1910 [8, p. 28]. Later, after the restoration works were carried out, it was completely painted, with the background of the frames in dark blue and red, and the cartouche in grey and leather colour, and the remaining elements yellow, red, and green, respectively. The restoration carried out by Noellner [4, pp. 304–306] was consulted by Bodo Ebhardt, an outstanding conservator and creator of historical architecture [9, p. 205]. The present condition of the sgraffito surrounding the portal is the result of subsequent restoration works from 2015<sup>2</sup>. Based on the archival photographic documentation and contemporary field research, numerous differences can be noticed in the

The entrance to the foregate building is framed by an arcade enclosed in a renaissance aedicule portal from around 1570 (Fig. 1C). Above the carved archivolt of the portal there is a horizontal frieze showing the eight coats of arms of families associated with Georg von Logau. The portal is crowned with a double-headed eagle with two griffins [6, p. 17]. The portal was created during the reconstruction of the castle from the times of Georg von Logau. It is distinguished by the richness of figural decorations from the personification of virtues: *Faith and Hope* on the pillars (symbolically trampling masks of monsters – the

The portal is fully composed of original fragments (Fig. 1D). Based on our research, it was found that it had been assembled from various 16<sup>th</sup>-century portal fragments or window dressings and inserted into its current location. The sample collected for petrographic tests was taken from the inner face of the right jamb of the portal at a height of about 60 cm. The tests have shown that it is grey-yellow, medium-grained sandstone with a clay-silica binder from the vicinity of Lwówek Śląski [10, pp. 4, 19].

The portal leading to the entrance hall is distinguished by two caryatids with capitals in the form of fruit baskets (Fig. 1E). It is a motif rarely found in portals in Lower Silesia. The armoured angels in the lower part of the portal constitute the original part of the decorations [11, pp. 256, 257]. In the description from 1826, Zemplin mentioned the third gate leading to the house, decorated with sculptures made by the same workshop as in the case of the main portal of the foregate. He noticed a lot of damage and noted that in 1823 one of the large figures was torn out and, as an ordinary stone, set in a nearby farm. At the same time, he pointed out that many doors, locks and window dressings were transported to neighbouring houses [2, pp. 15, 18]. The portal was modified many times, and it certainly acquired its present form at the beginning of the 20<sup>th</sup> century. Schaetzke mentioned both caryatids carrying baskets filled with fruit, placed on pedestals raised with consoles, with a large area framed in the form of a semi-circle, garlands stretching from the archivolt key in both directions [4, p. 309]. Rozpędowski noticed that the portal was an element of the reconstruction of the earlier gate, where part of the opening was walled up and only a window place was left as a witness [6, p. 16]. He also stated that the portal was subject to conservation in 1826 [13,

Samples for petrographic tests were collected from each of these portals. They come from the following places: the first portal in the enfilade (Fig. 1K) on the left jamb next to the frame, from the next portal (Fig. 1L) from the rear part of the lintel in the left corner, from the portal with a woman in a scarf (Fig. 1L) from the rear side of the left jamb, at the fracture, while from the last portal of this group (Fig. 1M) a sample was taken from the right jamb at the anchor fixing point. All tests results showed that it is grey-yellow, medium-grained sandstone with a clay-silica binder from the vicinity of Lwówek Śląski [10, p. 19].
