OLENDER ETHNOGRAPHIC PARK IN WIELKA NIESZAWKA: ASSUMPTIONS AND IMPLEMENTATION

Ewa Tyczyńska

Maria Znamierowska-Prüffer Ethnographic Museum in Torun
ORCID 0000-0001-9837-5043

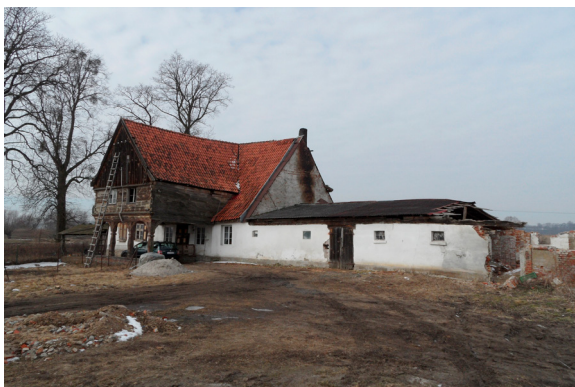
2. Kaniczki homestead (1757) before the translocation to the Olender Ethnographic Park in Wielka Nieszawka, state as in 2011

The next homestead was translocated from the village of Kaniczki (Sadlinki Commune, Kwidzyń County, Pomeranian Voivodeship). It was built in 1757, this testified to by the inscription preserved in the porch. The facility was selected for the Park not merely because of the preserved inscription with the construction date accompanied by initials, possibly of the builder, and the owner: Martin Petzke, but owing to a pillar porch from the front of the building. This homestead is one of the last porch houses preserved along the strip on the planes on the Vistula.²⁷ It has the residential part raised as a log structure land inearily connected with the livestock section.

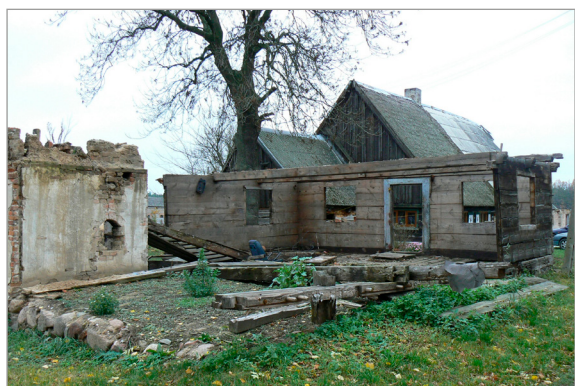
3. Farmhands' cottage from a homestead at Mątowskie Pastjwiska (1827), state as in 2008

Having served its purpose in a large Olender farm at Mątowskie Pastwiska (Ryjewo Commune, Kwidzyń County, Pomeranian Voivodeship),³³ this only preserved example of timber buildings for farmhands in the Lower Vistula Valley was built in 1827, as shown in the inscription with the date preserved on the door lintel over the main elegant entrance. The building's walls were raised as a log and a post-and-plank structure, while the roof was covered with pantile. The two-bay interior was composed of two rooms, a small hallway, and a kitchen. As much as the genuine layout of the rooms and the hallway does not arouse any doubts, the kitchen and mainly the applied stove-chimney solution suggest that this space was created secondarily. The interior may have been introduced in the late 19th century at the earliest or at the turn of the 20th century. The fact that previously there had been no 'black' kitchen in the building permits the below hypothesis: the cottage was located close to the main homestead, which may suggest that it was rented seasonally to farmhands who used to have their meals with the hosts. It may be supposed that subsequently the need arose for permanent farmhands to be employed at the farm, and at that point the decision to introduce the kitchen was made. As can be judged by the photographic documentation, the chimney was removed in the mid-20th century.

In 2009, when the building was donated to the Museum, it was in ruin. The roof truss damaged earlier led to a complete collapse of the roof, and the facility's owner started its dismantling. The team of the Olender Ethnographic Park in Wielka Nieszawka, who were in the course of designing the Museum, aware of the worth of the facility, inventoried the preserved walls with drawings and measurements.³⁴ Following the conservators' guidelines, the elements transported to the construction site were deposited protected under a shelter awaiting their reassembly in 2015. While the building was being reconstructed the consensus was reached for the facility to be restored to its form from the early 20th century, thus harmonizing with the timeframe adopted for the whole farm displayed in the Park. And thus the chimney, removed earlier, was reconstructed, and so was the damaged roof truss covered with old historic roof tiles. The farmstead already featuring the homestead and the farmhands' cottage was also added two other detached farm buildings: a barn (1841) from the village of Wielkie Wełcz (Grudziądz Commune, Grudziądz County, Kuyavian-Pomeranian Voivodeship) and a 19th-century granary which came from the village of Wielkie Zajęczkowo (Dragacz Commune, Świecie County, Kuyavian-Pomeranian Voivodeship). In the course of their usage neither of the latter two facilities had undergone any essential alterations in the structure of the walls or roof, and thus at the designing stage it was decided to leave the two featuring their genuine solutions. The preservation state of both was satisfying to the degree that they did not require any major conservatory treatments.

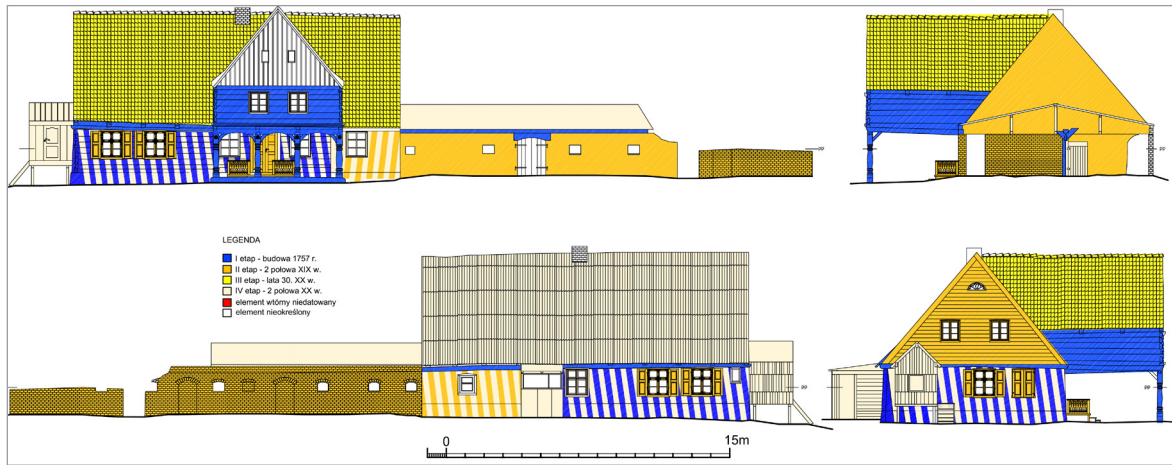
4. Historical and architectural research into the Kaniczki homestead: chronological stratification, elevation, scale of 1: 150, in: *Architectural Research into the 1757 Homestead at 21 Kaniczki, Kwidziń County, Toruń 2011, M. Prarat (comp.), MET Archive*

the disassembly, that the homestead had been altered on several occasions.²⁸ The first alterations took place in the second half of the 19th century: at that point, the interior of the hallway in the residential section was altered. The large space was divided with a brick partition wall, this leading to creating two hallways: an elegant and a farm one. The original entrance leading to the 'black' kitchen was bricked in, and a new one was made on the other side. The kitchen's interior was given a vault, while a smoking chamber was placed in the attic in the chimney part. Over the same time also the window and door joinery was entirely replaced in the dwelling section. In the late 19th century, the decayed wooden walls of the cowshed, originally raised as a timber-frame structure, were supplanted by brick walls. This is documented by a pillar with struts that had constituted an element of the structure, the only one preserved in this part of the building. After the timber-frame part of the farm section had been dismantled, a brick cowshed was raised in its place, with a brick fire wall being introduced to separate the house from the cowshed. The latter together with the residential section were about 60 m long. It is likely that at the end of the enfilade there was also a barn. As it has been confirmed, in 1876, when the farm was owned by Gustaw Worm, there already was a large freestanding barn.²⁹ The next essential alterations were introduced in the 1930s when the homestead was owned by Helena Becher, and later her son Albert.³⁰ These included mainly the reconstruction of the roof truss over the residential section. At that point the light thatched roof was replaced with heavy ceramic tiles. This required strengthening of the roof structure by introducing a roof frame roof trusses.

The historical and architectural study of the building proved that all the wooden walls of the residential section were genuine. Due to their decay they were covered with plaster at least twice: in the interwar period and following WW II.³¹ At that point the quoins were cut off in the corners. Immediately prior to the disassembly the residential section of the homestead featured an entirely altered spatial and functional layout adjusted to face the need of several families occupying it in separate flats. Additionally, the window and door joinery was partially exchanged.

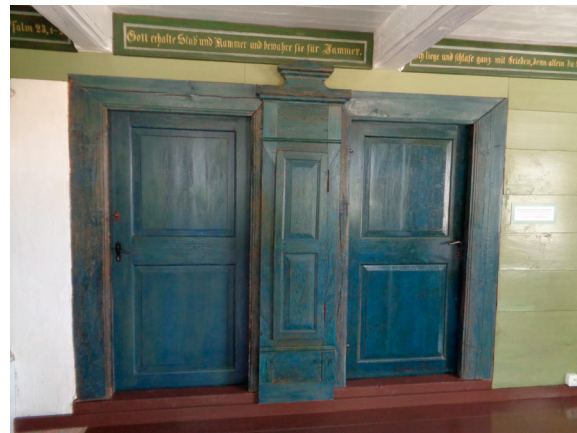
5. Interior of the main room in the Gutowo homestead, Olender Ethnographic Park in Wielka Nieszawka, 2018

Prior to launching the reconstruction works on the homestead in the Park, the decision had been made to restore it to its form from the early 20th century. This allowed to expose in the dwelling section the main room with the preserved panelling together with the planks featuring the inscriptions, the fitted wardrobe and the door portal, as well as the tile stove with the ornamental crown.

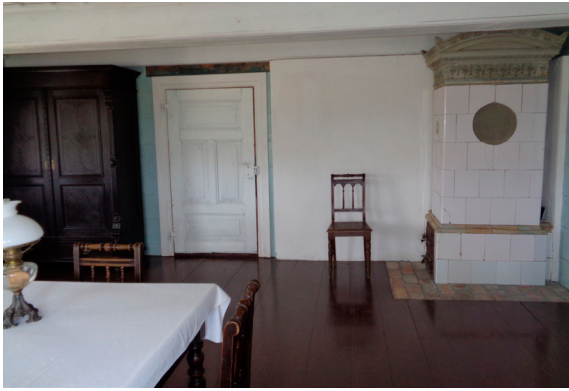
6. Interior of the main room with an authentic tiled stove in the homestead from Niedźwiedź, Olender Ethnographic Park in Wielka Nieszawka, 2018

the restoration of the building's appearance as from the late 19th century. Therefore, inside the dwelling section, following the removal of the secondary partition walls, the two-bay layout with a centrally located 'black' kitchen, adjacent to which there are two rooms separated with a chamber and a passage hallway, was restored. When the facility was being dismantled, in both rooms remains of several layers of wall paper were discovered, these, regrettably, too destroyed to be recreated. That is why during the reconstruction both rooms were given blueish and greenish wall colouring reconstructed according to the models from other Olender houses. The painted inscription uncovered during the disassembly on the lintel over the door leading to the main room was covered with panelling in the late 19th century; in order to obey the faithfulness principles, the panelling should be covered. However, in this case exceptionally, in view of the high profile of this particular detail, the decision was made

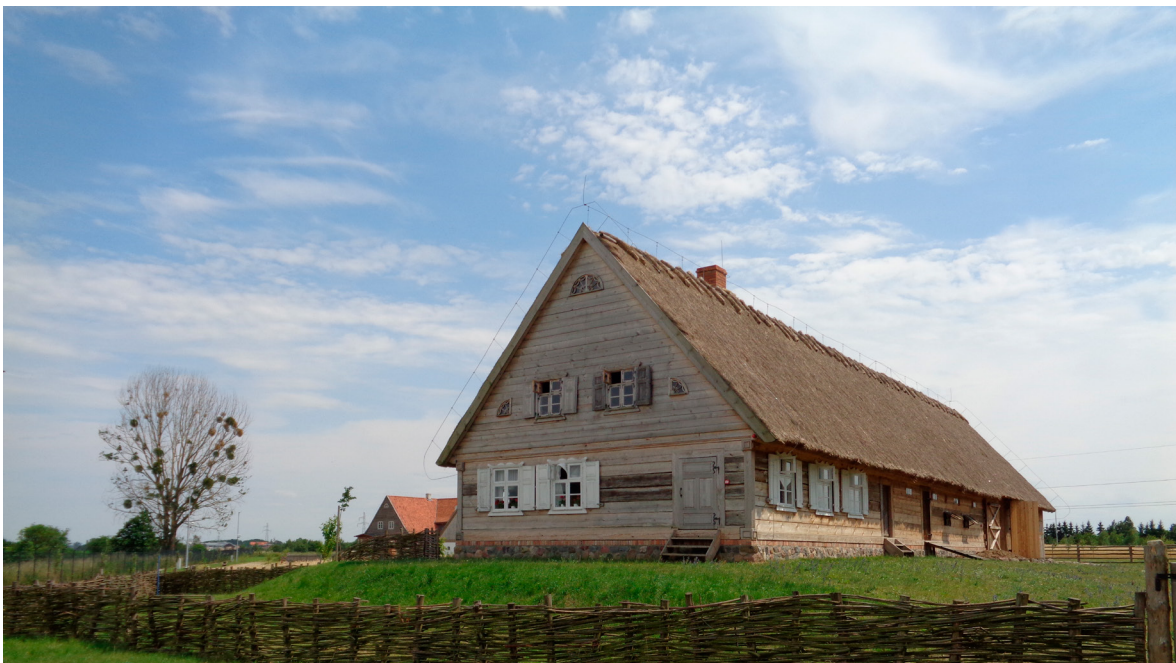
7. Niedźwiedź homestead from the late 18th c., Olender Ethnographic Park in Wielka Nieszawka, 2018

The second homestead was transferred from the village of Niedzwiedź (Świecie Commune, Świecie County, Kuyavian-Pomeranian Voivodeship).²² It dates back to the second half of the 18th century, this confirmed during the disassembly when the inscription featuring the construction date: 179? and the name: Etrman Zarske, possibly of the house owner, was found on the door lintel in the main room. It represents a linear homestead in which the log-structure residential and livestock sections are linearly placed under one roof with a timber-frame-structure barn boarded with planks.²³ It is the last example in the whole strip of the planes on the Vistula of a wooden homestead preserved in its unaltered form. This definitely decided that it was to be translocated to the Museum, all the more so as in the field no other alternative buildings were found. Additionally, the historical and architectural investigation of this homestead showed that many of its historic elements came from the time of its construction.²⁴ These include e.g. the perimeter wall in the log structure of the house and cowshed, the 'black' kitchen,²⁵ the bottle oven of adobe brick, and fragments of the timber-frame structure and roof truss in the barn section of the facility. A tile stove with an ornamental crown was preserved inside the main room.

The materials obtained in the course of the disassembly showed that in the 19th century the homestead underwent several alterations. The essential changes affected the interior, these followed by the replacement of structural elements. And so the entire window joinery and partially the door joinery in the dwelling section were replaced. The corners in the residential part, after the external beam endings had been cut off, were covered with decorative pilasters. In

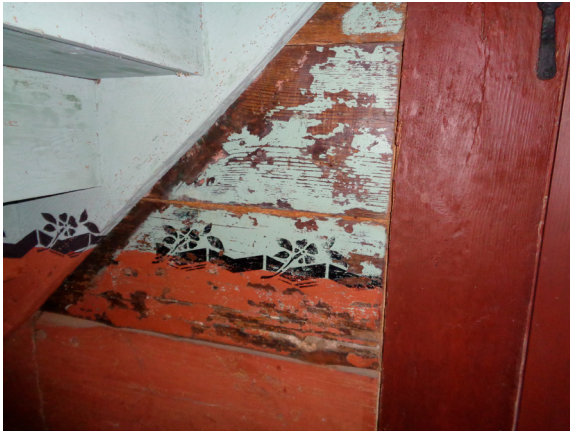
9. Preserved fragment of painting decoration on the hallway wall in the Kaniczki homestead, Olender Ethnographic Park in Wielka Nieszawka, 2017

When the guidelines for the reconstruction of the homestead were being worked out, its appearance was the subject of quite a number of controversies. Finally, the decision was made to reconstruct it in its version from the 1920s. This allowed to retain a number of innovations and the subsequent layers which were created following that caesura.³² And so, in the interior of the main room the genuine wall paper with an openwork pattern was discovered in fragments during the disassembly. In the course of the dismantling works numerous documents belonging to the pre-WW II owners, namely the Becher family, were found (e.g. the invoice for the wallpaper issued in 1910). During the conservation works, fragments of the wallpaper were taken off the walls and joined together in such a way so as to display its original appearance on one of the walls. The remaining walls were decorated with the

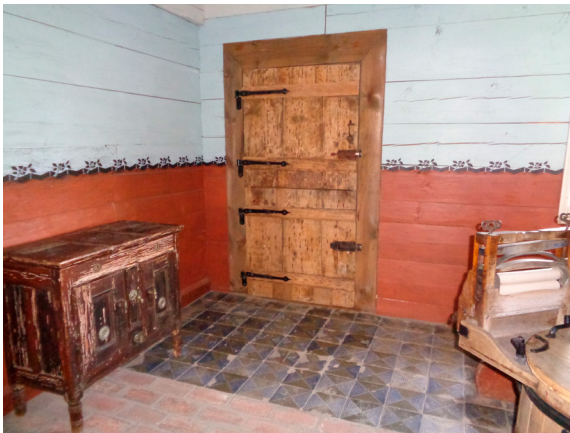
10. Reconstructed stencil pattern on the hallway wall in the Kaniczki homestead, Olender Ethnographic Park in Wielka Nieszawka, 2018

wallpaper's copy featuring a slightly different colour-range from the original.

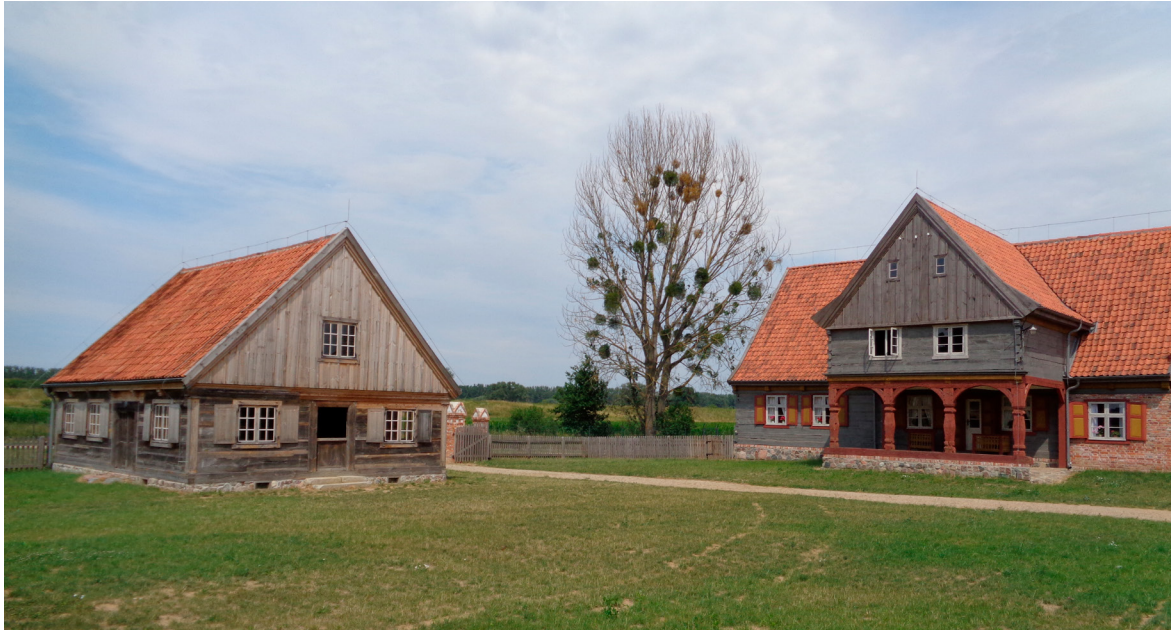
11. Farmhands' cottage from Mątownskie Pastwiska (1827) and the residential section of the Kaniczki homestead (1757), Olender Ethnographic Park in Wielka Nieszawka, 2018
