Alexandria Kom el-Dikka. Excavations and preservation work in the 2018 season

Abstract: The 2018 season saw a continuation of research on Roman housing and urbanism in Alexandria. Excavations were focused in the central area of the Kom el-Dikka site, where some early to mid-Roman structures (2nd–3rd centuries AD) were explored. The uncovered part of the building seems to combine domestic and commercial functions. A couple of shops opening onto the street were identified. Evidence of artisanal production of glass beads was also recognised in the post-occupation phase. Post-processing of the finds (pottery, glass vessels, painted wall plaster and coins) was continued. The paper also brings an overview of the preservation program, which was limited this season to maintenance conservation of structures seriously threatened by unfavourable climatic conditions (mainly the Baths and auditoria).

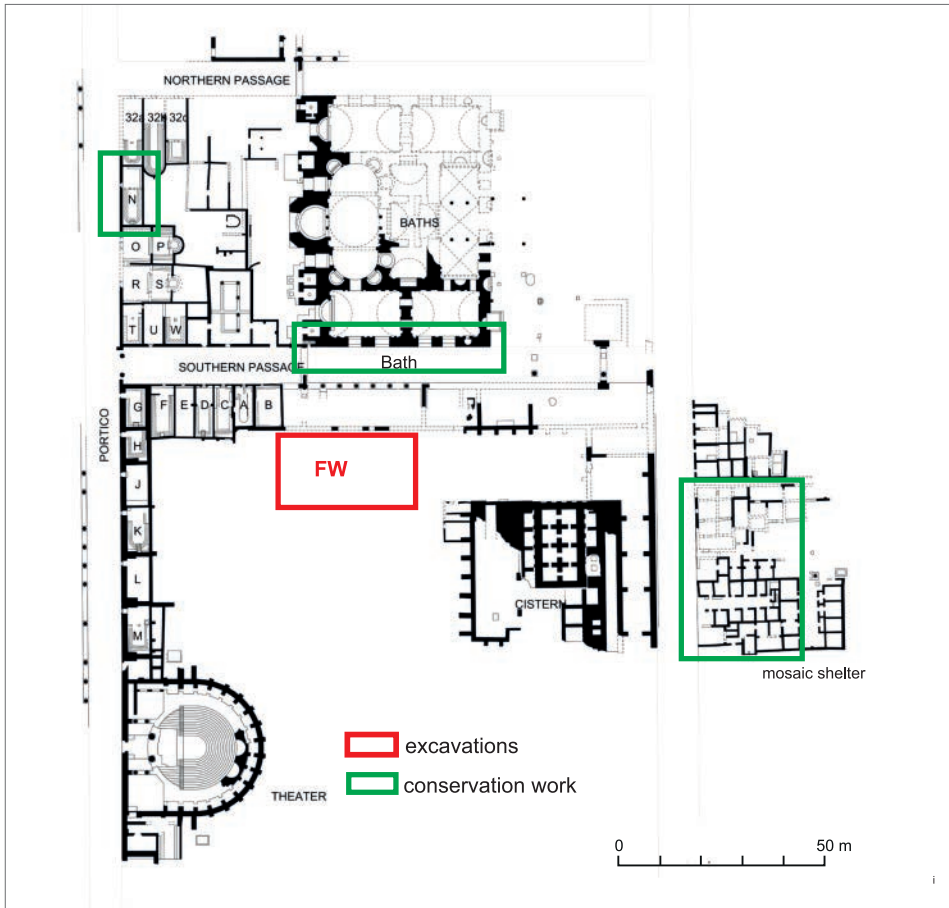
Fig. 1. The Kom el-Dikka site: areas of excavation and conservation work in the 2018 season (PCMA UW Alexandria Kom el-Dikka Project | drawing W. Kołtąj, updated D. Tarara)

Research on vestiges of early Roman domestic architecture previously identified in the central part of the site [see Fig. 1] was at the core of the season's schedule

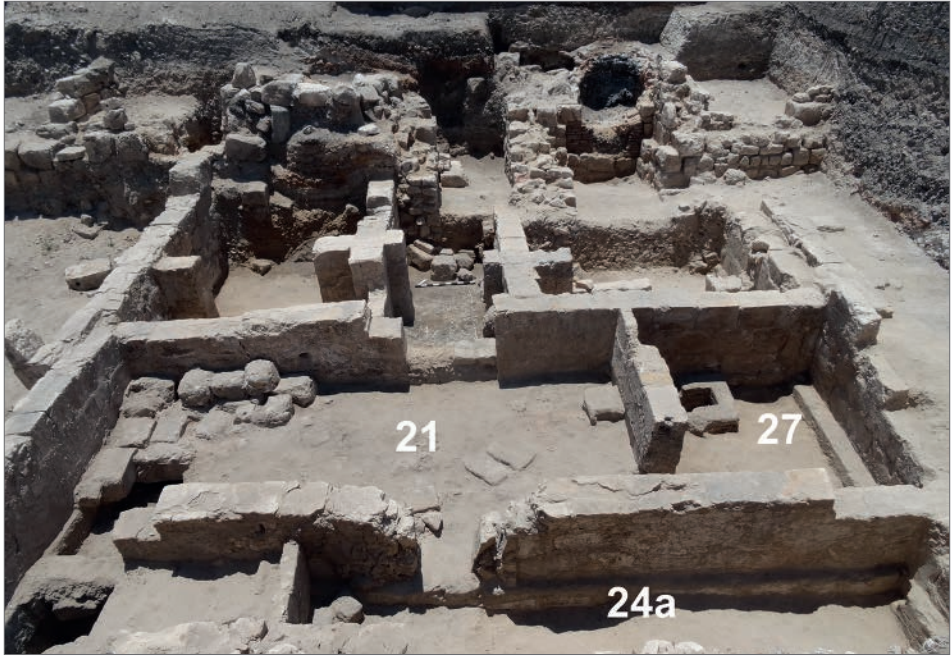
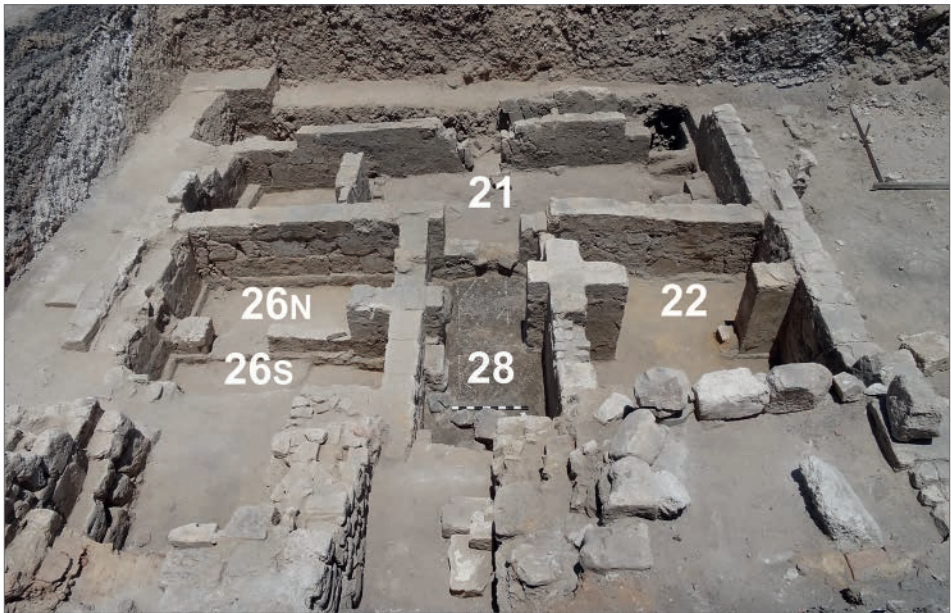
Fig. 3. The early Roman building in Area FW: top, looking south; bottom, looking north, on the entrance axis (PCMA UW Alexandria Kom el-Dikka Project | photos G. Majcherek)

The wall construction technique, identified in sections explored this season, was paralleled by other structures of early Roman age excavated at the site. Walls, approximately 0.40–0.45 m thick, standing to an average preserved height of 0.90–1.00 m above floor level, were built in the regular isodomic technique with courses of ashlar ranging from 0.35 m to 0.45 m. Lime mortar with some ash added to it was used in construction. Ashlars were invariably cut from local soft oolitic limestone, quarried in one of the carbonate ridges extending along the coast, either in the Mex district or further west in the Mareotis (Klemm and Klemm 2008: 36–39). As before (Majcherek 2018), deep diagonal and almost vertical fissures, generally considered as earthquake-induced, are observed in some walls (Stiros 1996), although no signs of sudden collapse were found directly on

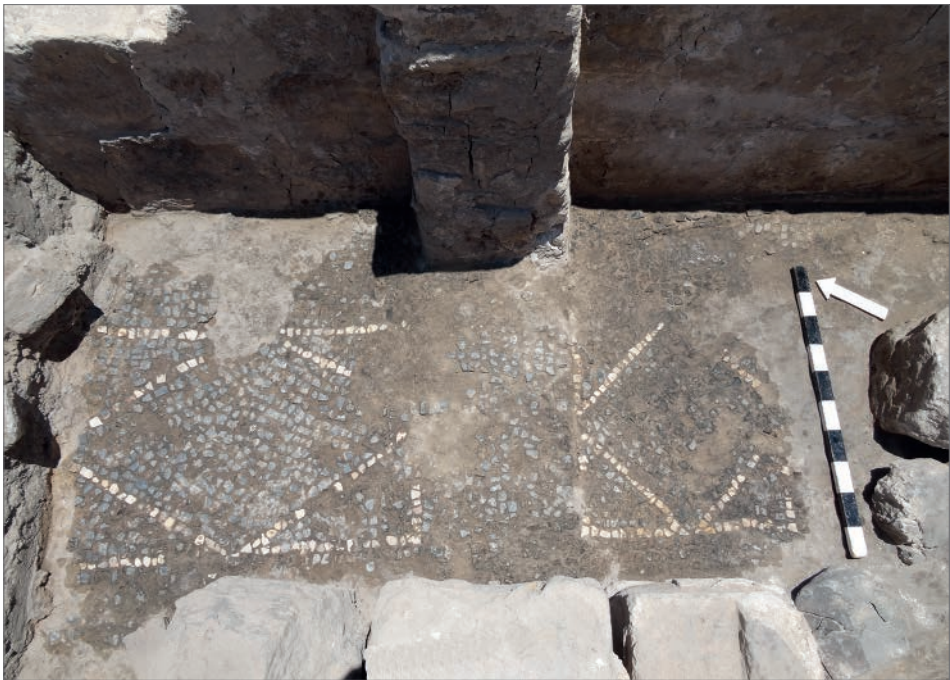
Fig. 4. Mosaic pavement in the corridor/vestibule (units 25 and 28); on left, entrance to room 21 (PCMA UW Alexandria Kom el-Dikka Project | photo G. Majcherek)

The actual entrance has yet to be excavated, but it appears to have opened onto a narrow corridor/vestibule (1.65 m wide), divided by two pilasters into two units (Nos 25 and 28), but forming a single space as indicated by the uniform floor decoration. It was a rather crude mosaic floor, featuring simple geometric decoration: two white single-filet lozenges inscribed in, respectively, a rectangle (1.15 m by 0.75 m) and a square (0.75 m by 0.75 m), both set against a black background [Fig. 4]. The large black and white cubes, roughly cut of basalt and marble respectively, of which the mosaic was made, measured between 3 and 4 cm.

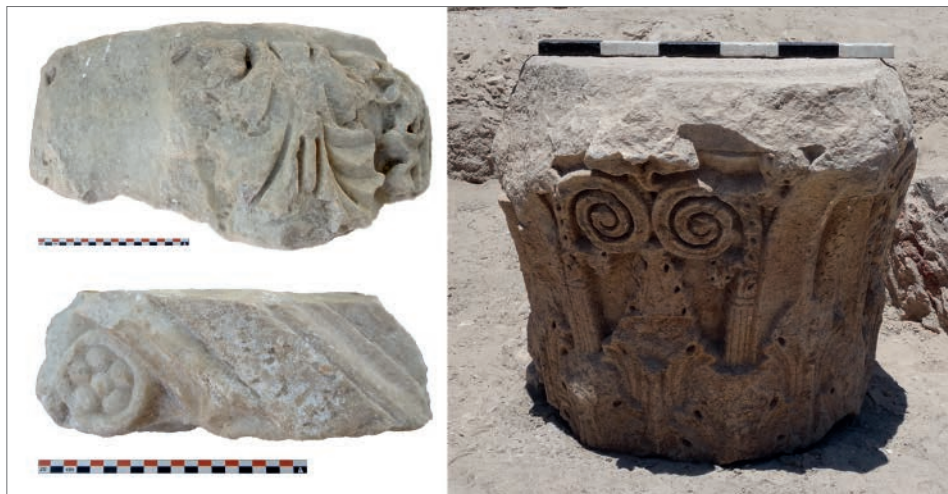
Fig. 7. Assorted architectural elements from the late Roman lime kiln complex: left, fragments of a capital and cornice of Proconnessian marble; right, late Ptolemaic capital of the Alexandrian I type, made of nummulithic limestone (PCMA UW Alexandria Kom el-Dikka Project | photos G. Majcherek, R. Kucharczyk)

two large lime kilns (marked respectively Fe and Ff) were excavated directly on top of the ruined front wall of the early Roman building. Both were found framed by solid walls made mostly of recycled material, including assorted limestone blocks, marble and granite column shafts, cornices, as well as fragments of capitals [Fig. 7 left]. Inside the southern section of the wall of kiln Ff, a large reused Corinthian capital was found. It is relatively well preserved, made of nummulithic limestone and dated to the late Ptolemaic period (2nd–1st centuries BC). The form is heterogenous [Fig. 7 right], combining traits of

the so-called Alexandrian 1 type of capital with those of a “standard” Corinthian one featuring helices stemming from the cauliculus (McKenzie 2007: 84–88).

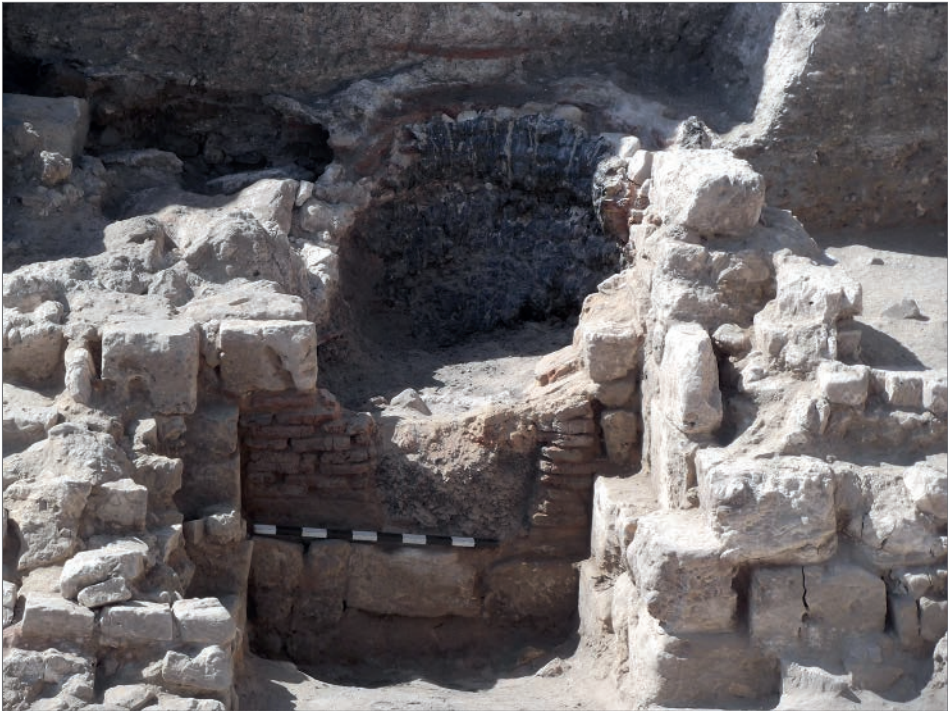
The westernmost of the kilns (Ff) was explored. Its rounded, rather moderately sized chamber (1.20 m in diameter) was built of flat square bricks: 25 x 25 cm, approximately 4.5 cm thick, encased in a stone-built outer wall. The chamber was apparently tronco-conical in shape (the inside has yet to be cleared) and most probably of the open-top type. The whole structure was partly sunk into the ground. A vaulted stoke hole (0.58–0.60 m wide) opened to the north. The chamber, its inside walls coated with a black vitrified layer testifying to high temperatures, was

found filled with ashes, slag, kiln waste and lime [Fig. 8].

Fig. 8. Lime kiln in area FW, looking south (PCMA UW Alexandria Kom el-Dikka Project | photo G. Majcherek)

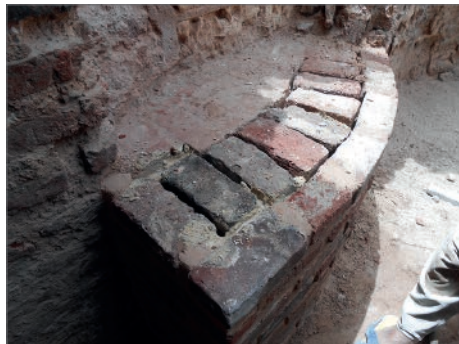
Fig. 10. Preserving the furnace in the *destrictarium* of the baths (PCMA UW Alexandria Kom el-Dikka Project | photo G. Majcherek)

satisfaction, causes issues for regular maintenance. Further degradation in the future can be eliminated only by denying direct access to the bath building. The area (26 m long) along the southern elevation has been fenced off with railings of the same type as used in other parts of the site, that is, a steel cable mounted on posts made of steel pipes, the posts additionally reinforced with concrete bases. Moreover, two *praefurnia* heating the *destrictarium* and a vaulted area accessible from the underground were repaired (Kołątaj 1992: 134–137, Fig. 46). They had also suffered some damage due to increased tourist traffic. In both cases, stoking channels and combustion chambers were seriously affected.

Damaged bricks had to be replaced, losses in joints completed with a new lime-based mortar and the whole structured consolidated [Fig. 10].

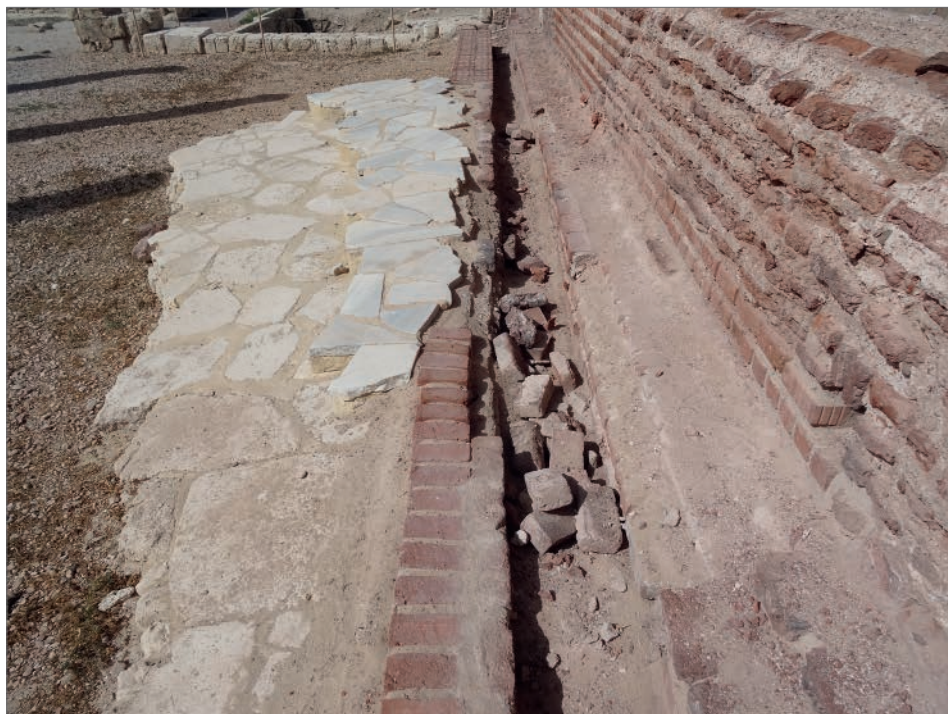
The southern elevation of the baths, restored in 2008 (Majcherek 2011: 46–47) was once again in dire need of repair and conservation. Damage, caused by

the increasing number of visitors, required quick intervention. One of the most affected structures was a brick-made water channel, running along the facade. Large sections of the channel walls next to the *sudatorium* were damaged and many bricks crushed and dislocated [Fig. 11]. Conservation measures, undertaken there, comprised fixing bricks with a new mortar, completed with restoration in modern bricks wherever necessary. As before, the new bricks had to be cut to measure, corresponding to the original dimensions. Likewise, the mortar used during the work was based on an ancient Roman

Fig. 11. The southern elevation of the bath, showing the damaged water channel (PCMA UW Alexandria Kom el-Dikka Project | photo G. Majcherek)

formula made of sand, lime and crushed bricks, the latter added for colouring.

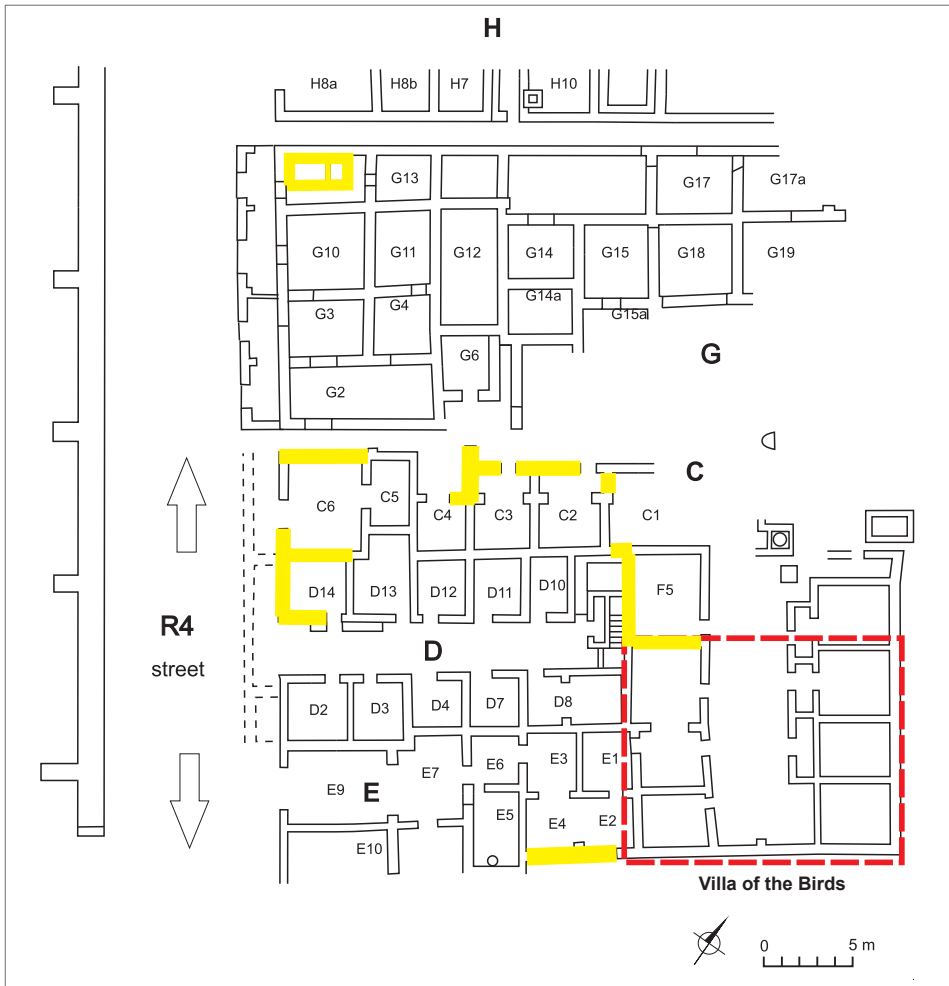
partly restored in the 1970s (Rodziewicz 1984). Large sections of walls in rooms C-1, C-2, C-4, C-8, and D-14, as well as F-5 were treated [Fig. 12]. The main reason for intervention was to reduce the speed of degradation by repairing the damage. Climatic conditions, moisture penetration and weak stone material (soft oolitic limestone) prone to weathering are the main causes of deterioration. In accord-

Fig. 12. Sector W₁N: areas of preservation work (in yellow) in the 2018 season (PCMA UW Alexandria Kom el-Dikka Project | drawing D. Tarara, M. Soltys)

ance with established procedures, well tested and effective traditional building methods were applied. In all these walls, washed out and decayed joints, which had almost entirely lost their resilience, were re-filled with new mortar and re-pointed. Similar measures were also applied to a set of two basins, uncovered in 1989 in room G-8 (Majcherek 1990: 82–83). Both were constructed of small blocks and lined with *opus signinum* (*cocciopesto*) plaster. Loose blocks were now re-set in new mortar. Furthermore, a wall capping was shaped in order to prevent water penetration.

The southwestern corner of room D-14 required more complex intervention. Large parts of the wall were in extremely poor condition. Some of the ashlar were almost entirely deteriorated, and the wall had lost its structural stability. The badly corroded blocks had to be replaced to prevent further decay and to consolidate the structure. This was done using ancient ashlar, found in nearby excavations, and kept in the storage area.

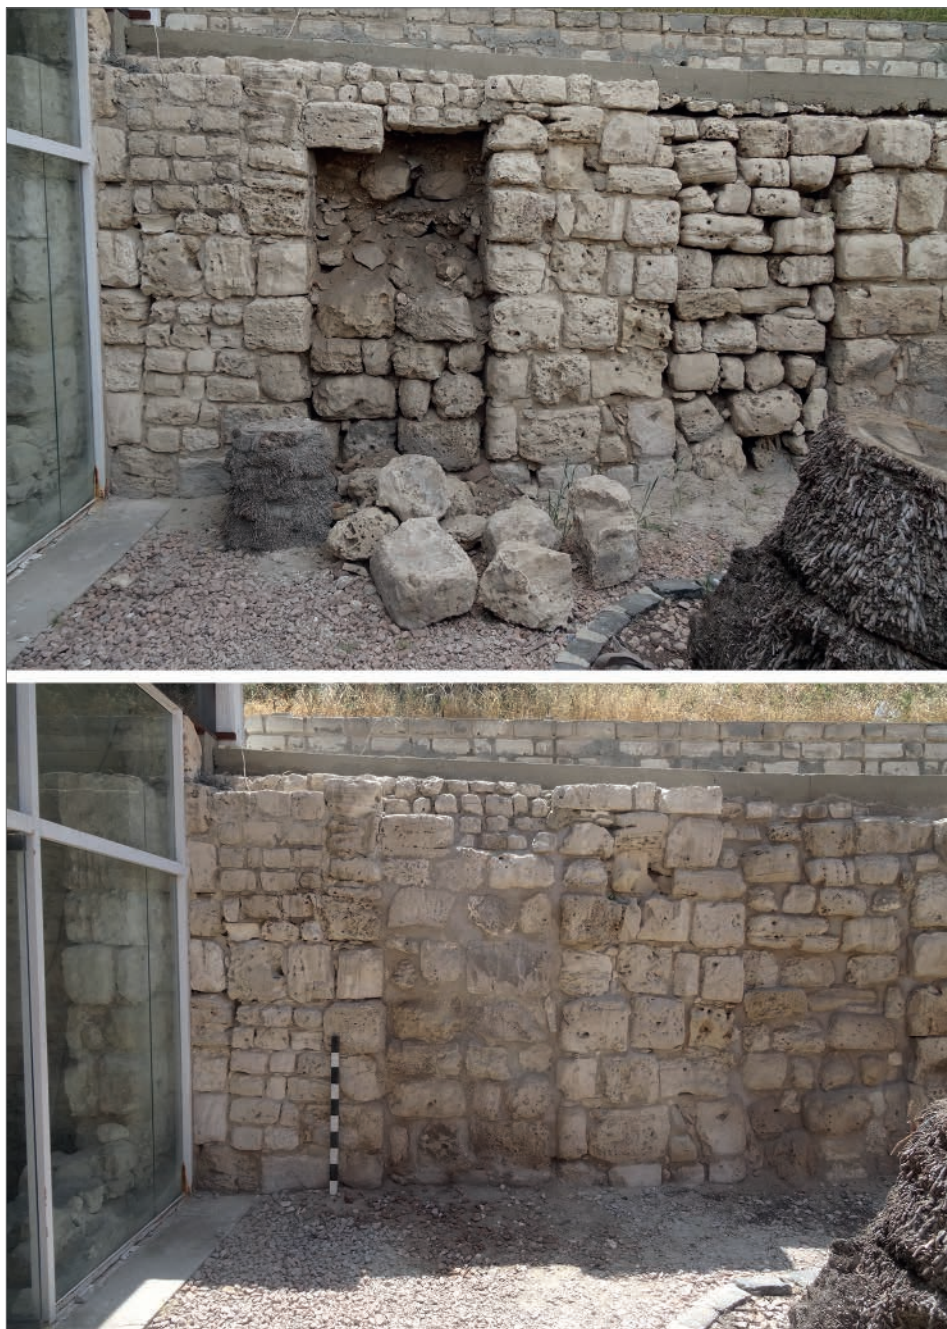
Fig. 13. Walled doors in rooms E-2 and E-4: top, prior to the preservation in 2018 and, bottom, after preservation (PCMA UW Alexandria Kom el-Dikka Project | photos G. Majcherek)

Some of the modern structures in the area also had to be repaired. The best example is the modern walling in the south walls of rooms E-2 and E-4 (next to the western entrance to the Villa of the Birds), which had partly collapsed during particularly heavy rains last year [Fig. 13]. Both structures were now rebuilt from scratch. Stones used in the original construction back in the 1970s were set in cement–lime mortar. Such reinforcement was necessary due to the fact that the restored blocking serves also as a sustaining wall, counteracting the heavy load of the escarpment behind it.

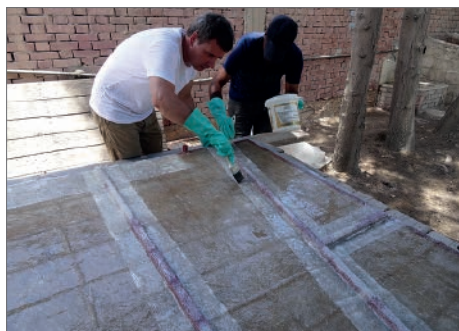
Fig. 14. Restoring the black-and-white mosaic from House MA (PCMA UW Alexandria Kom el-Dikka Project | photo G. Majcherek)

The conservation of a black-and-white mosaic with geometrical decoration, excavated in the 1970s, was initiated this season. The mosaic was found in Roman House MA (under the portico, near the theatre), temporarily protected and put into storage (Rodziewicz 1984: 35, Fig. 19). The face of the mosaic was protected with canvas and soaked with PVA glue. A heavy steel frame and lime–cement stabilizing layer at the back, introduced in 1987, were both removed. The bedding was then levelled with a thin layer of lime–sand mortar, mixed with PVA. A new rigid supporting surface was made of layers of glass fibre, set in epoxy resin (Araldite 1306, produced by Huntsman International LLC), and reinforced with diagonally welded iron bars [Fig. 14]. Once the conservation work scheduled for the next season is completed, the mosaic will be placed on display in the Villa of the Birds mosaic shelter.

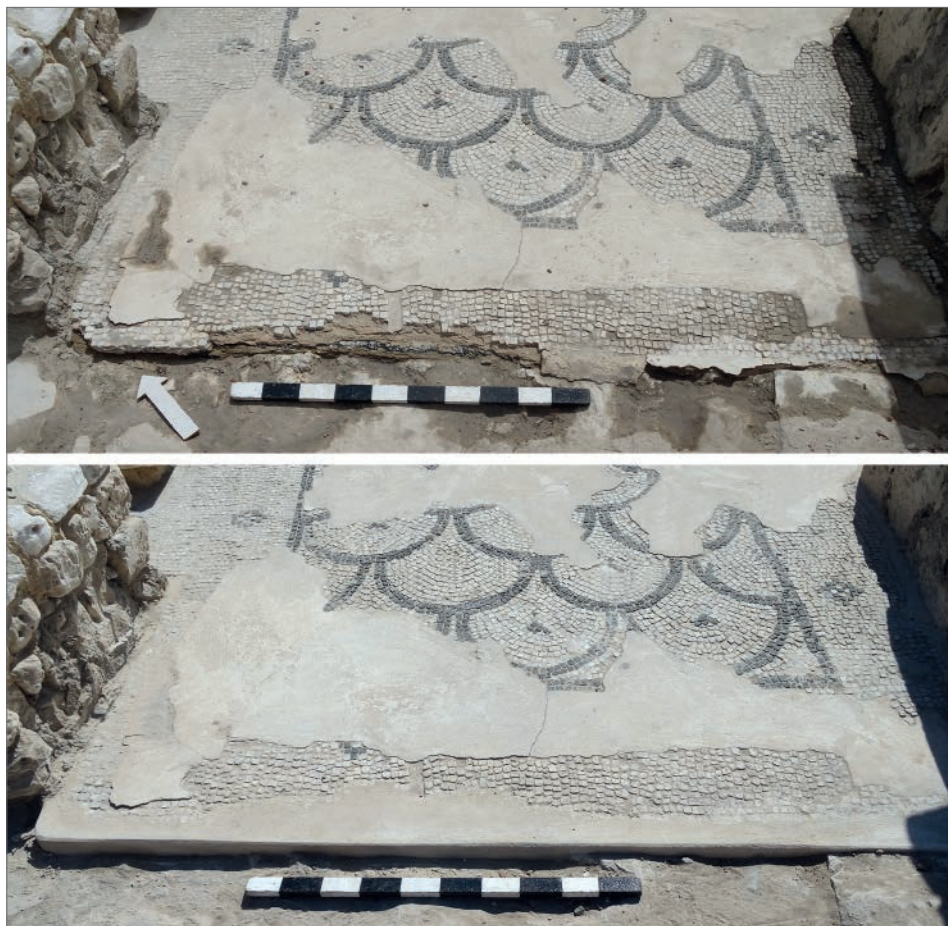
Fig. 15. Damaged mosaic in the northern vestibule of the theatre: top, before repairs and bottom, following preservation (PCMA UW Alexandria Kom el-Dikka Project | photos G. Majcherek)

The Mission undertook also some additional work in other monuments, located outside the current excavation area. In the Theatre, a floor mosaic in the northern vestibule decorated with a scaling pattern and restored in 1967 (Kołątaj and Kołątaj 1975: 88–90), was now treated. The seriously damaged edges of the mosaic were repaired, and lacunae and loose tesserae consolidated [Fig. 15].
