Alexandria, Kom el-Dikka Season 2016

Abstract: The PCMA expedition to Kom el-Dikka conducted fieldwork between March and July 2016, filling out the usual multiple-task agenda encompassing both conservation projects and archaeological excavation. The program of work was conditioned to a large extent by the pending completion of the first stage of the Kom el-Dikka Site Presentation Project (southern zone of the site). Top priority was given to preservation work, supplemented with limited excavation in the early Islamic necropolis. A vast collection of finds including coins, plasterwork, glass artifacts of different age (from Ptolemaic to early Islamic) originating from previous seasons of fieldwork continued to be documented and studied by a group of specialists. The appendix brings a brief report on the glass finds from area CV, stratigraphically from the level of the Lower Necropolis, but chronologically from the late Roman/early Byzantine period (5th–6th century AD).

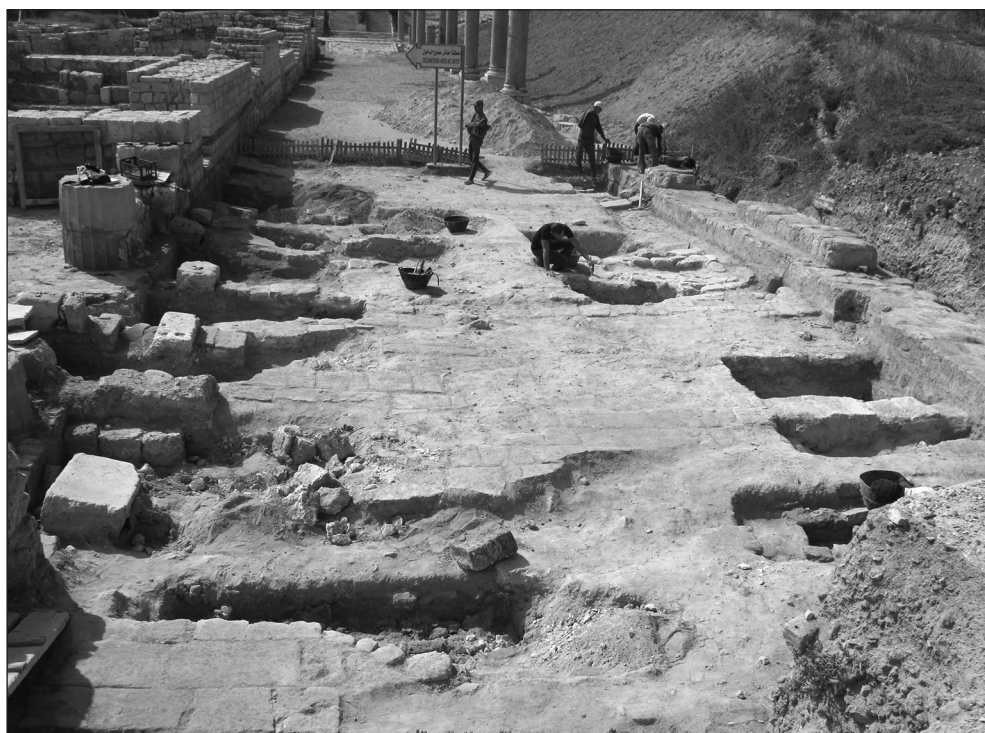
Fig. 2. *Exploration of the early Islamic necropolis in area CV, view from the north*
(PCMA Alexandria Kom el-Dikka Project/photo E. Kulicka)

The planned opening of the site for visitors determined the excavation agenda, limiting exploration to the western section of area CV, which plays a key role in the envisioned itinerary for visitors. Excavation next to the western gate of the bath complex consisted of a trench approximately 12 m by 10 m [Figs 2, 3], opened in an area where investigations in the 1997/1998 season uncovered a large section of an early Islamic cemetery (Upper Necropolis phase). At the same time, a probe dug next to its eastern edge revealed remnants of a gate leading

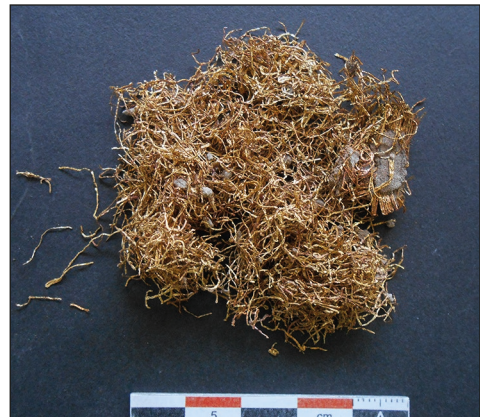
Fig. 5. Golden thread, from grave CV176 (PCMA Alexandria Kom el-Dikka Project/photo G. Majcherek)

The exploration of multi-burial grave CV176, located next to CV178, produced an even more surprising and spectacular find. The burial chamber, which again was built of small regular blocks in typical manner, contained three rather poorly preserved skeletons. A bundle of golden metallic thread was found next to the lowermost burial [Fig. 5]. This spiralling thread, preserved in tiny pieces on the skeleton and underneath it, must have

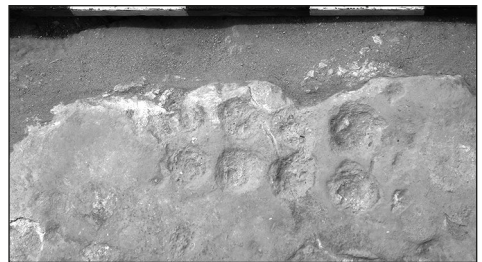
Fig. 8. Mancala game board preserved on the pavement (PCMA Alexandria Kom el-Dikka Project/photo G. Majcherek)

The worn-out surface of the pavement is yet another sign of extended use over a longer period of time. *Mancala*-type game boards were scratched into the surface of two of the pavers [*Fig. 8*]. The boards feature the typical two rows of four to five cup-shaped depressions, also previously identified as game boards in the portico (Bell and Roueché 2007). On yet another slab (next to the stylobate),

a series of concentric incisions of unknown purpose, most probably yet another game board, were found.

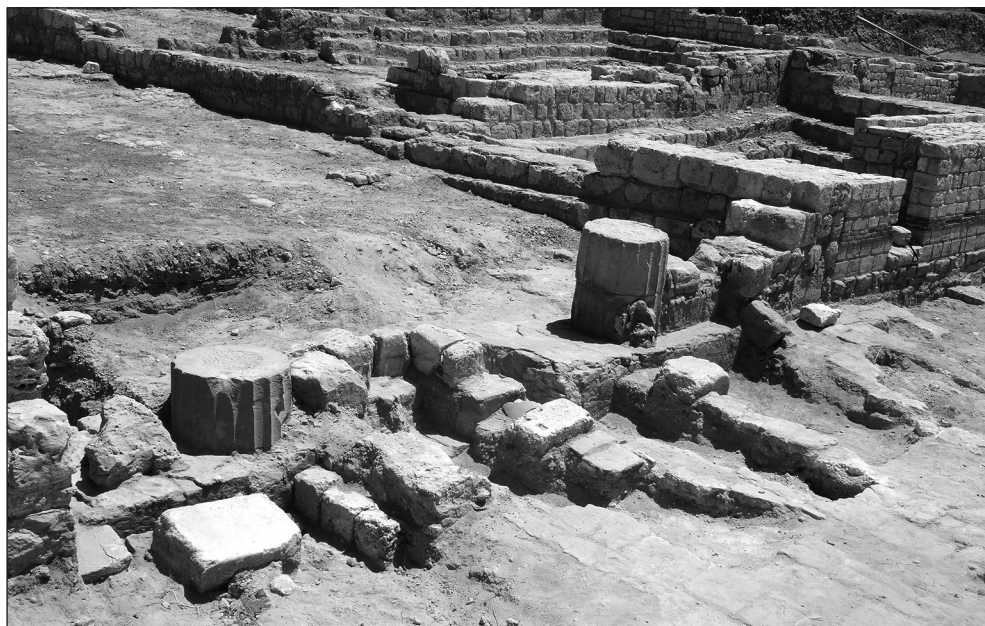
Fig. 9. Gate leading to the bath complex; state prior to conservation in 2016 (PCMA Alexandria Kom el-Dikka Project/photo G. Majcherek)

Both the stairs and the pavement belong to the latest phase in the portico history, when the whole structure was substantially rebuilt following widespread destruction. The operation included not only rebuilding of the backwall of the portico, but also raising of the stylobate and subsequently also of the pavement. In a small test pit (B)

The gate leading from the portico to the bath complex was also the object of conservation work. Procedures involved restoration of two steps of the large stairs located in the entrance, flanked by two Doric columns (work supervised by Marcin Polak and Grzegorz Majcherek). Restoration was seen as a necessary step not only for safeguarding existing remnants of the stairs [see Fig. 9], but also as a requirement for the planned visitors

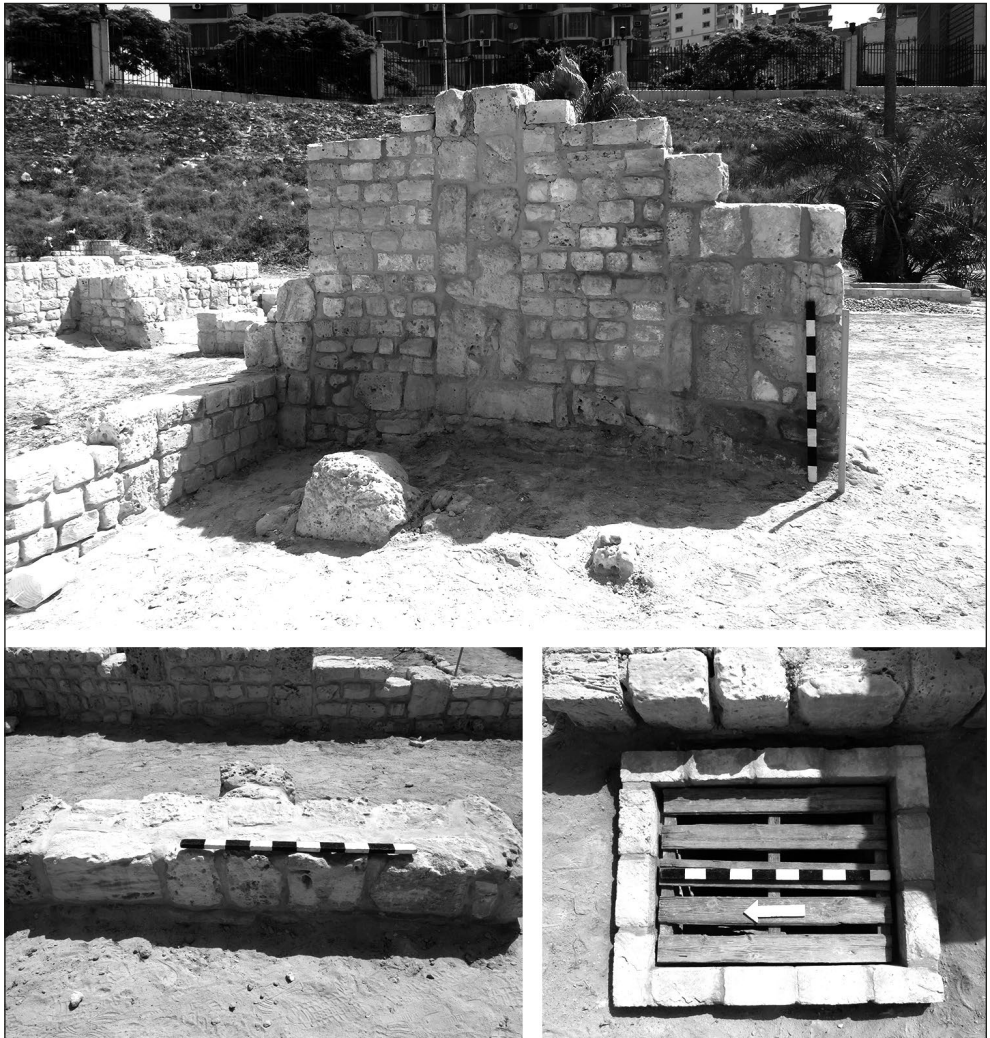
Fig. 10. House G: top, restored western elevation and shops; bottom left, wall between G6 and G7 after conservation; bottom right, street R4: restored manhole (PCMA Alexandria Kom el-Dikka Project/photos G. Majcherek)

The work in 2016 focused on building G, excavated in 1990 in the central part of the area (Majcherek 1991). A section of the western elevation (approximately 16 m long), enclosing rooms G2, G3, G8 and G10, was consolidated (work supervised by Marcin Polak). The weakened and deteriorated joints, some of which had lost almost all resilience, were either filled with new mortar or re-pointed, while some smaller losses and gaps were completed with new stones. The same procedure was applied to shops uncovered along the facade of House G and the opening onto the street [*Fig. 10* top]. The whole annex is made up of four small units of roughly similar size (approximately 1.50 m wide) with walls made of rather large masonry.

completed already in 2006 (Majcherek 2008: 39). Only one course of the original masonry was then restored, in an effort to retain the balance between restored and original fabric. Work done in the present season was essentially routine repairs limited to refilling losses in joints or replacing some modern, badly corroded blocks in the walls, which had suffered from the heavy rains that swept Alexandria the previous fall.

Some other seriously damaged walls of House G, e.g., the high wall between rooms G6 and G7, were also repaired [*Fig. 10* bottom left]. Similar measures were also undertaken in the case of the northern wing of House C. Sections of walls in rooms C4, C5 and C6 were treated likewise.

The rectangular well heads of two manholes located in the R4 street, restored in the past, were now repaired [*Fig. 10* bottom right]. Seriously deteriorated modern blocks were replaced with new ones, and the original form of both well heads was duly restored. A similar operation was also carried out in the case of a much larger rectangular wellhead of the underground cistern, located north of the mosaic shelter. There, however, it was necessary to rebuild the entire wellhead, two courses high.

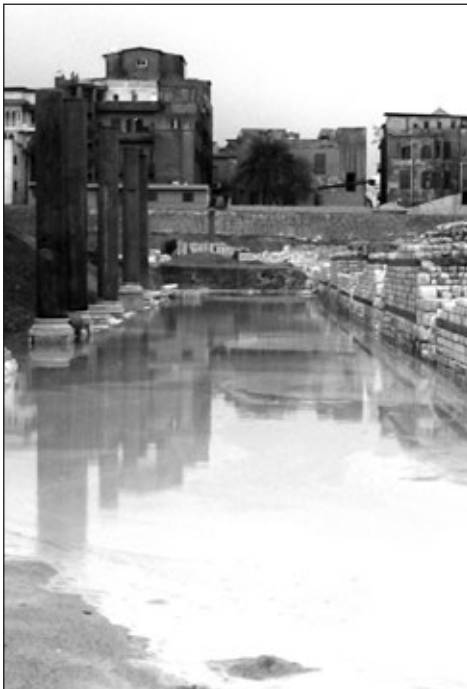
Fig. 14. Flooded portico after heavy rains in the fall of 2015 (Photo Mahmud Mohammed al-Said)

Heavy rains in October 2015 flooded large parts of the site, resulting in extensive damages [Fig. 14]. The devastating effect of water was observed in several monuments throughout the site. The theater and the portico appeared particularly vulnerable due to the lay of the ground. The high steep

earth slopes around them would normally absorb runoff were they not occasionally cemented or covered with stone. Moreover, a clogged drainage system along the portico did not help in effective handling of runoff water.

In several areas, where rainwater had been standing for a longer period of time (in front of the theater and next to auditorium M), serious ground subsidence was observed. Most of such damage was duly repaired, but this unplanned work involved moving large volumes of earth, backfilling and shaping new surfaces with a proper ground pitch. Damaged structures likewise had to be treated. A partly destroyed ancient staircase in the northern vestibule of the bath was repaired. Loose stones were fixed with new mortar, and eroded bricks (dating from the 1960s conservation operation) were replaced with new ones.

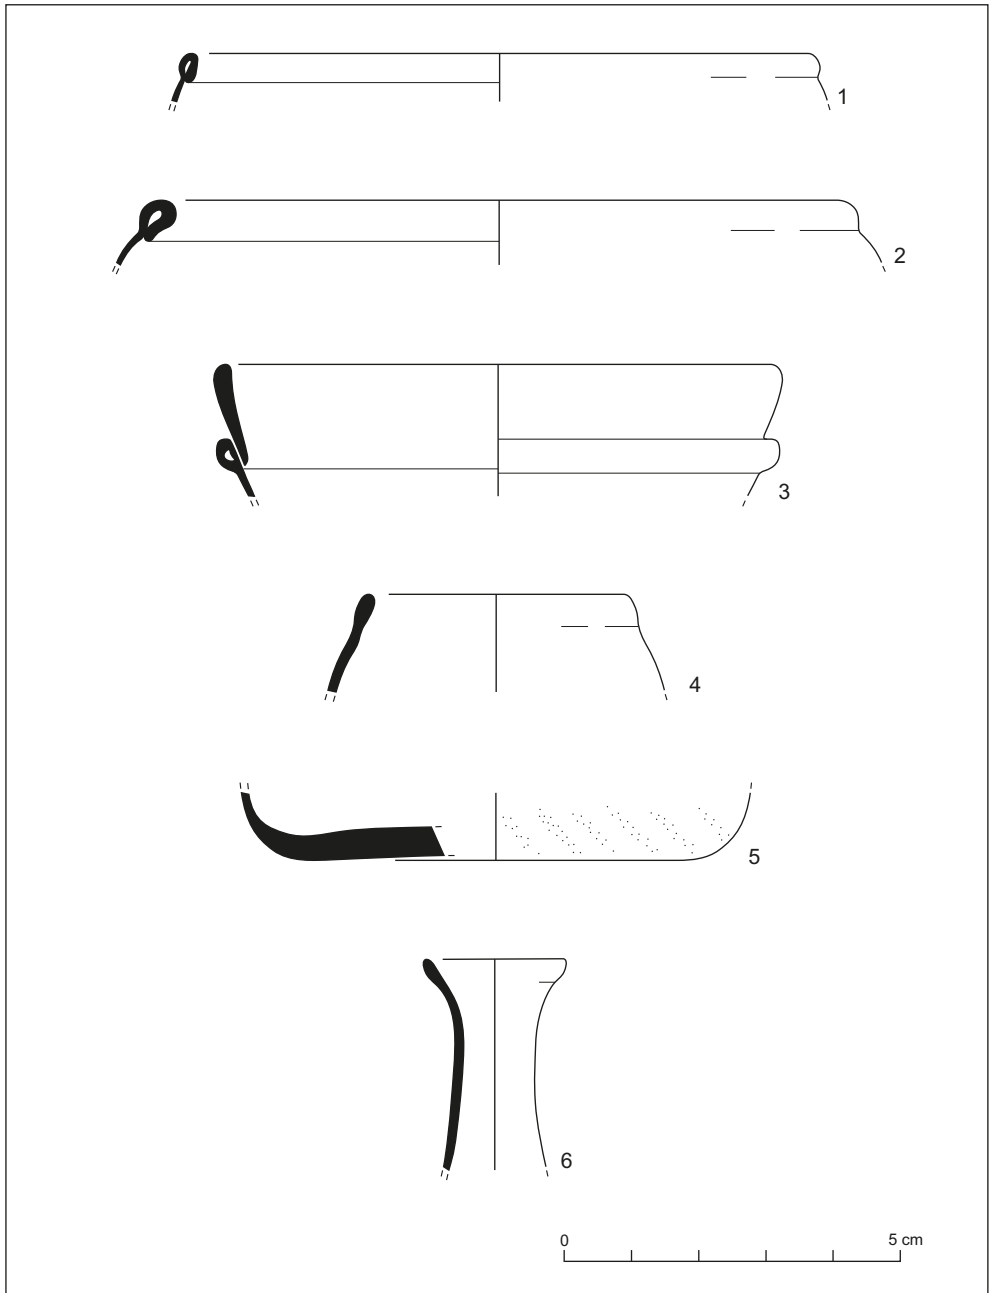
Fig. 15. Glass finds from area CV
(PCMA Alexandria Kom el-Dikka Project/drawing E. Kulicka, digitizing M. Momot)

Three rim fragments belong to bowls with convex-curved bodies [*Fig. 15:1–2*]. They are characterized by delicate walls and in-folded rims with small elongated openings. Vessels were made of pale bluish-green glass of low quality with pinprick bubbles and small black impurities. No weathering was evident.

The third fragment is of special interest, representing as it does a deep, conical specimen with flaring walls and a high collar rim with a rounded thickened edge. It was made separately and neatly fused on the inside to an in-folded rim with

a small, horizontal opening [*Fig. 15:3*]. These bowls, although found at Kom el-Dikka in relatively small numbers, should be identified as local products (Kucharczyk 2010a: 60–61, *Fig. 3:5–6*; 2011: 59–60, *Fig. 2:6–7*; 2016: 90, *Fig. 2A:8, 98, Fig. 7:2–3, 101–102, Fig. 9:1*). The evidence of deep bowls with in-folded rims of the late Roman period also came to light in the eastern subterranean cistern of House 1 at Marina el-Alamein (Kucharczyk 2010b: 120, 122, *Fig. 5:3–4*).

One shard came from a small flask with a long cylindrical neck, widening towards the shoulders, and a conical funnel-shaped mouth with a simple, fire-rounded thickened rim [Fig. 15:6]. The specimen was made of extremely bubbly

Two fragments of glass were found on the surface. One shard most probably belongs to a wineglass with a thin, slanting wall and a thick, fire-rounded rim [Fig. 15:4]. The second shard comes from a straight-sided bottle (too small to be illustrated). Both vessels are dated to the 5th–6th century AD and were made of bluish-green bubbly glass and showed no signs of weathering.
