NEA PAPHOS. SEASONS 2012 AND 2013

Henryk Meyza

Institute of Mediterranean and Oriental Cultures, Polish Academy of Sciences

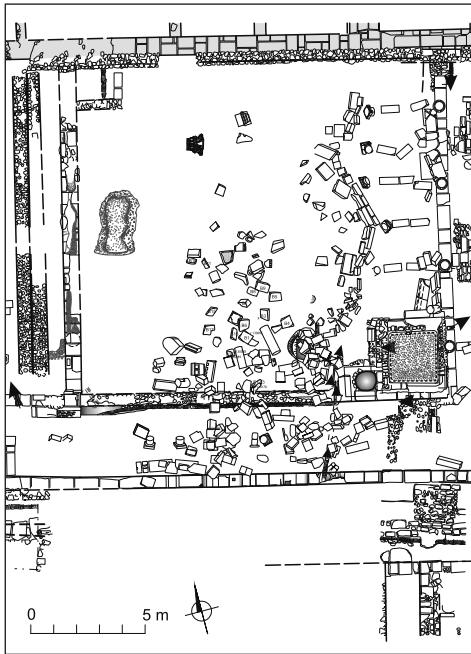
Fig. 1. Main courtyard of the “Hellenistic” House (1) and its southern portico, street A’ and remains of insula 10B’ (Drawing A. Brzozowska, S. Medeksza)

using wooden elements. Some of these blocks were left *in situ*, covered again by soil and enclosed in a modern supporting wall. Similar remains were uncovered in 2014 further south in the collapse stratum of the same portico [Figs 1, 2].

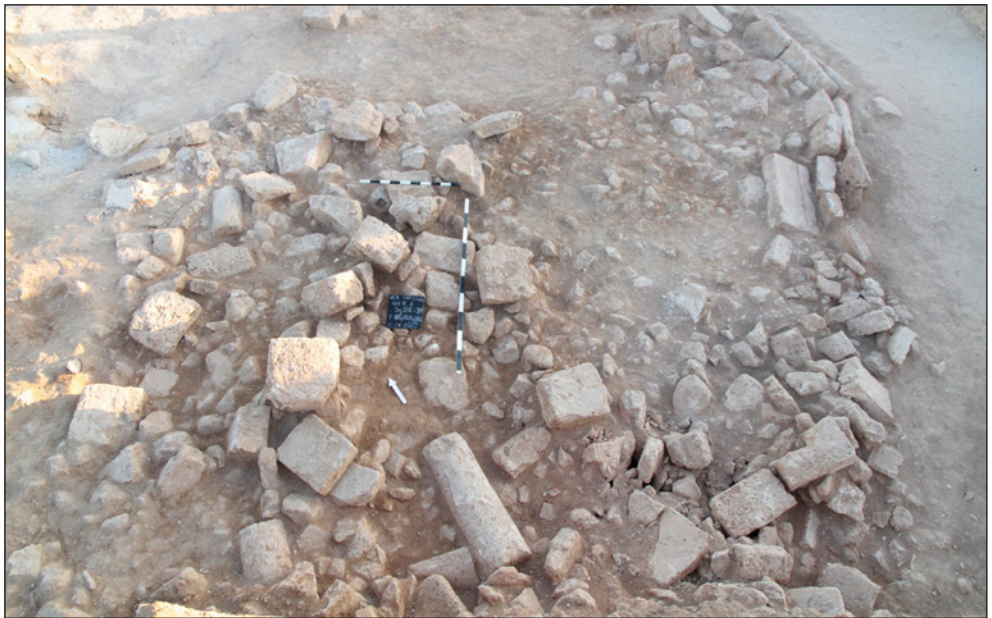
Fig. 2. Eastern part of the main courtyard of the “Hellenistic” House (1) and remains of the entablature of the eastern portico (Photo H. Meyza)

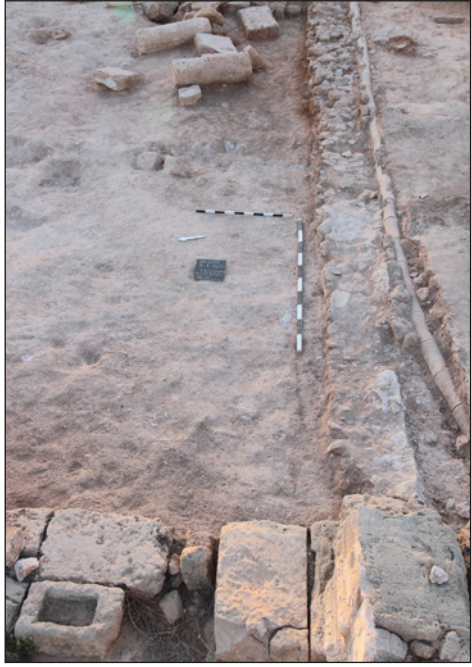
Fig. 3. *Stylobate of the southern portico (R.3)*
(Photo H. Meyza)

africanum/incertum and the position of pillars, built of larger blocks, seems to be preserved in some places in the arrangement of the rubble [Fig. 4]. The stylobate of the southern portico, however, was robbed out. The foundation was preserved with traces of gypsum plaster, which was used to set the stylobate blocks [Fig. 3].

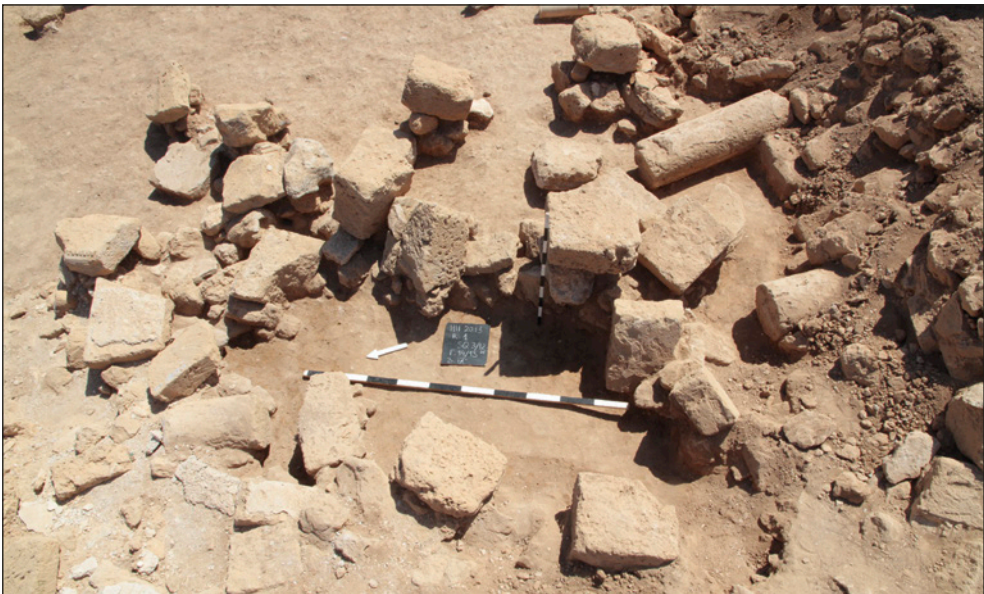
Fig. 4 *Remains of pillars of opus africanum/incertum walls collapsed in the courtyard and partly disturbed by stone-hunting* (Photo H. Meyza)

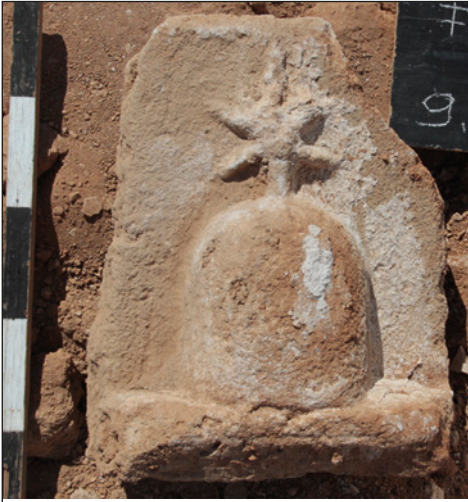
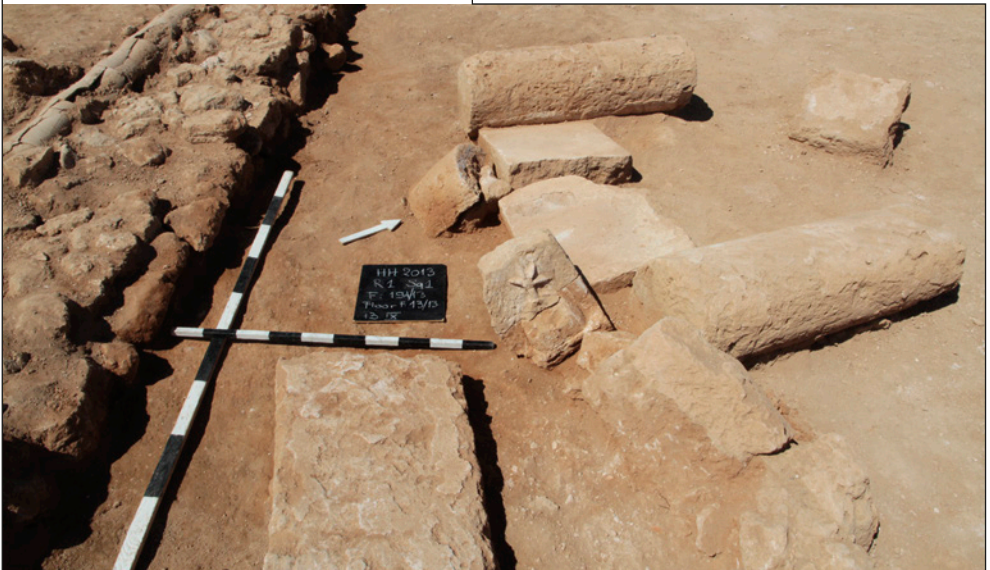
Fig. 5. Acroterium with symbols of the Dioskouroi: pilos and star; below, the acroterium found in situ (Photos H. Meyza)

The lowest drums of the southern colonnade were removed together with the stylobate, while remains of the entablature were found between the upper drums. These included two acroteria with symbols of the Dioskouroi: a pilos with a superimposed star (Barnard 2003: 74–75; Papantoniou 2012: 254; Zapiti and Michaelidou

2008: 128, No. 23) [Fig. 5]. The position of these on top of the entablature is conjectural. Their position could mark the entrance to the building from the south; a wide door (2.20 m between jambs) existed in the back wall of the portico, which is at the same time the southern elevation of the building on street A'. Other possible traces of their wooden construction were suggested by a set of bronze nails and an iron tube, which may have belonged to the hinge [Figs 6, 7].

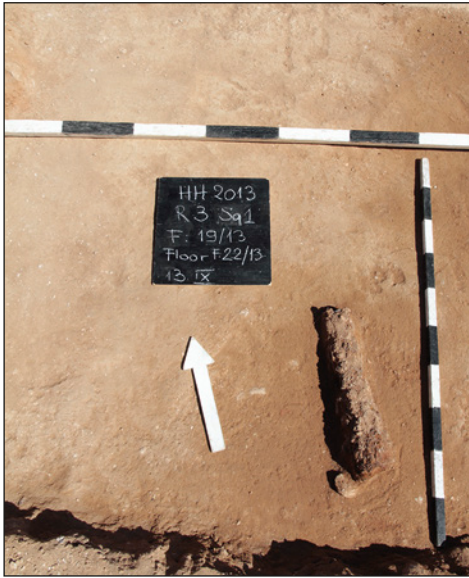
Fig. 6. Iron tube, probably hinge of large door leading from street A' to the southern portico (R.3) (Photo H. Meyza)

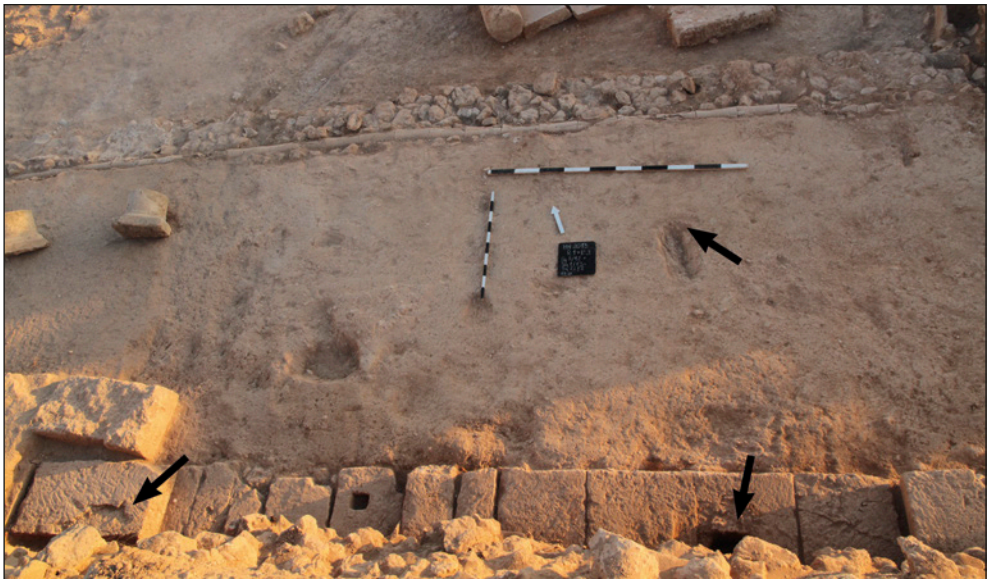
Fig. 7. Southern portico: jamb sockets in a door threshold leading from street A' and position of tentative iron hinge marked (Photo H. Meyza)

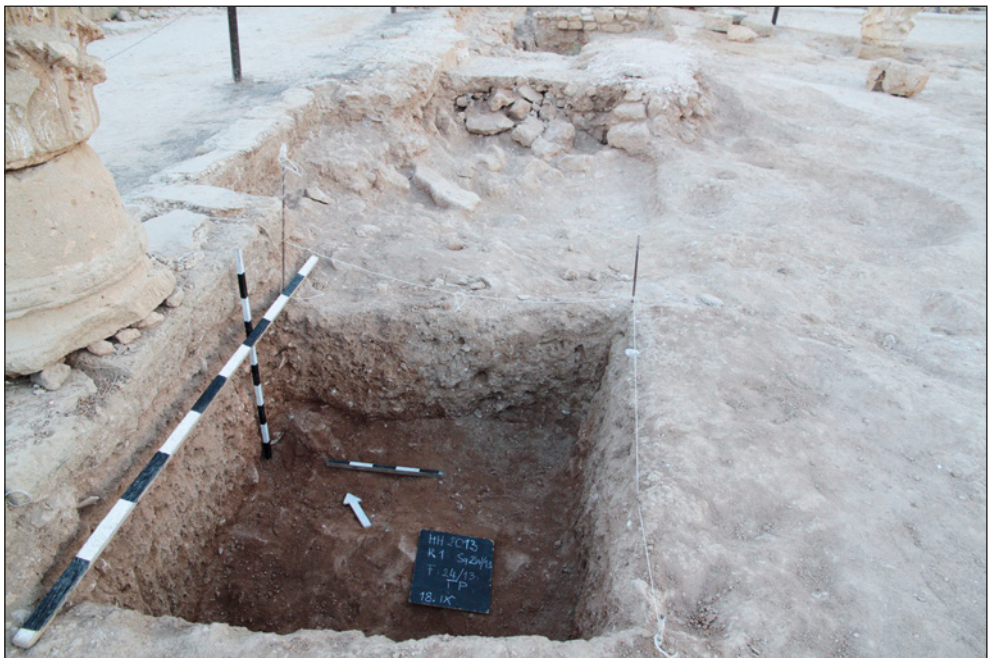
Fig. 8. Trial pit below reconstructed Corinthian column; in the background deep cut along eastern side of western portico stylobate, cutting hydraulic floor in the courtyard (1) (Photo H. Meyza)

A trial pit east of the probable site of one of the Corinthian columns aimed at verifying the character of its foundation. The hydraulic plaster covering that part of the “stylobate” preserves a partial imprint of a large round base and the base found at northern end of the courtyard was restored to that place. This was topped with a Corinthian capital found

at the southern end of the “stylobate”. No foundation of a width corresponding to the “stylobate” top course was observed; further digging under the base was not possible because of safety reasons. Two layers were explored with grayish clay superimposed over brown soil entering under the top course of the “stylobate”. Pottery found in these layers suggests that the fill on the courtyard was not much earlier than the destruction and that the “stylobate” was constructed at the end of the 1st century AD or even slightly later. Cypriot Sigillata forms P11, P29 (Hayes 1991: 44, Fig. 19,29) and P40 as well as “carrot” amphora fragments were present in the grayish clayey stratum. In the lower stratum, such pottery (a few pieces) was mixed with Hellenistic material.

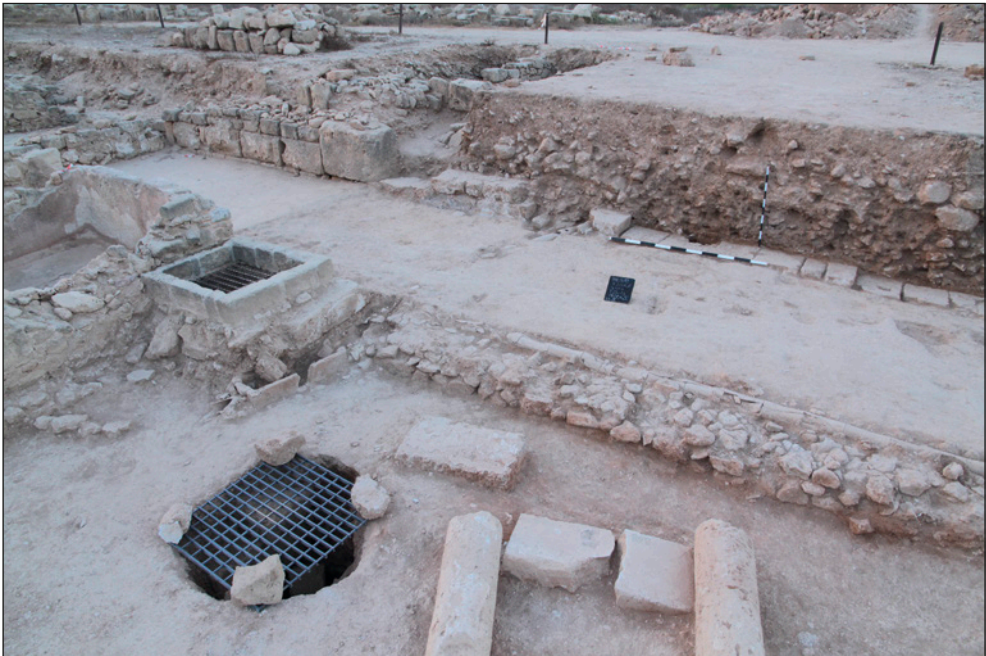
Fig. 9. Water installations in the southeastern corner of the main courtyard (1)
(Photo H. Meyza)

A settling tank and a pipe leading from the street A’ were situated along the western side of the well-head of the subterranean cistern uncovered in 1991 just west of the aboveground basin in the southeastern corner of this courtyard. The settling tank was built against a reused block (it is plastered on its western side), positioned north–south and included within the frame of the well-head. The pipe cut across the southern elevation of the building and through the southern stylobate foundation as well as the pipe running along it on southern side [Fig. 9]. A fragment of a pipe leading further north from the settling tank was found, but it was discontinued after just a single segment. It may have continued along the foundation supporting the basin

[see *Fig. 9*], projecting on the west and north below the basin walls. The layer covering the settling tank contained large amounts of crushed pottery, all belonging to various plain water containers, used to transport or pour water lifted from the underground cistern. This pottery could not be well dated.

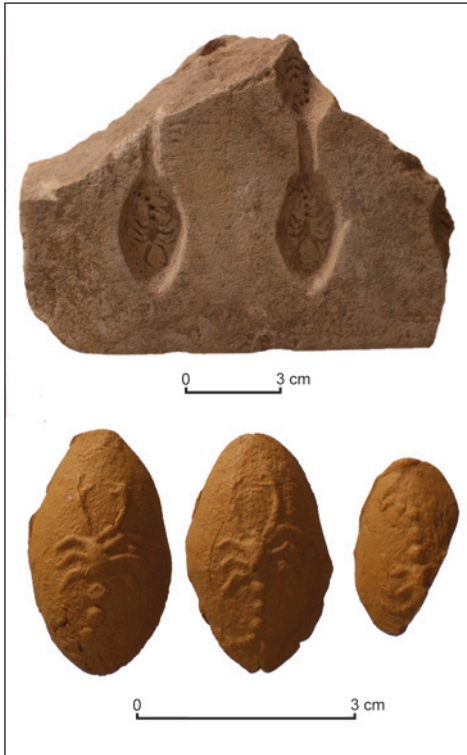
Fig. 10. Molds for sling bullets decorated in the form of a scorpion in relief; bottom, impressions of sling bullets in clay (Photo K. Bajerowicz-Dolata)

In the disturbed fill above the courtyard surface there were few finds of intrinsic interest apart from a mold for sling bullets with decoration in the form of a scorpion in relief [*Fig. 10*]. Two joined bullets of this type were found in the Agora Project excavations. Four coins, two better preserved lamps and a small pawn of dark stone were also recovered. The rubble yielded numerous decorated architectural elements, including a series of fragments of “Nabatean” capitals of a variant

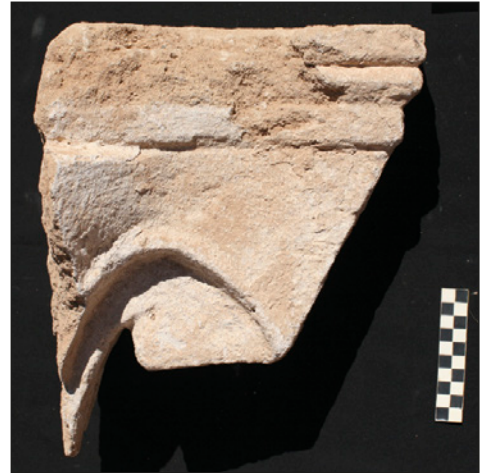
Fig. 11. Corner of a “Nabatean” capital of the Nea Paphos II type (Photo K. Bajerowicz-Dolata)

first encountered in 2012 [Fig. 11], then described as featuring schematic volutes, and now, after a study of comparative pieces seems to be a form specific for Paphos. This type of “Nabatean” capital occurs in the main courtyard, but the number of variants known from the “Hellenistic” House has risen to five. It seems probable that the capitals belonged to the decoration of the northern side of the courtyard, and thus each of the four porticoes was built in a different style. While the southern and eastern porticoes were relatively low, with columns 2.90 m high,

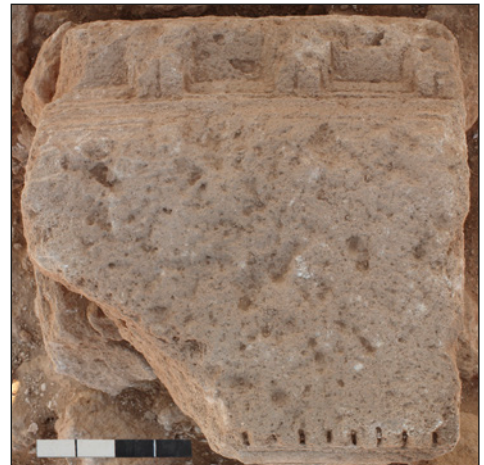
Fig. 12. Possible tholos lintel fragment (Photo K. Bajerowicz-Dolata)

Two reused blocks belonging to a structure of round plan were also found [Fig. 12]. The blocks formed a two-sided decorated lintel(s), possibly installed over a door (and/or) window in the external

wall of a tholos. It does not seem to have exceeded 3 m in diameter. The existence of a structure of this kind nearby is purely hypothetical, but it does encourage deeper excavation in the courtyard as the curved blocks were evidently reused in the final (Roman) phase of the “Hellenistic” House.
