Shaping a city and its defenses: fortifications of Hellenistic Berenike Trogodytika

Marek Woźniak

Polish Centre of Mediterranean Archaeology, University of Warsaw

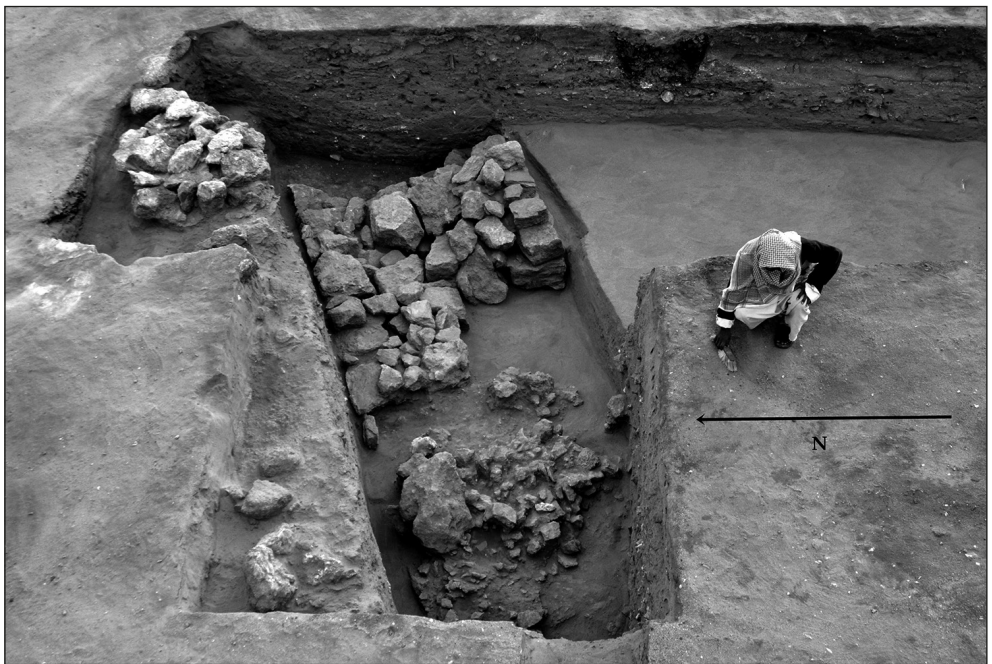
Fig. 2. Remains of the northern Hellenistic defensive wall: view looking east (PCMA–University of Delaware Berenike Project/photo S.E. Sidebotham)

Excavation in 2013 (trench BE 13-90 and its extension BE 13-93) [Fig. 1 top] revealed clusters of highly eroded blocks of anhydrite in more or less regular alignment [Fig. 2]. Stretching from east-northeast to west-southwest, these assemblages usually consisted of one course (two courses survived only in a few places) and were from 0.50 m to 1.50 m wide. The

most interesting observation about the unearthed clusters of blocks and fragments of partly slaked anhydrite of various size was that they lay on the northern edge of a 2.50-m-wide strip of sand, which was, in fact, a large robber pit. It ran the same course as a stretch of anhydrite blocks suggesting that the two features were in some way connected. Lying at the bottom of the robber trench was a stretch of wall, one-meter wide, composed of blocks of diverse sizes, and broken fragments of anhydrite on a footing that was 1.60 m wide and made of the same material. The remains were at a depth of more than 1.50 m. Two of the largest blocks, both regular and quite well worked, measured 0.50 m in length and width, by 0.30 m thick; a third block was 0.70 m long, 0.35 m wide and 0.20 m

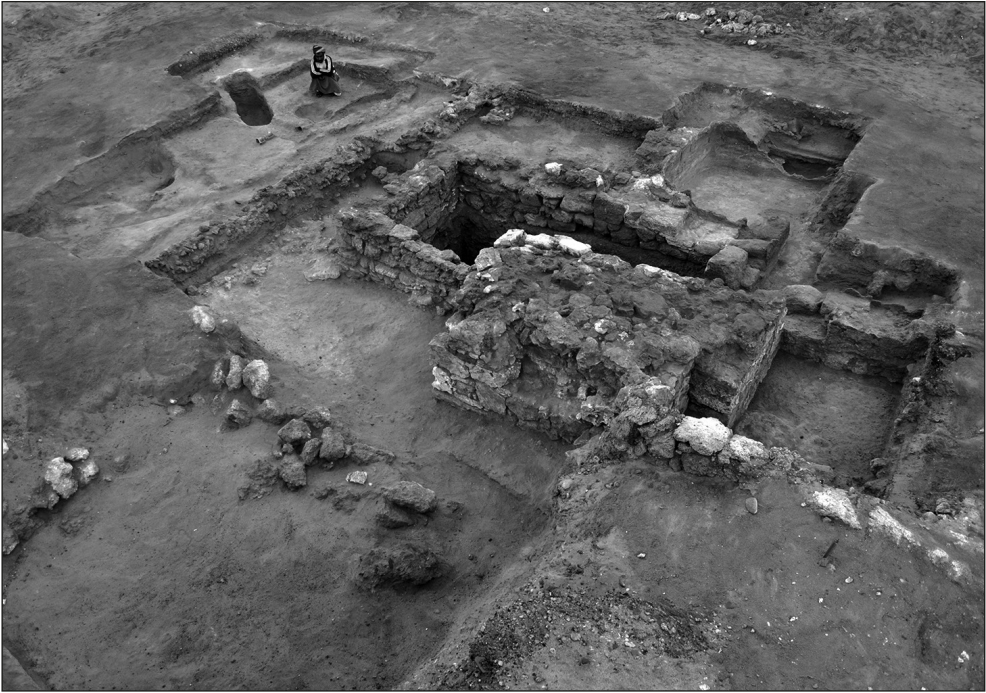
Fig. 3. Remains of the fortified northern gate of Hellenistic Berenike Trogodytika, view from the northwest. In the foreground, the western “pylon” with the destroyed remains of a retaining wall protecting the northern portal of the gate against sand and water. Main chamber of the gate behind the pylon, enclosed by later walls and with the northern and southern thresholds raised to protect it (PCMA–University of Delaware Berenike Project/photo S.E. Sidebotham)

was cautiously identified as a solid western “pylon” of a fortified gate from the Hellenistic period [*Figs 3, 4*].

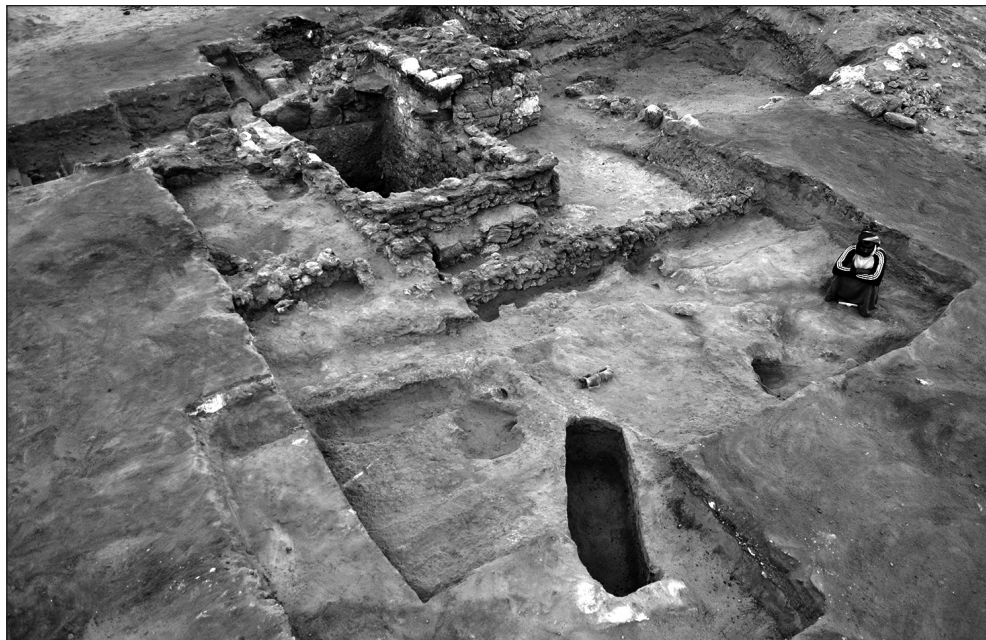
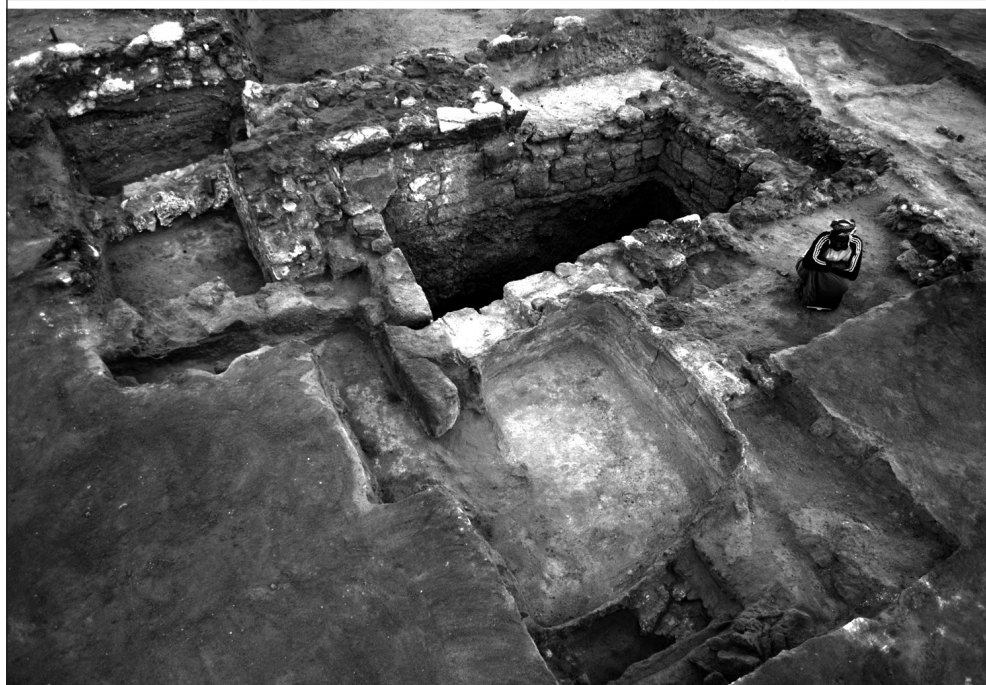
Fig. 4. (opposite page) Remains of the fortified northern gate of Hellenistic Berenike Trogodytika: top, view from the east; bottom, view from the southwest (PCMA–University of Delaware Berenike Project/photos S.E. Sidebotham)

Top, foreground: earthen installations for accumulating rainwater with early Roman graves cut into them. In the background, the rebuilt east wall of the inner chamber of the gate (the only remains of the original first phase of the wall are the four large blocks in its central part). In front of it stands a late Hellenistic east wall built of small irregular stones. It was erected already after the destruction of the east curtain wall, which had originally run between the first Roman grave seen in the foreground and the northeastern corner of the trench where the human scale is seen.

Bottom: a large pool (not yet explored) seen in the foreground and to the north of it, the inner chamber of the gate with the western “pylon”. The main west curtain wall is visible in the top left corner and in front of it there is the footing of the rampart connected with the northwestern corner of the “pylon”. East of the “pylon”, the wall blocking the northern portal, raised twice; note the threshold.

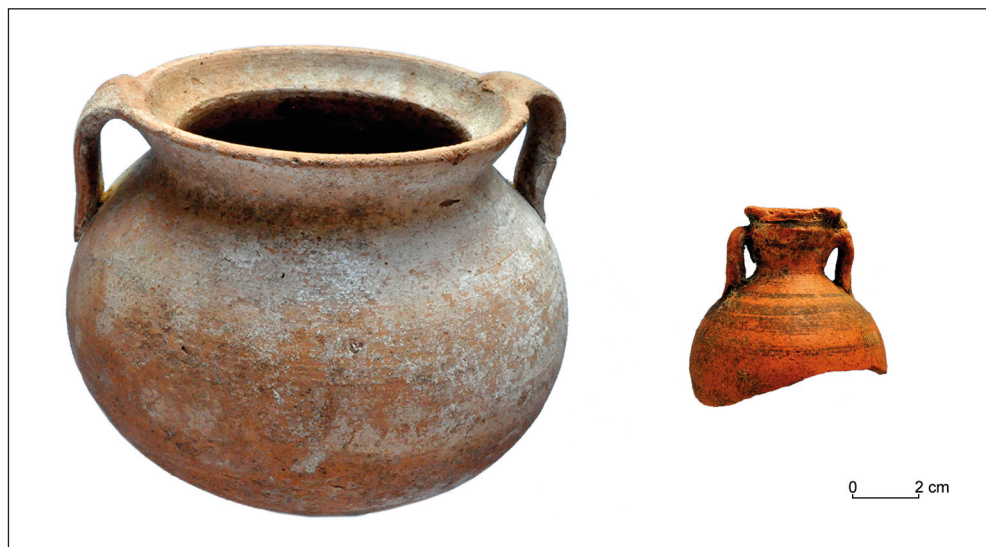
Fig. 5. Hellenistic pottery found in the fill of the negative of the east curtain wall (PCMA–University of Delaware Berenike Project/photos S.E. Sidebotham)

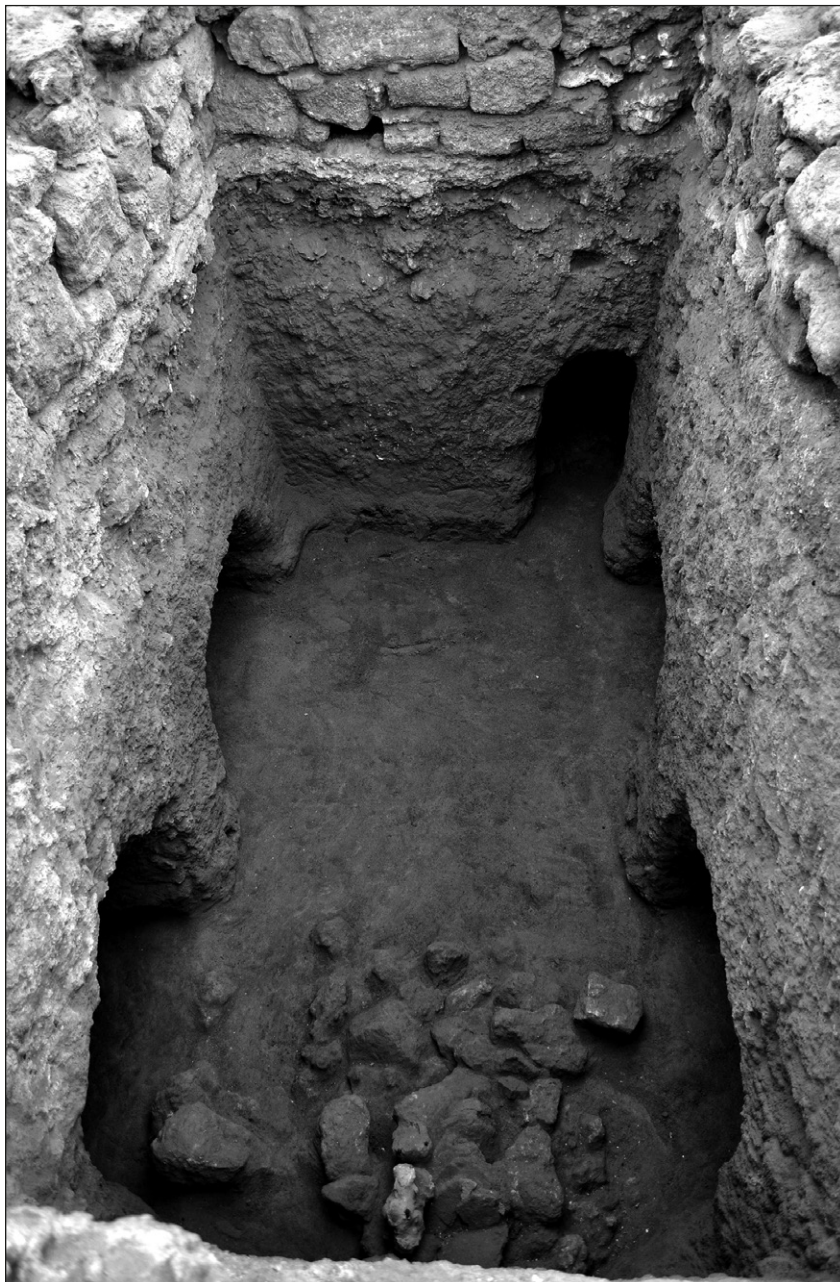
Fig. 6. Inner chamber of the Hellenistic gate, view from the west. In the foreground, top of the rubble heap in the partly-explored sandy fill (PCMA–University of Delaware Berenike Project/photo S.E. Sidebotham)

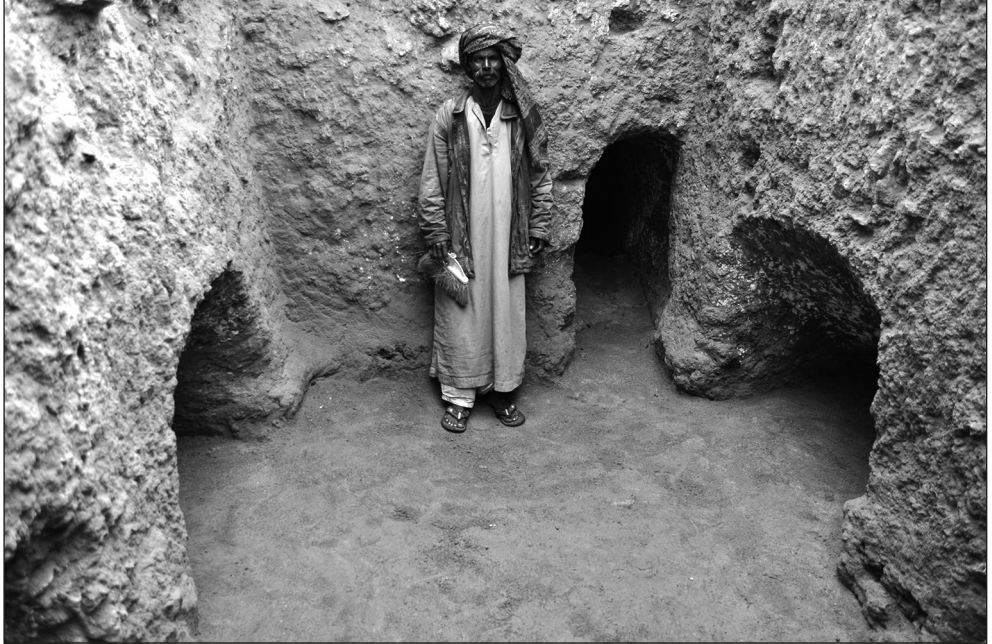
Fig. 7. Inner chamber of the Hellenistic gate: top, entrances to the unexplored small underground rooms with sloping ceilings (shafts or entrances to rooms located deeper) in the south and north walls and a slightly higher opening in the east wall leading to a tunnel; left, close-up of the top of one of the entrances in the northern wall (PCMA–University of Delaware Berenike Project/photo S.E. Sidebotham)

reason for this persistence in protecting the inner gate chamber from drifting sand. Entrances to four small (0.80–1.10 m wide and 1.50–1.60 m long) rooms or chambers were found inside the rectangular chamber of the gate, about 2.00–2.50 m below the preserved tops of walls and approximately 1.50 m below the level of bedrock forming the plateau (the interiors have yet to be explored) [Figs 6, 7]. Two of these rooms were hewn in the north wall of the chamber and two directly opposite in the south wall. All the entrances had flattened arches and the ceilings sloped sharply towards the back at an angle of approximately 45° [Fig. 7 left].

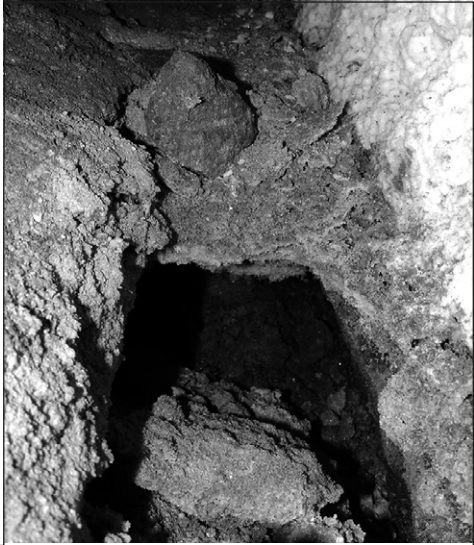
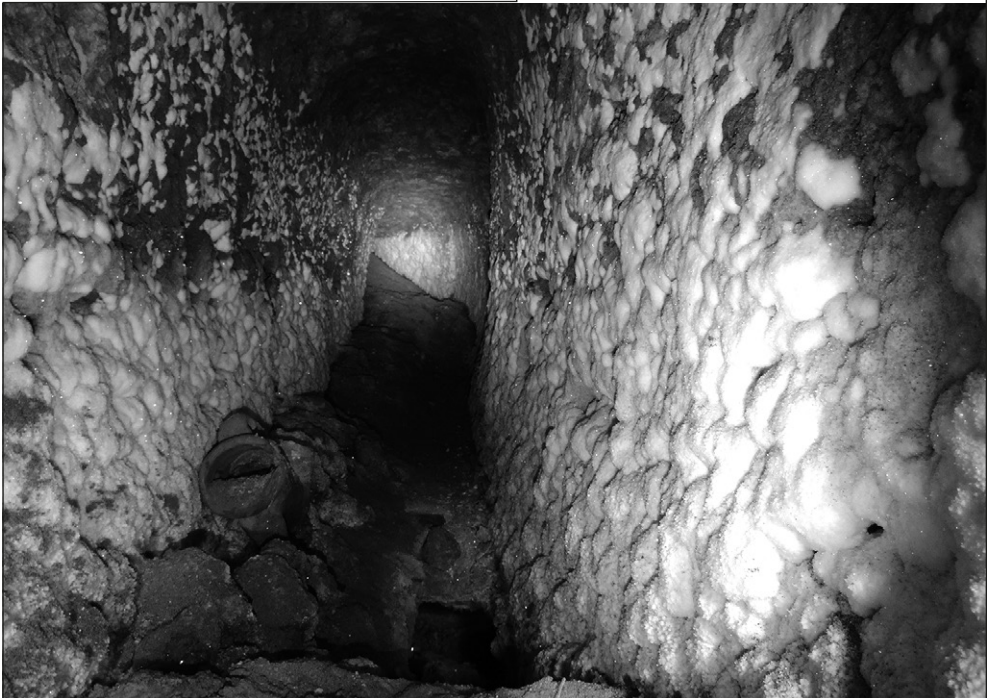
Fig. 8. Tunnel in the east wall of the inner chamber of the Hellenistic gate: top, view toward the back end where it turns to the northwest; thick salt efflorescence covers the walls; right, sunken part of the channel cut into the floor of the tunnel inside the chamber of the Hellenistic gate and covered with thin stone slabs (PCMA–University of Delaware Berenike Project/photos M. Woźniak)
