Assessment of the building's geometry and technical condition on the basis of the data acquired by means of 3D terrestrial laser scanning

The measurement was conducted in Klewki, a location in the Warmia-Mazury Province (Poland). The historic St. Valentine and Roch's parish church has been selected as the object of the study. The first temple building was erected in this place approximately in 1352. Unfortunately, it was burnt at the beginning of the 15th century. The church was rebuilt, but it experienced another fire in 1718. During its reconstruction some parts, e.g. windows, were redeveloped. In 1829, the subsequent redevelopment took place, during which a timber tower was erected. The church is buttressed, which means that vertical counterforts have been used in it as structural members, transferring the load to the foundation and strengthening the walls. It is a Gothic church built of bricks and field stones. The timber tower adheres to its western side and the sacristy is located at the northern side (Fig. 1). The main body of the building is covered by the ridge roof, made as double collar-beam timber structure.

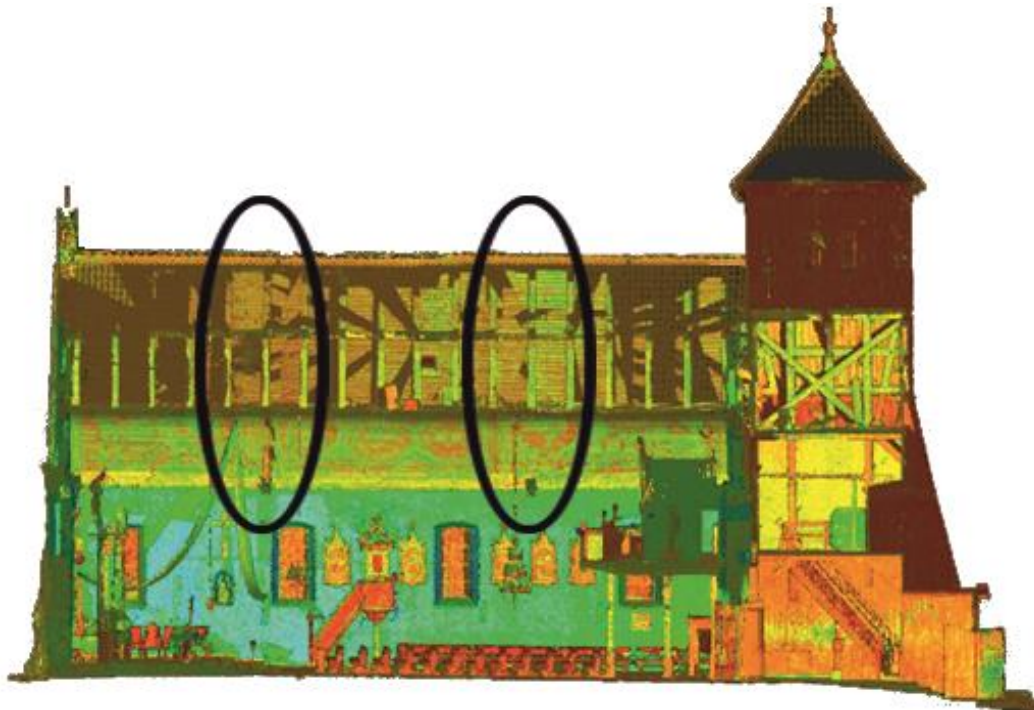
Fig. 2. Longitudinal section made using a point cloud with the discussed issue marked
Source: Own work.

In the course of research making use of a point cloud, the structural members of the church were identified. Measurements covered the whole of this typical sacral building. A rood beam, placed over the nave, turned out to be an interesting element. This architectural member usually performs a decorative function. However, after the longitudinal section of the object was prepared on the basis of the point cloud, it was observed that it performed also a structural function and it was positioned exactly in the same place as the rafters, thus forming a complete truss (Fig. 2). Between the fink trusses and also between the truss and the wall, the fixed number of attic trusses can be found. It shows certain dependencies exploited by the designer. It is difficult to notice these dependencies during the site inspection, as it is impossible to see all structural members of the roof at the same time. Thus, laser scanning made it possible to analyse the structure and describe the characteristics of the rafter framing and its component parts.

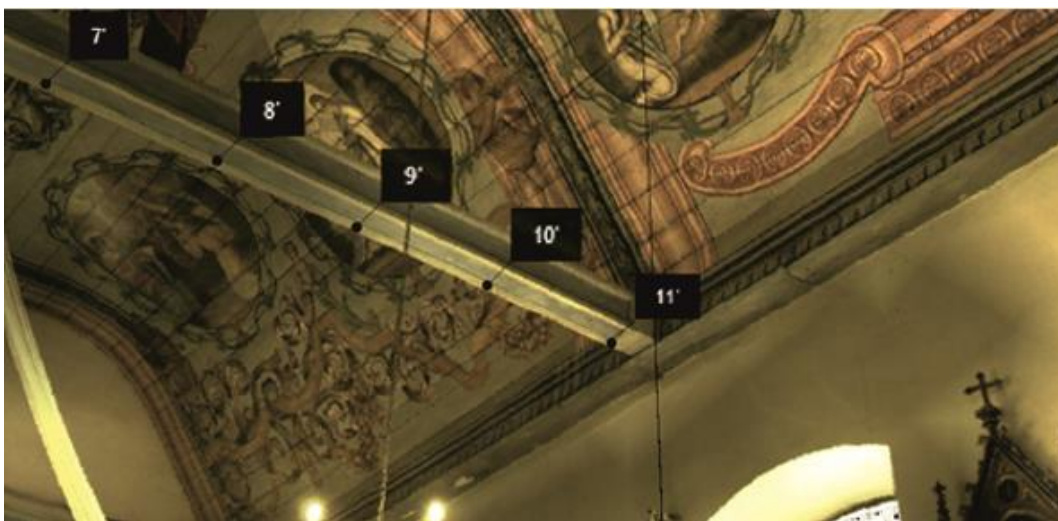
Fig. 5. Examples of measuring points on the rood beam
Source: Own work.

Measuring points at which the coordinates of the truss were read were placed along the beam (Fig. 5). Theoretically, to measure the deflection of a simply supported bent beam three measuring points are sufficient, one at the centre of the span and two at the supports. However, they are not sufficient in practice, as deformations may be caused by different errors made at the stage of execution or installation, which are unpredictable.

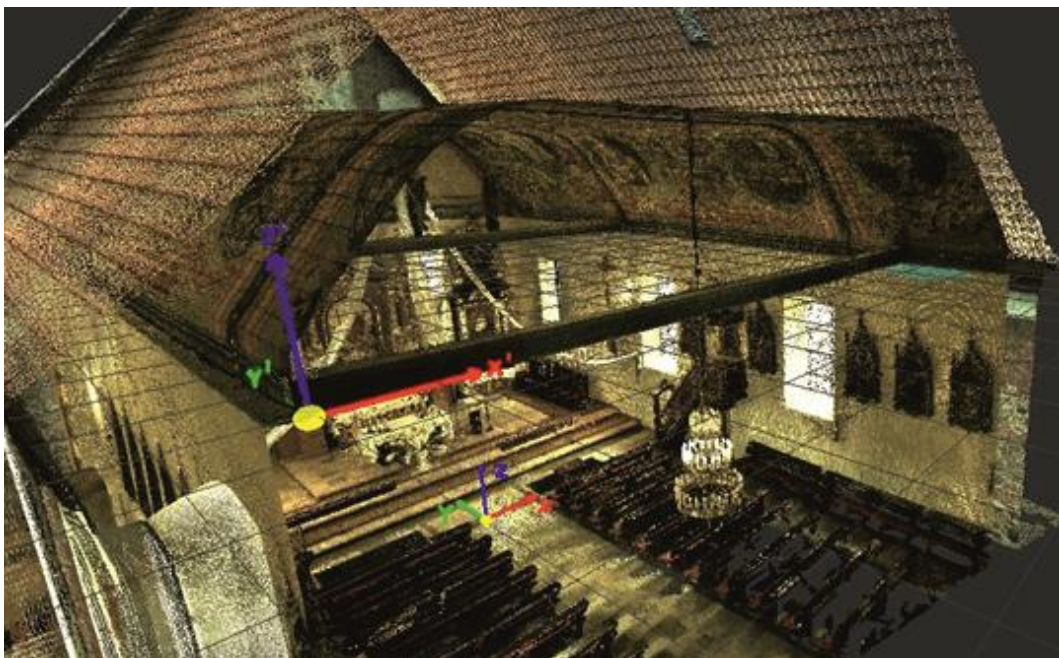
Fig. 6. Established coordinate systems: (XYZ) on the floor and ($X'Y'Z'$) on the beam
 Source: Own work.

A timber beam located over the nave of the church was examined. In the course of conducted research the analysis of the shape of the beam was made, using two mutually independent reference systems to enhance the reliability of the obtained results. The first new coordinate system (XYZ) was established at the point located on the floor (Fig. 6). After adopting the ordinate of the floor at the point of intersection of two diagonals running between the corners of the building $z = 0.00\text{ m}$, the coordinates of the points located at the bottom of the beam were read. Analysing the difference in height the deformation of the member can be observed as well as the difference in the height of the support. The second coordinate system ($X'Y'Z'$) was created on the beam support (Fig. 6). The set reference plane, passing through the X' and Y' axes, provides the basis for comparative analysis.

After comparing the results of measuring the beam deformation from the two different reference systems it can be stated that the change in the position of the centre of the coordinate system has no impact on the measurement results (Table 1).
