## **Fretting wear in an interference fit with a modified surface layer of the shaft**

Research results presented in the article pertain to fretting wear in a push-in connection. The research was carried out on an interference fit - a shaft and a sleeve. Surface layer of the examined shaft was modified through rolling and surface hardening. The analysis also adopted the research over shafts without modifications to the surface layer. At first the tear and wear tests were carried out in a fatigue machine, enabling to perform rotational bending of the sample, as a consequence of which cooperating oscillatory shifts appeared on the surface, which is a condition for the fretting wear emergence. After the tear and wear phase, there were laboratory tests carried out, the purpose of which was to determine the actual condition of the surface layer. Those examinations included macroscopic and microscopic observations carried out with an optical and scanning microscope. The research proved that elimination of the adhesion phenomenon limits development of fretting wear. Observation of samples suggests that application of surface hardening limits development of fretting wear to the greatest e

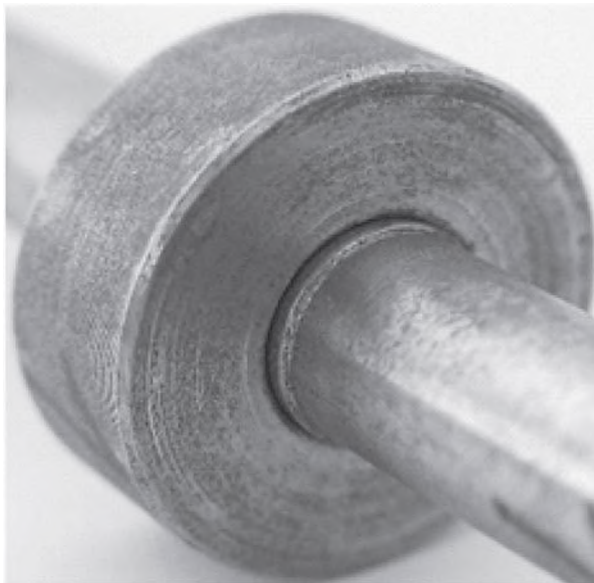
Fig. 2. View on the sample around the push-in connection

The connection between the shaft and the sleeve was made through pushing the sleeve into the shaft. Fig. 2 presents the samples near the connection.
