Witold Lenart, Małgorzata Roge

THE IMPACT ASSESSMENT OF CONSTRUCTION AND OPERATION  
OF THE TRANSIT GAS PIPELINE RUSSIA — WESTERN EUROPE  
ON ENVIRONMENT

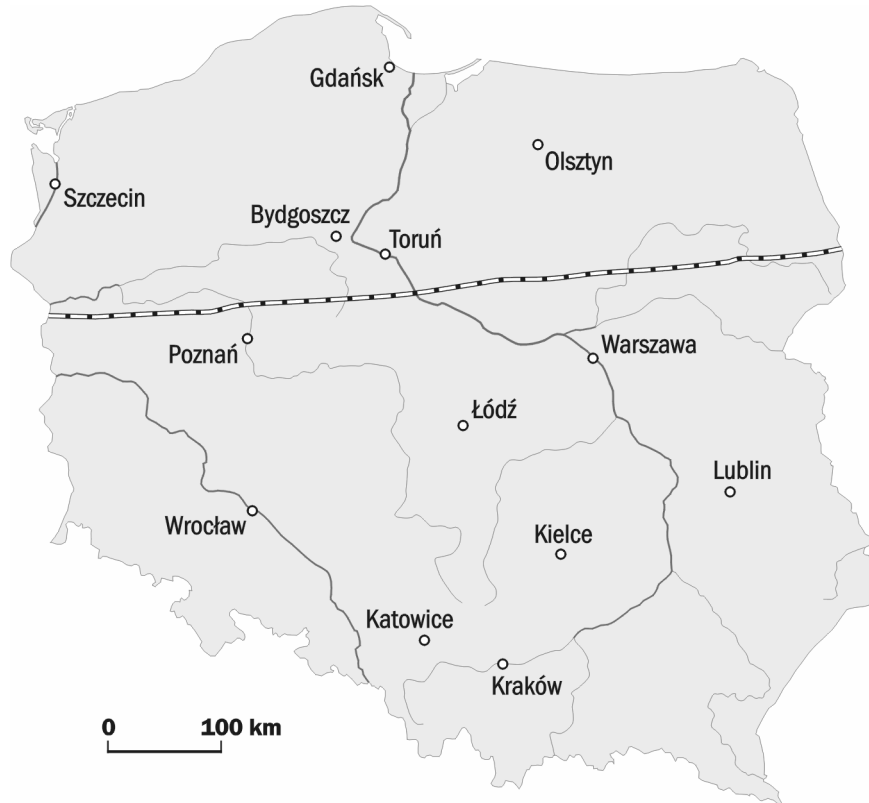
Fig. 1. The route of the transit gas pipeline across Poland.

The realisation of the transit gas pipeline Russia — Western Europe started in 1993. Construction of the first line lasted four years and ended in the Fall of 1999. The length of the Polish section of this line is about 680 km. Its route was conditioned by the locations of connections on the boundaries of Poland with Belarus' and Germany, the assumed minimum distance from the densely populated areas, and the stimulation of determination of the possibly short route of the pipeline. It was attempted to stake the pipeline across the agricultural areas. Resulting from the efforts made in order to comply with such requirements the pipeline crosses the area of Poland from the East to the West along a line close to the straight one. The construction of the pipeline started at the western border, with the first section of more than 100 km treated as a good testbed. The route of the pipeline across Poland is shown in Fig 1.
