Andrzej T. Jankowski, Marek Ruman

WATER LEVEL FLUCTUATIONS IN THE TURAWA RESERVOIR IN RELATION TO THE TOURIST USE OF THE WATER BODY*

Abstract: The aim of the paper is to assess the fluctuations of water levels in the Turawa Reservoir (50° 43' N, 18° 08' E) in relation to the tourist use of the water body. The reservoir is situated within the macroregion of the Silesian Lowland in the mesoregion of the Opole Plain. In administrative terms, the reservoir is situated in the pole Province within the borough of Turawa. In hydrological terms, in turn, it is situated in the catchment area of the Mała Panew river, which belongs to the basin of the Odra river. The Turawa Reservoir was opened for use in 1938, and in 1948 it was filled with water to its maximum for the first time. At present, the surface area of the reservoir, when it is filled with water to its maximum, is about 20.8 km², its volume 99.5 mln m³, and its depth exceeds 13 meters. In the period of hydrological years 1976-2000 water levels in this reservoir were characterized by high, unnoticed in natural conditions, amplitudes of changes reaching 6.99 m. Anthropogenically stimulated fluctuations in the water level result in c

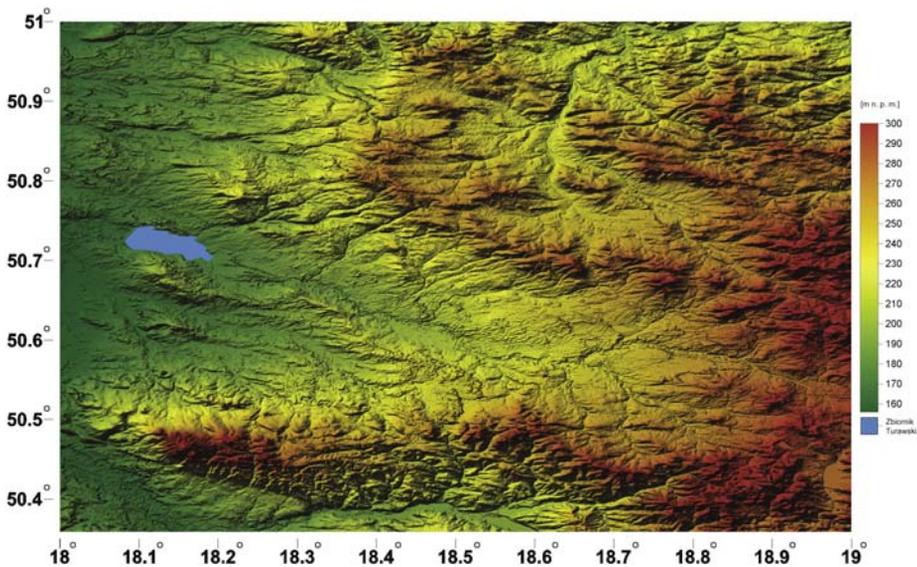
Fig. 1. Situation of the Turawa Reservoir in the digital terrain model (own compilation).

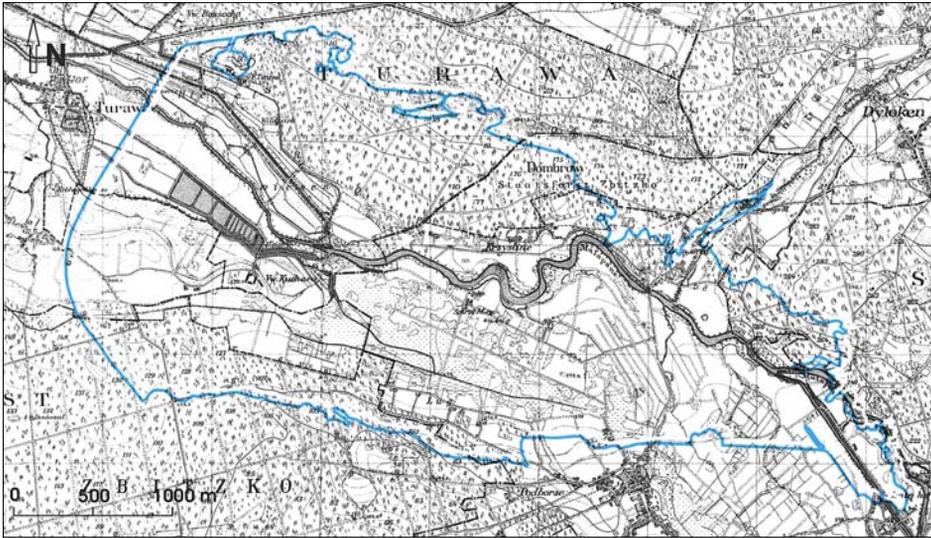
Fig. 2. Planned areal extent of the Turawa Reservoir (based on Staubacken an der Malapane bei Turawa..., 1933)

The earliest historical records regarding construction of the reservoir date back to the early 20th century. In late 1903 the beginning of field work in the valley of the Mała Panew River was reported. The construction work which was carried out at that time would later become the foundation of the dam. Actual work, however, did not start until more than 30 years later (Świerc 1992). Construction work of the reservoir in Turawa started in July 1933 and ended in late autumn of 1936. In 1933 the first map was compiled presenting the regions of the Mała Panew valley that would be taken up by the reservoir to be built (Fig. 2).

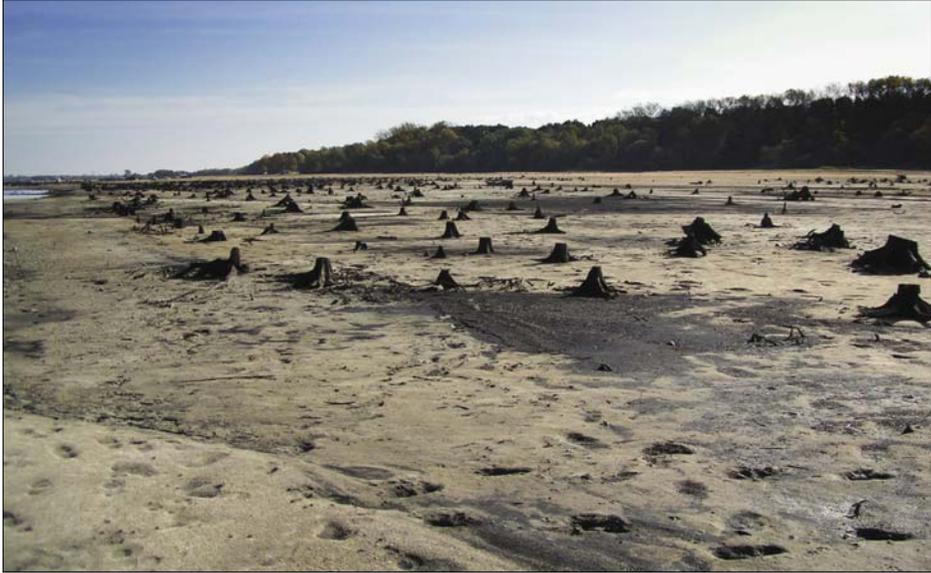
Photo 1. Exposed bottom of the Turawa Reservoir – December 2006 (Photo by M. Ruman)

Before building the Turawa Reservoir, the land situated south of the Mała Panew River had been used mainly in agriculture as fields, wet meadows and pasture land. The land situated north of the river, in turn, had been almost entirely afforested, mainly with pinewoods (Teisseyre 1983). Roots remaining of those trees were not removed during the construction of the reservoir. These roots still exist in the bottom of the reservoir and can be noticed in autumn and winter when the water level is low (Photo 1).

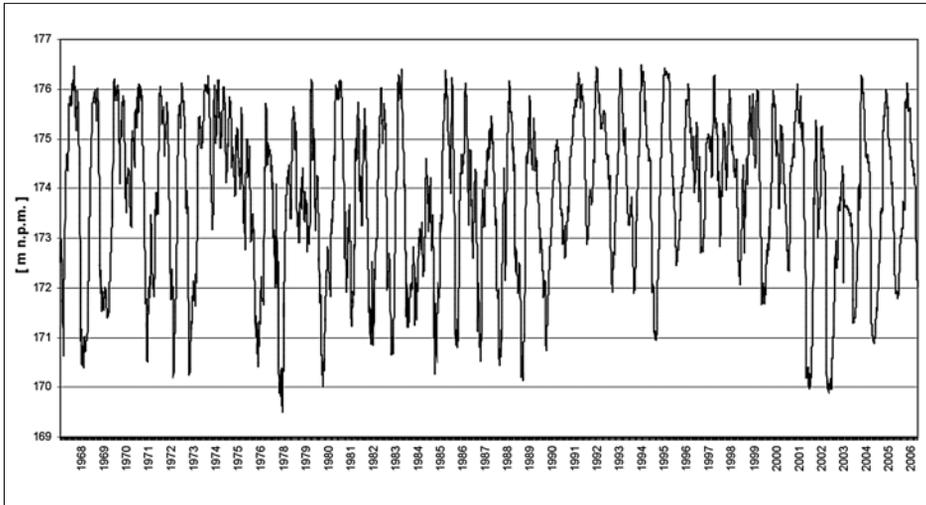
Fig. 3. Daily water levels in the Turawa Reservoir in the period of hydrological years 1968-2006 (own compilation based on data by RZGW)

Multiple functions of the Turawa Reservoir and following the directions of water management have become the source of problems in its management followed by high fluctuations in its water levels. In the period of hydrological years 1968–2006 water levels in this reservoir were characterized by high amplitudes of changes reaching 6.99 m. (Fig. 3). Changes in the water level resulted in changes in its retention (Fig. 4). In the period of hydrological years 1968-2006, the lowest retention was at 7.6 mln m³ (7% of total volume), and the highest was at 96.8 mln m³, (90% of total volume), which gives an amplitude of 89.2 mln m³. In the period under discussion, the lowest volume of the reservoir was reported in November and December (about 28% of total volume), and the highest volume in May (about 70% of total volume).

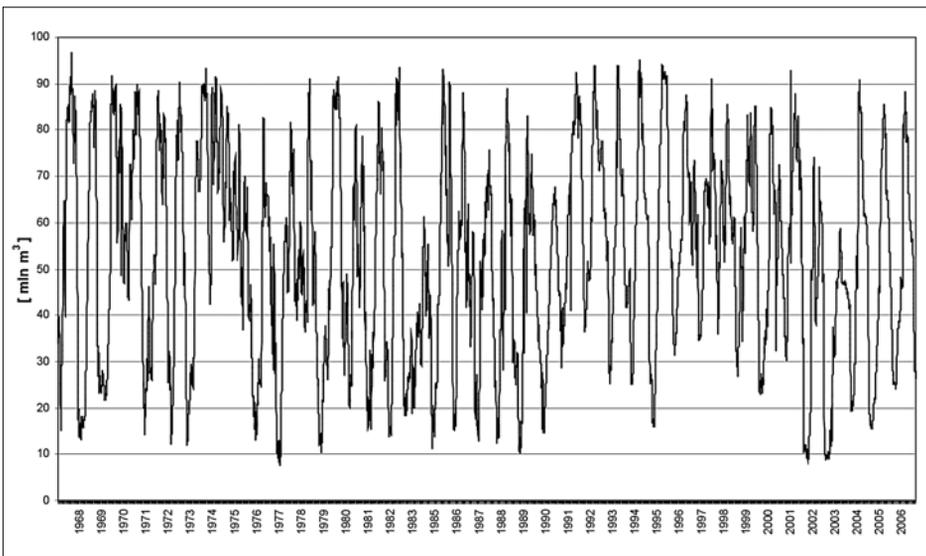
Fig. 4. Daily water retention in the Turawa Reservoir in the period of hydrological years 1968-2006 (own compilation based on data by RZGW)

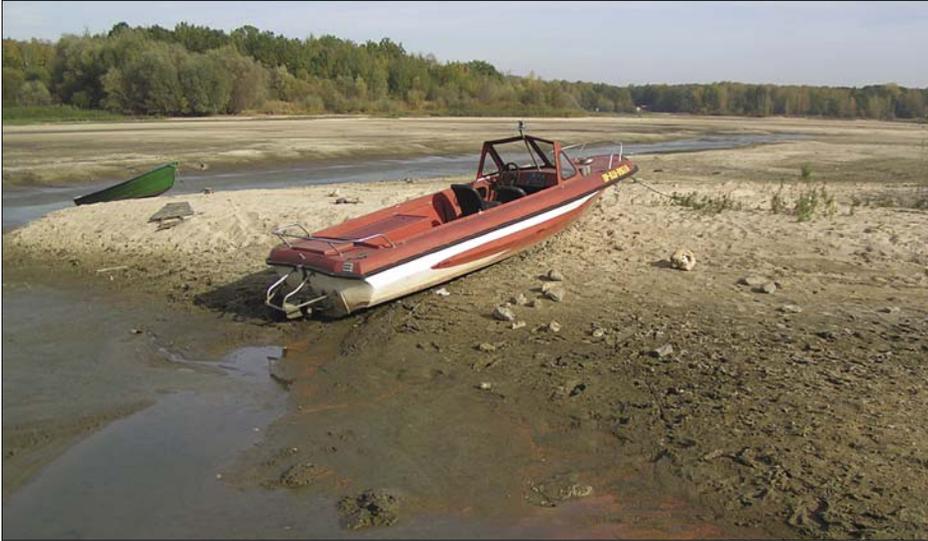
Photo 2. Low water levels hinder the recreational use of the Turawa Reservoir – October 2006 (Photo M. Ruman)

Anthropogenically stimulated fluctuations in the water level result in conflicts in terms of tasks and functions that the Turawa Reservoir was designed for. Excessive outflow and intake of water in the autumn-winter season lowers the water to the level at which the use of the Turawa Reservoir for recreation and relaxation becomes seriously hindered (Photo 2).

The exposed muddy bottom makes it impossible to reach the waters of the reservoir at that time. Fishing is only possible, but is limited to the crown of the dam. In winter, when the reservoir is frozen, fluctuations of the water level cause a lot of dangers and hindrances. When the water level rises in the reservoir, ice dams on the banks of the reservoir and makes it impossible to do ice sailing or fishing (Photo 3). When the water level drops rapidly, in turn, an air layer is formed between the ice layer and the water level, which is very dangerous for unaware tourists.

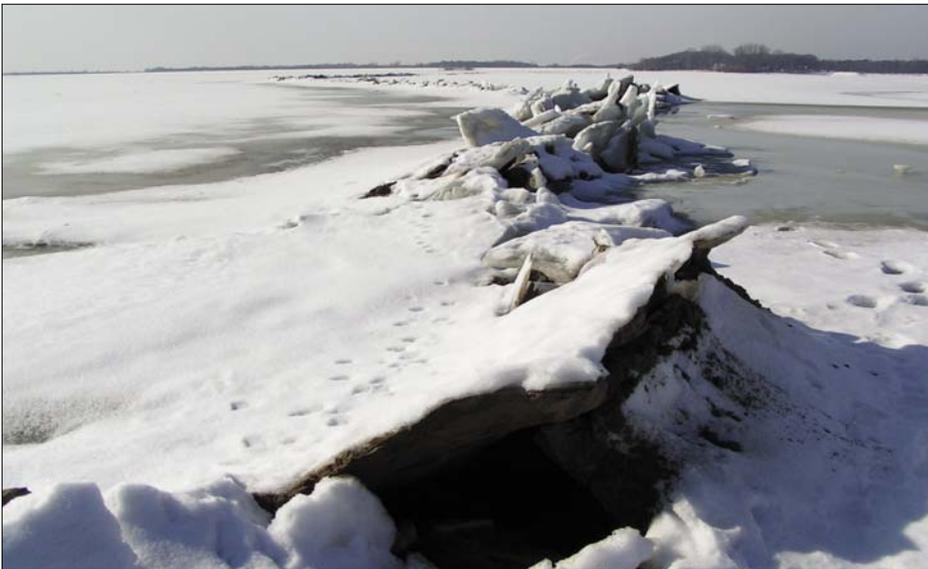
Photo 3. Damming of ice cover in the Turawa Reservoir – February 2006 (Photo M. Ruman)

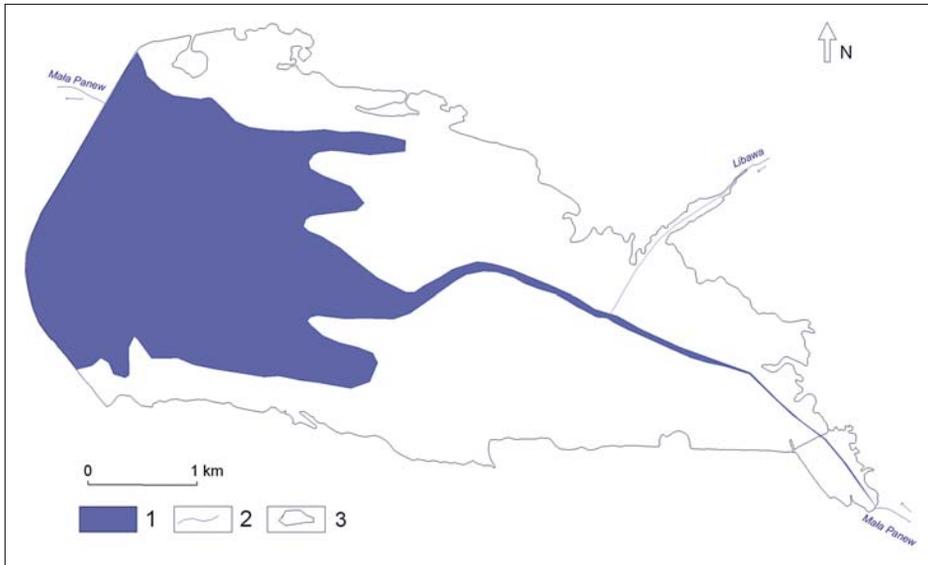
Fig. 5. Changes in the surface area of the Turawa Reservoir (own compilation) 1 – extent of the reservoir on November 3, 2004 (170.88 m a.s.l.) marked basing on the calculations using the GPS receiver, 2 – water streams 3 – extent of the reservoir at normal water damming (176.35 m a.s.l.)

Such significant changes in the volume of the reservoir make fish farming difficult (problems to keep the number and health condition of fish at a desired level) and decrease the aesthetic value of the vicinity (Jankowski, Rzętała 1997; Machowski, Ruman, Rzętała 2005). During low water levels, the bank zone moves towards the inside of the reservoir resulting in bottom exposure (Fig. 5, Fig. 6).

The surface area of the reservoir decreases to about 8 km² during the lowest water levels, which is about 38% of the total surface area at 20.90 km². Exposure of the reservoir bottom has a negative effect on the quality of water. Intensive decomposition and mineralization of organic matter occurs. Mineral salts and humic substances that are created as the result of this process cause – directly and indirectly (growth of algae and bacteria) – deterioration of water quality when the reservoir bottom is fully covered with water again (Pasternak 1984). That, in turn, intensifies eutrophication in summer, which makes the tourist use of the reservoir impossible. Algal blooms result in forma-

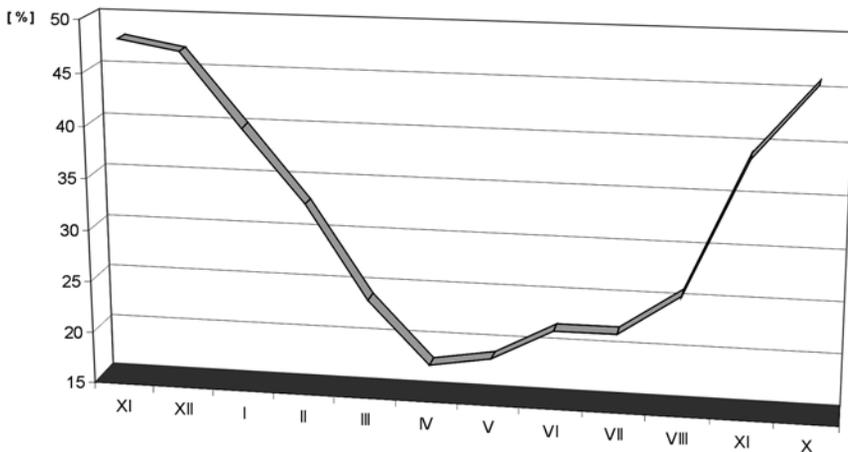
Fig. 6. Average monthly exposure of the bottom of the Turawa reservoir in the period of hydrological years 1996-2005 (own compilation)
