# Excavations next to House H1 in 'Marea' (Egypt) in 2017

Abstract: Archaeological excavations in the 2017 season continued the investigation of the early Byzantine and early Islamic House H1 in the northeastern part of 'Marea'. The building had already been excavated, but required further study to identify the type and function of structures in its immediate vicinity. Five stratigraphic trenches were excavated, exploring a well shaft, one of the wall abutments, a small cell added to the building, a sewer and streets with an accumulation of debris and rubbish. This also enhanced a better view of the house surroundings as well as their development in the course of the 6th century and later. A range of Roman ceramics from layers underlying the house was also discovered in the deepest of the trenches.

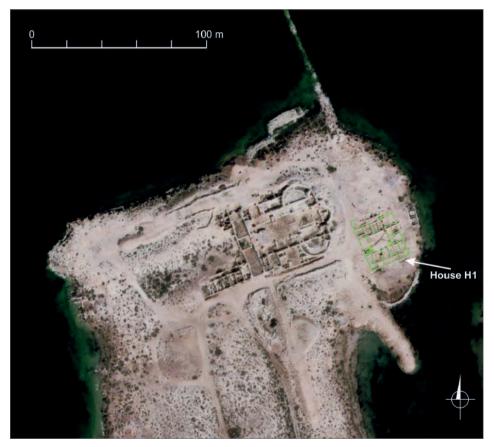
Fig. 1. Satellite image of the northeastern part of 'Marea' with the indication of the position of House H1 (University of Warsaw Marea Archaeological Project | processing M. Gwiazda)

The 'Marea' site is located on the southern shore of Lake Mareotis, near the modern village of Hawwariyah and about 40 km southwest of Alexandria. The identification of the ancient name of the settlement has long been disputed (Rodziewicz 2003: 27–38; Wipszycka 2012), even so most researchers continue to refer to the place as 'Marea'. Intermittent excavations since 2011 have focused on the uncovering of a house designated as H1, a feat finally completed in 2016 (Kościuk 2012: 29–32; Babraj, Drzymuchowska, and Willburger 2014: 48; Wielgosz-Rondolino and Gwiazda 2016) [Fig. 1].

least the mid 8th century. It is the only residential building excavated in 'Marea'. Other buildings in its vicinity include an early Byzantine church just across the road, a port warehouse, quay and latrine [see Fig. 1].

this part of the settlement was discharged south, towards an artificial bay/port (see Rodziewicz 2010: Fig. 4.14) [see Fig. 1].

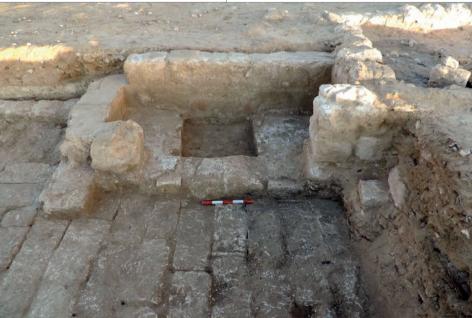
Fig. 3. Well (cistern?) in trench T1: bottom, view of the enclosure looking north; top, west wall of the shaft (University of Warsaw Marea Archaeological Project | photo M. Gwiazda; drawing A. Pawlikowska-Gwiazda, digitizing M. Gwiazda)

Clearing the space adjoining Room 22 on the north in 2016 uncovered a room designated then as T1. It had a stone floor and two unidentified installations, located by the south and north walls respectively. These rectangular enclosures were filled with earth. The northern installation was excavated. Some 2 m of deposits were removed (before stopping because of a high groundwater table) from a shaft measuring 1.00 m by 0.80 m [Fig. 3 bottom]. One of the inside faces of the well was documented [Fig. 3 top]. The well (cistern?) was built of limestone ashlars covered with pink waterproof plaster and furnished with typical openings in the walls enabling climbing up and down inside the shafts.

of the installations located there. The partly excavated shaft, made of pseudoashlars bonded in hydraulic mortar, was certainly a well or cistern. Characteristic footholds for climbing, known from the Christian basilica and the sagiyah (Szymańska and Babraj 2008: 85, Figs 31, 32, 34, Phot. 71; 2012: 60, Fig. 3), were previously identified in other structures of this kind in 'Marea'. In the case of House H1, the presence of a relatively narrow shaft may indicate that it was indeed a well wherefrom groundwater would have been drawn (see Mycielska-Dowgiałło and Woronko 2008: 23). Similar structures are also present in other parts of House H1. Two wells were found previously in the northeastern and southwestern parts of Courtyard 17. Another small presumed well, built entirely of bricks, was added to the east wall of the house. east of Room 12. The installation uncovered in room T1 is different because it was enclosed on three sides by walls creating a small room that was probably originally roofed. Most probably, this newly examined well was originally connected with a building located on the north side, and only later incorporated into house H1.

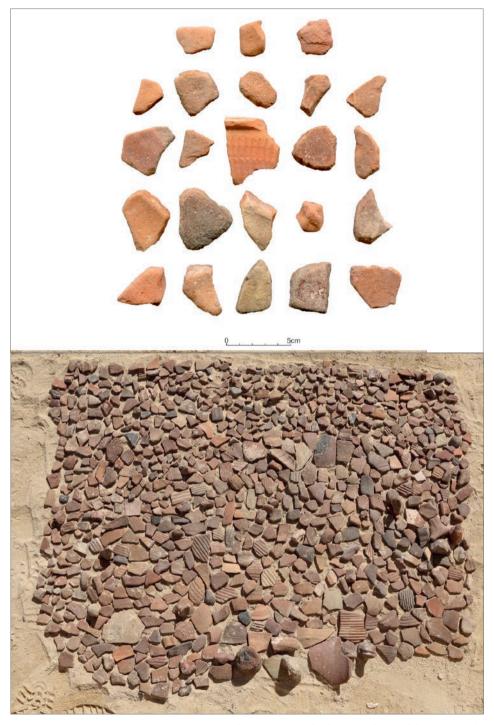
Fig. 11. Selected small water-washed ceramics from Trench T8 (top) and T9 (bottom) (University of Warsaw Marea Project | photos A. Pawlikowska-Gwiazda and M. Gwiazda)

The underlying deposit was 0.20 m thick with a significant number of small fragments of ceramic vessels with rounded edges [Fig. 11 bottom]. The deposit also contained tableware (LRD and ERSW A), LRA 4, LRA 5/6, LRA 7 [Fig. 10:1–7], and Egloff 167 amphorae, dating this layer and the ones above it to the second half of the 7th century or later. The debris underneath was composed of small ir-

Of interest are the small pieces of water-washed ceramic sherds, found in abundance in trench T8, in the levelling layers under the house, and in trench T9, in the trash from the end
